# **USS *Yorktown* Remediation Plan Final**

Research Planning, Inc.  
1121 Park Street, Columbia, South Carolina 29201

**19 July 2023**

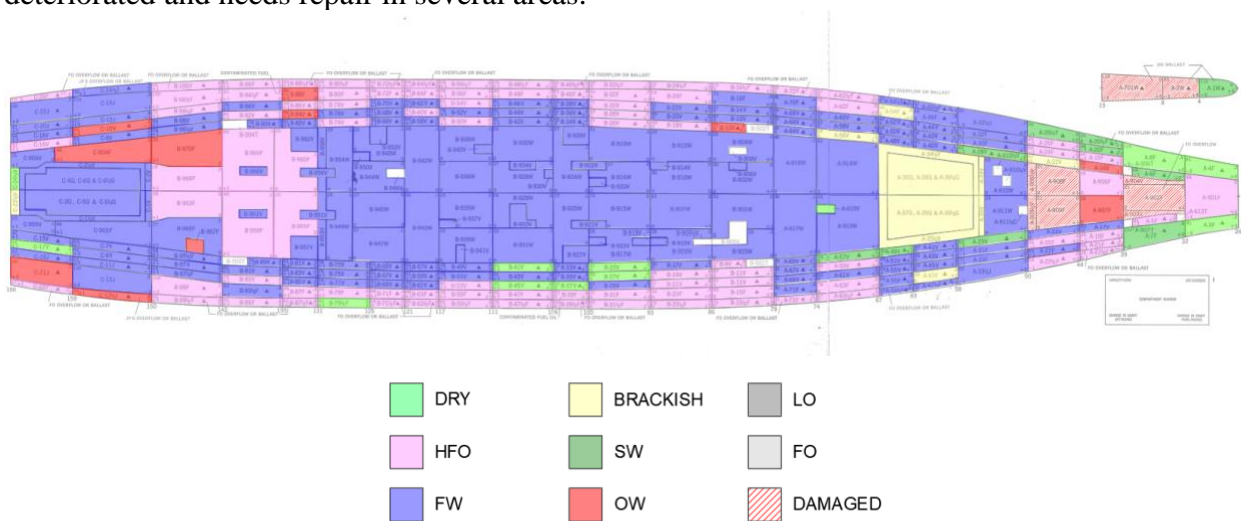
Figures 2-3 and 2-4 provide an indication of the distribution of the types of contents. These are shaded illustrations of the Damage Control Diagram 1 – Liquid Loading drawing. This drawing is used to reference the tanks typically used for storing fluids when the vessel was in service. The drawing mainly shows the tanks below the 4<sup>th</sup> deck and double bottom tanks. Full size pdf files are included in the appendices and attachments.

Not shown in the illustrations are the third bottom and other voids/ cofferdams considered as tanks. Please refer to the HECSALV report for details. Several tanks containing HFO are integral to the hull plating. Previous reports and observations indicate the tidal zone of the hull has deteriorated and needs repair in several areas.

**Figure 2-3.** Distribution of tank content types per the Damage Control Diagram 1 - Liquid Loading drawing.

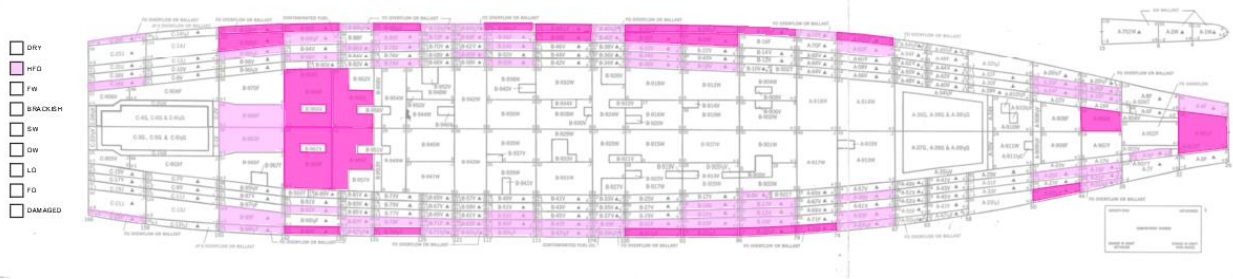
**Figure 2-4.** Tanks containing HFO (significant amounts in bold).

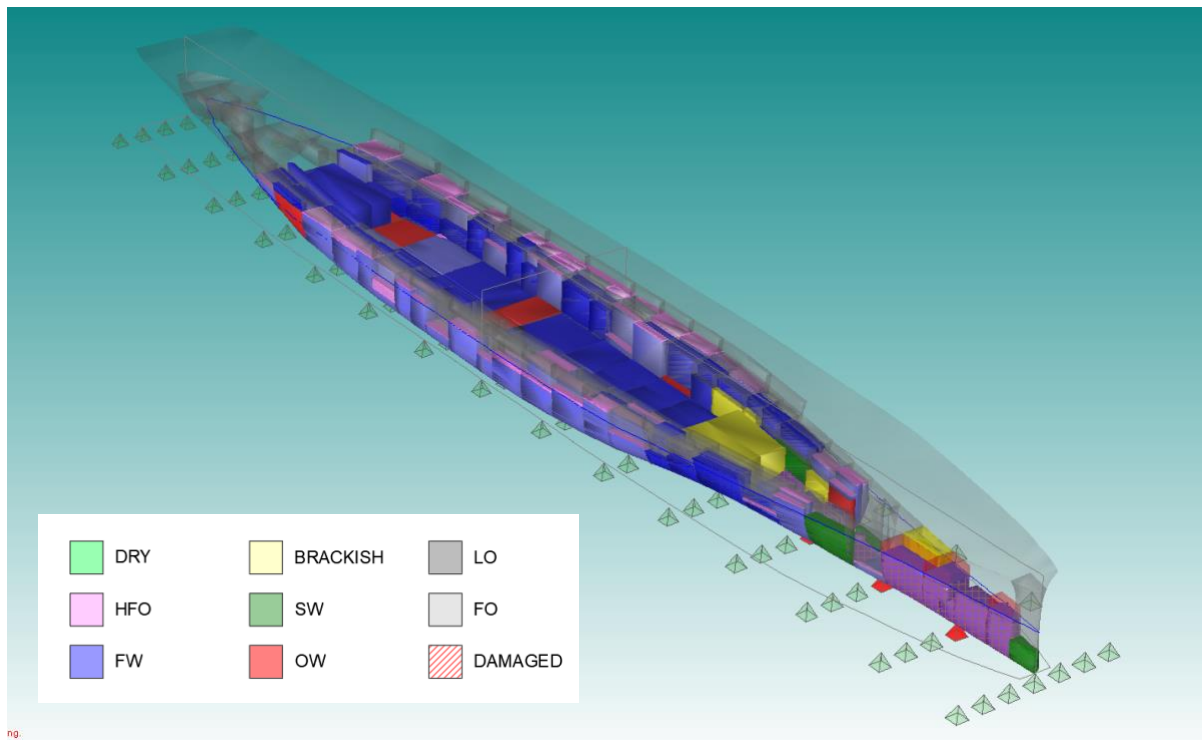
Figure 2-5 illustrates the distribution in an isometric view of the structural tank model. The quantity of each type of content observed is listed in Table 2-3.

**Figure 2-5.** An isometric view of tank contents, shaded by type.

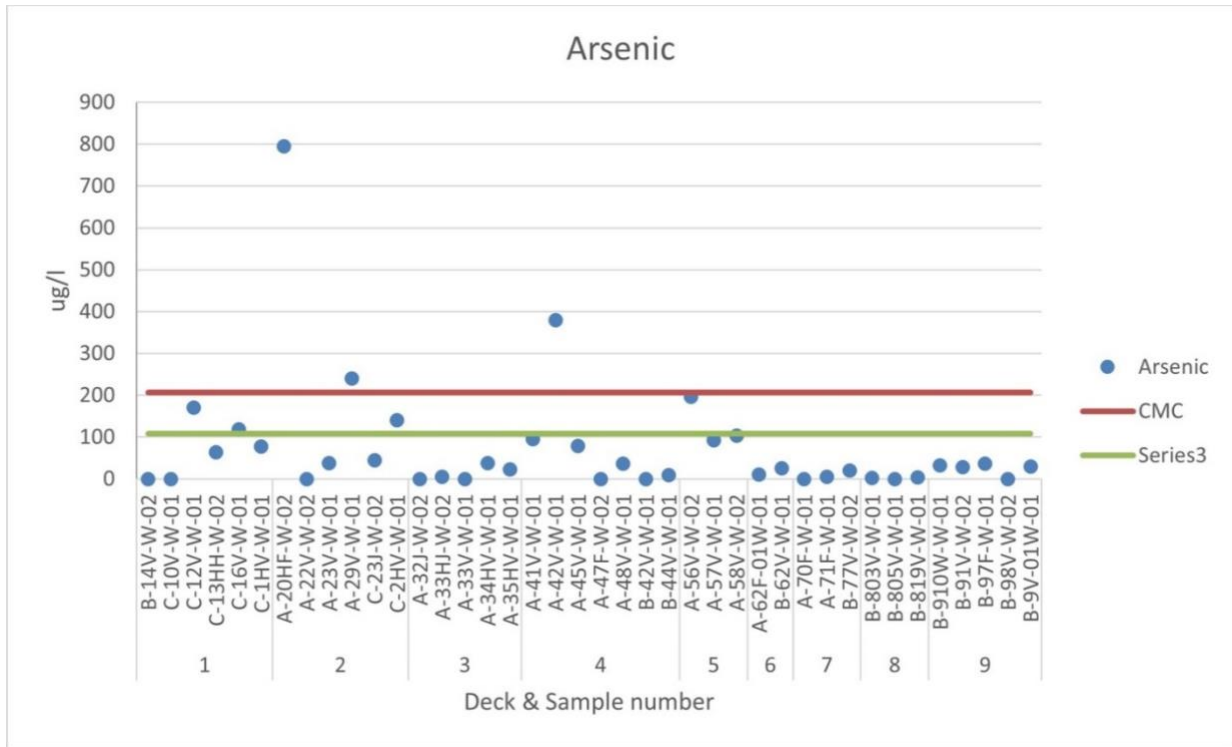
The water concentrations for the tested metals are shown by tank and deck in Figures 3-1 to 3-8, with colored lines representing the CMC (red) and CCC (green) standards. The CMC is the most appropriate water quality standard to consider because any discharge of water from the tanks onboard the USS *Yorktown* would be a one-time release, rather than a continuous discharge. Most of the water in the tanks exceeds the SCDHEC CMC saltwater standards for the tested metals except for barium, selenium, and silver. Lead levels in multiple tanks exceed the saltwater standards by three orders of magnitude; chromium by a factor of 30; and mercury by a factor of 40. Therefore, any water removed from the USS *Yorktown* as part of the efforts to remove the bulk of the oil would require treatment prior to discharge into Charleston Harbor. Small releases of water from leaks through the hull would likely be rapidly mixed into the water column and diluted below the salt water quality standards. Therefore, it is not recommended to pump off any water as a mitigation option, other than to access tanks for oil removal or to establish and maintain watertight integrity. Any replaced water would leach metals from the tank walls and eventually reach similar concentrations.

**Figure 3-1.** Concentration of arsenic in µg/L in water on the USS *Yorktown*, compared with SCDHEC salt water quality standard.

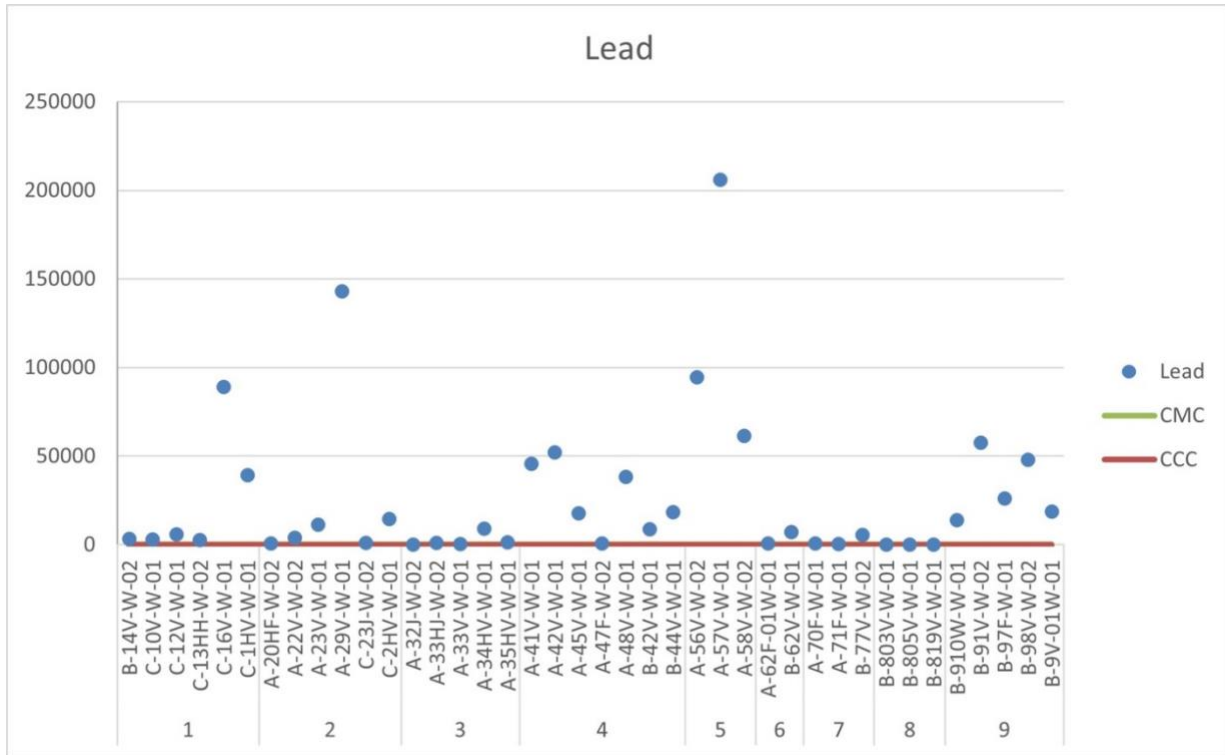
**Figure 3-5.** Concentration of lead in µg/L in water on the USS *Yorktown*, compared with SCDHEC water salt water standard. The CMC and CCC lines overlap at this scale.

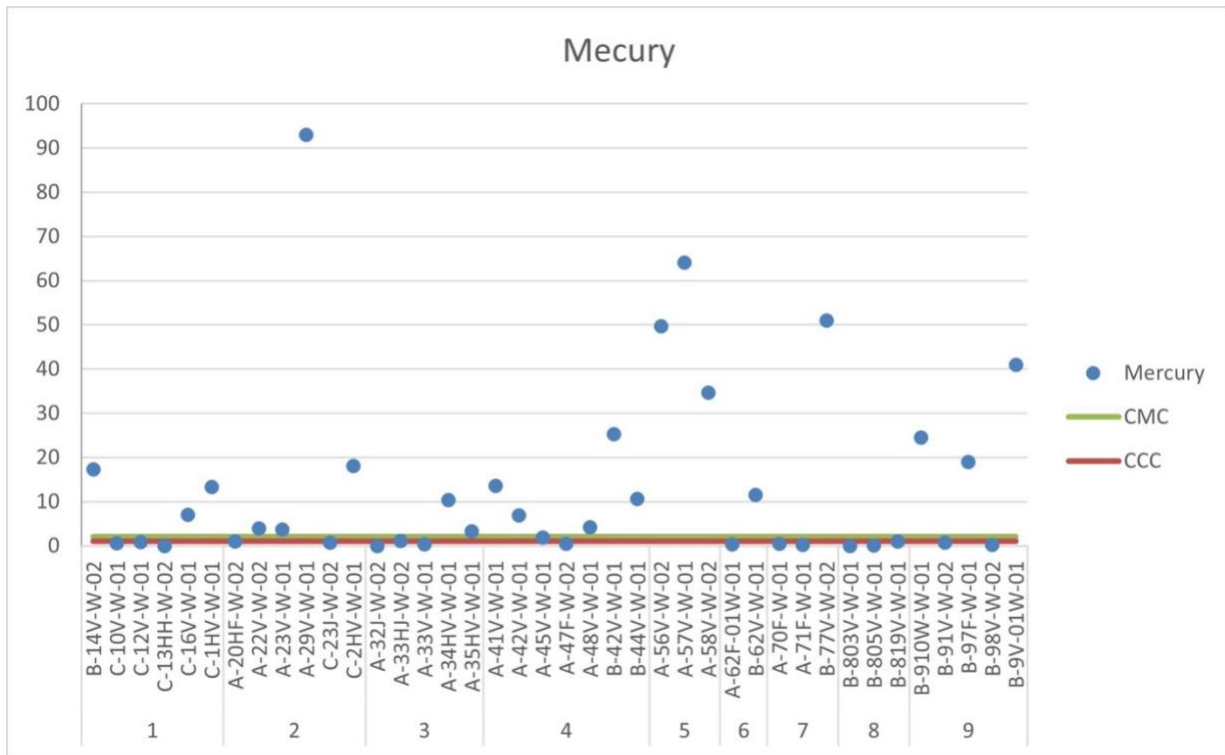
**Figure 3-6.** Concentration of mercury in µg/L in water on the USS *Yorktown*, compared with SCDHEC salt water quality standard.

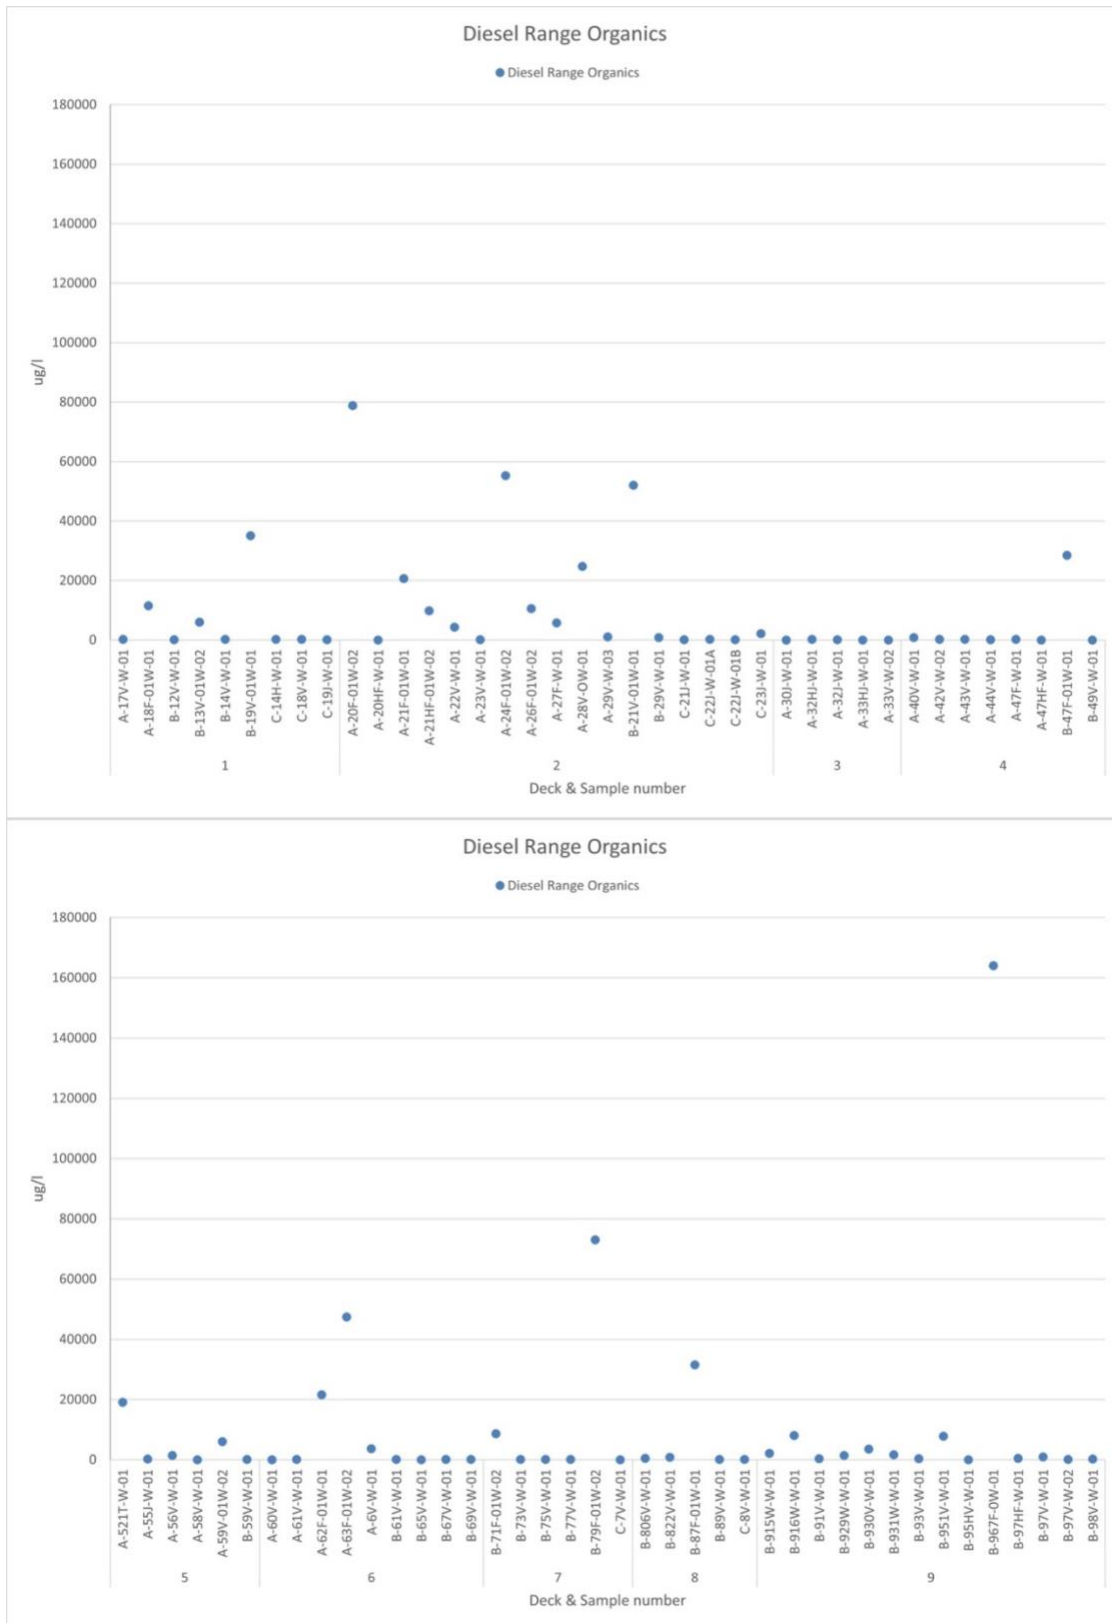
**Figure 3-9.** Concentration of diesel range organics (DRO) in water on the USS *Yorktown*, for values up to 180,000  $\mu\text{g/L}$  for decks 1-4 (top) and 5-9 (bottom).

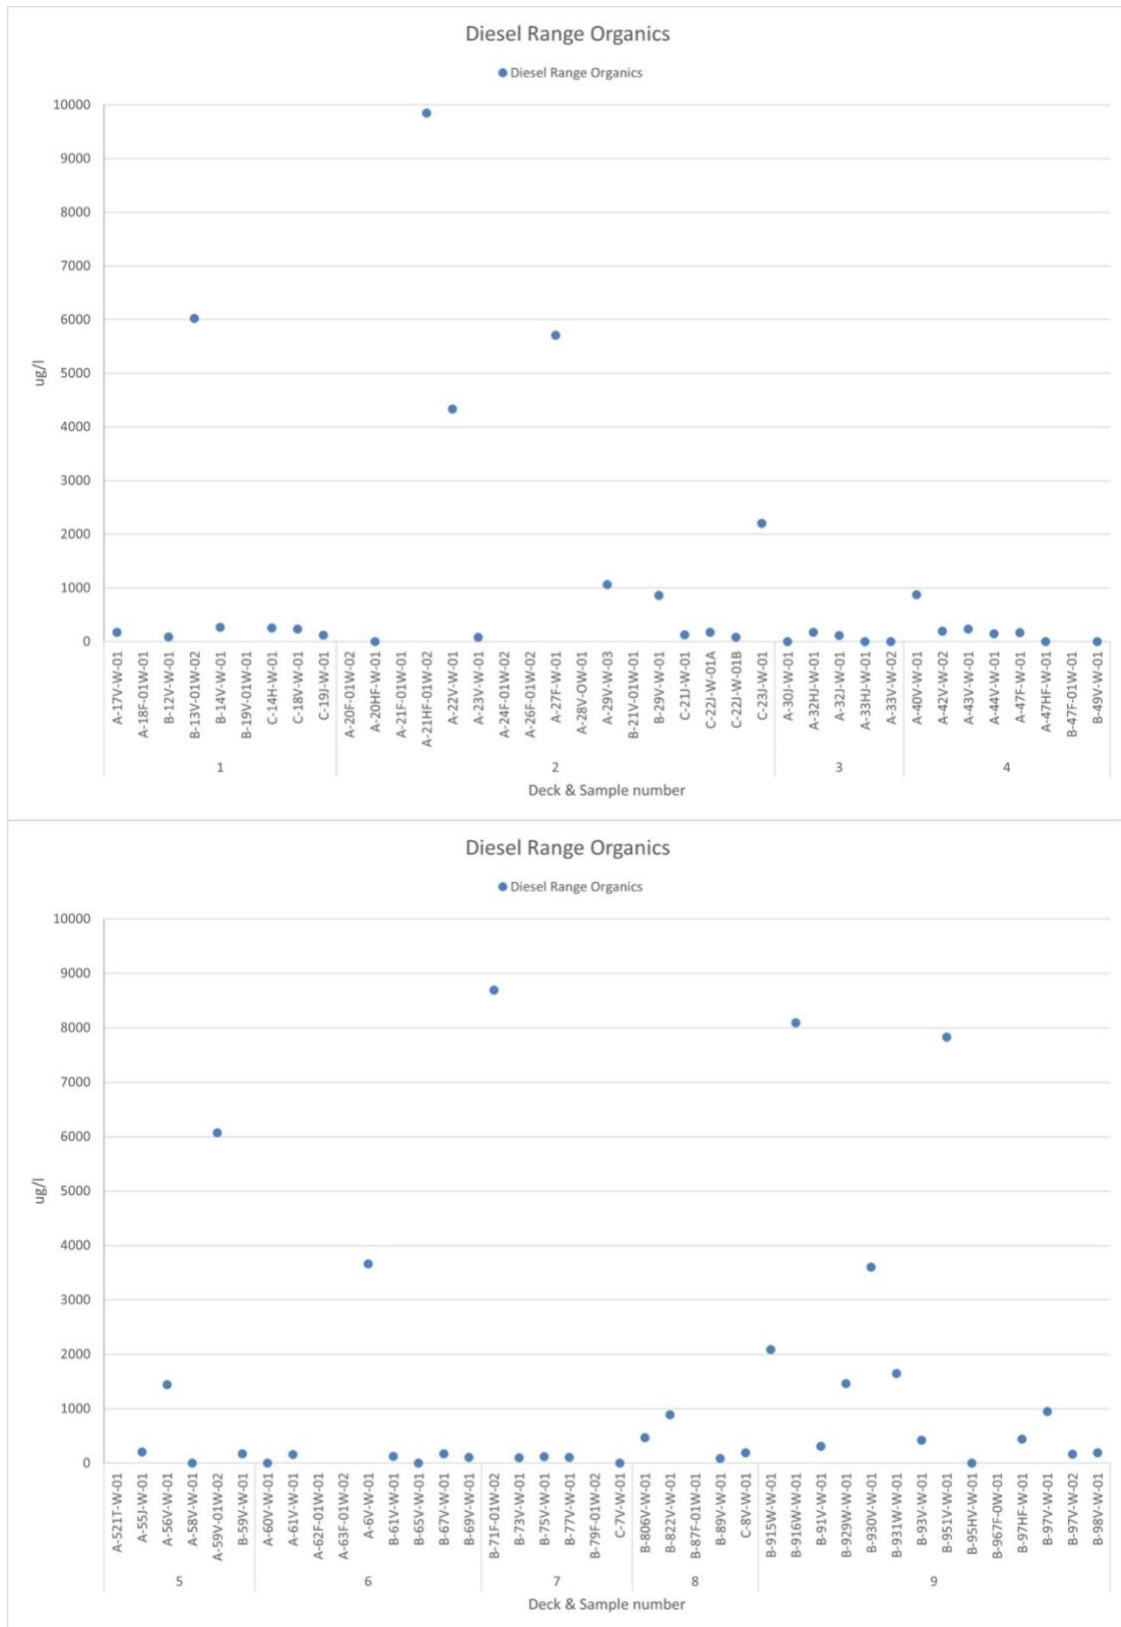
**Figure 3-10.** Concentration of diesel range organics in water on the USS *Yorktown*, for values up to 10,000  $\mu\text{g/L}$  for decks 1-4 (top) and 5-9 (bottom), making lower values visible.
