# USS *Yorktown* Immediate Repairs Report Final

Submitted to:

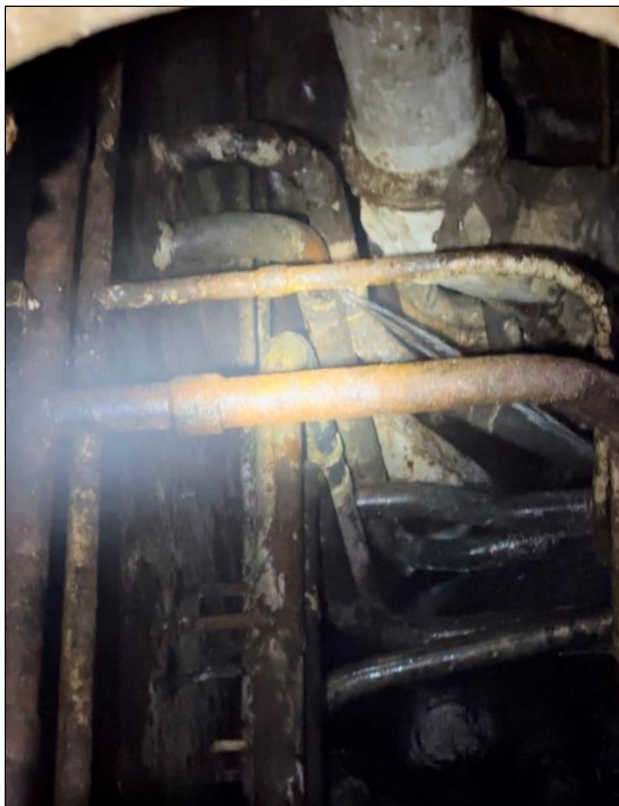
Figure 1. Leaking piping in tank A-28V.

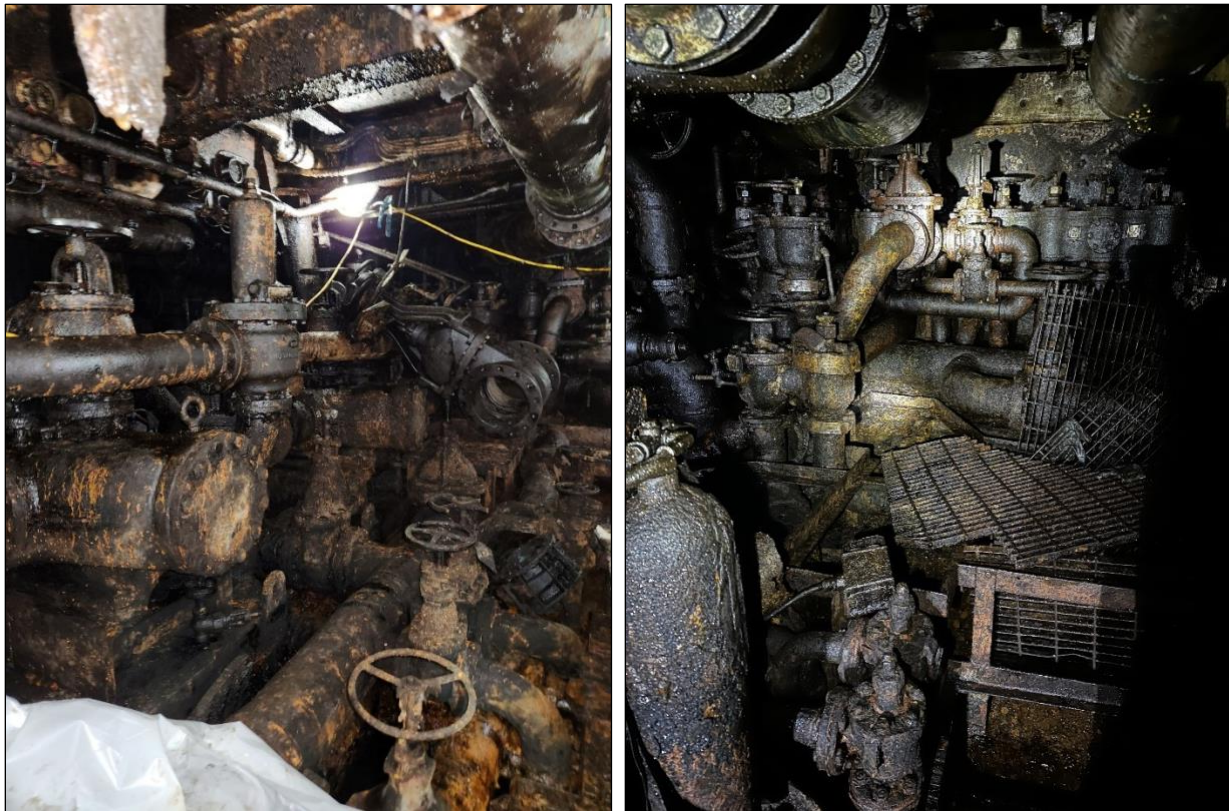
Figure 2. Photographs of pump room A-713E.

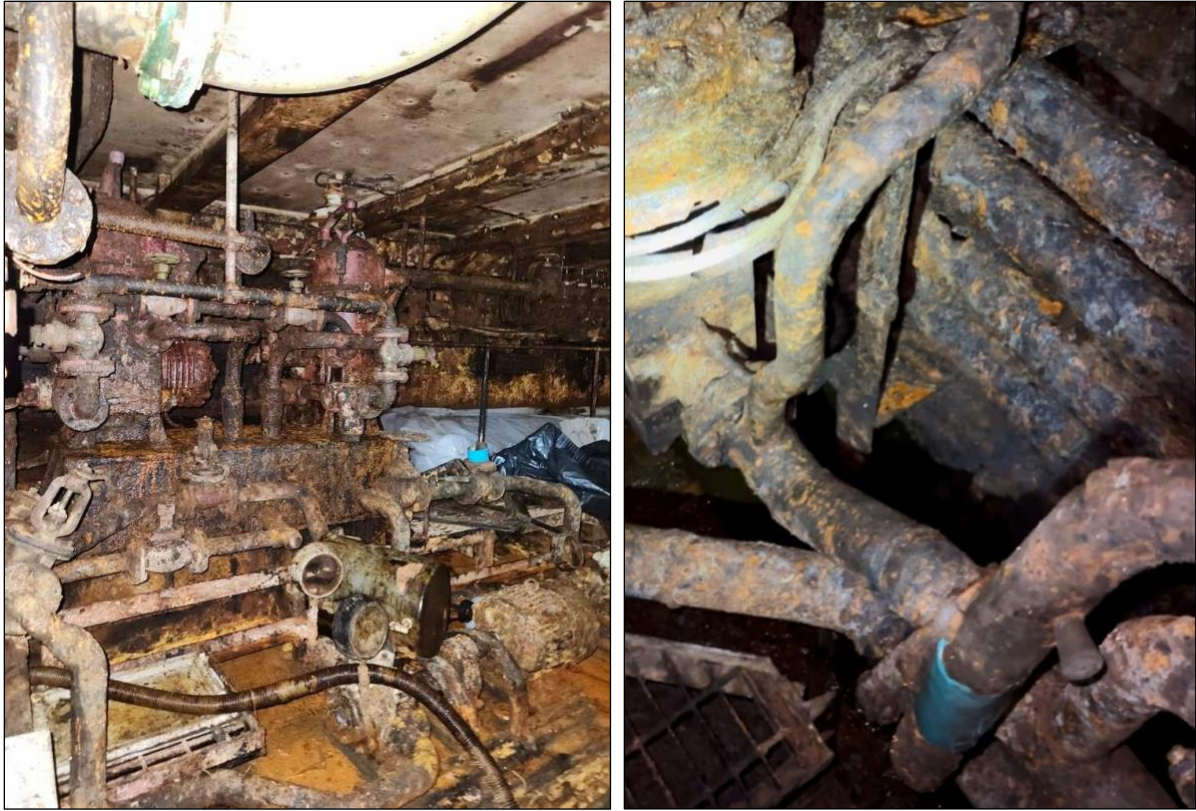
Figure 3. Examples of deteriorated condition of the piping in the pump rooms, A-713E.

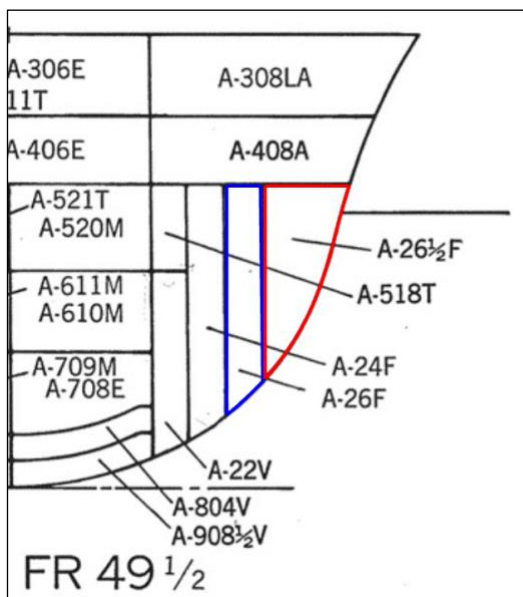
Case 1 – All piping into the outboard tank A-26.5F penetrates the inboard bulkhead directly from the second from side shell tank A-26F.

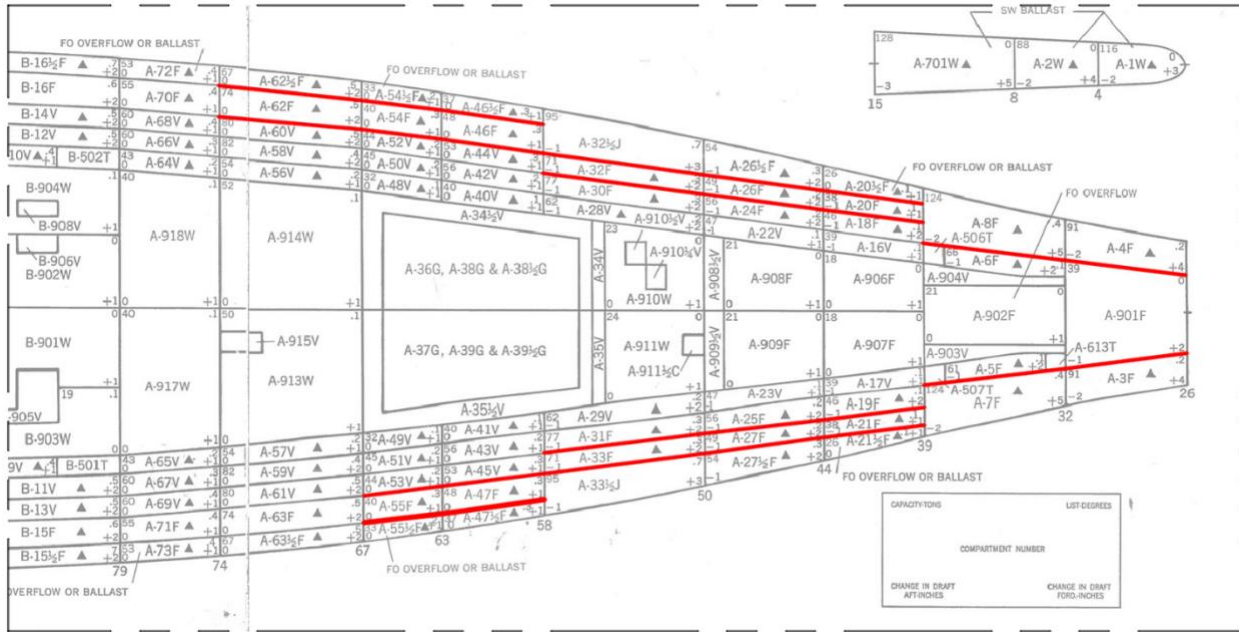
Figure 5. Boundaries (in red) created by removing sections of pipe at the bulkheads and sealing the bulkhead penetrations, consequently isolating the outboard tanks and restricting water migration through piping.

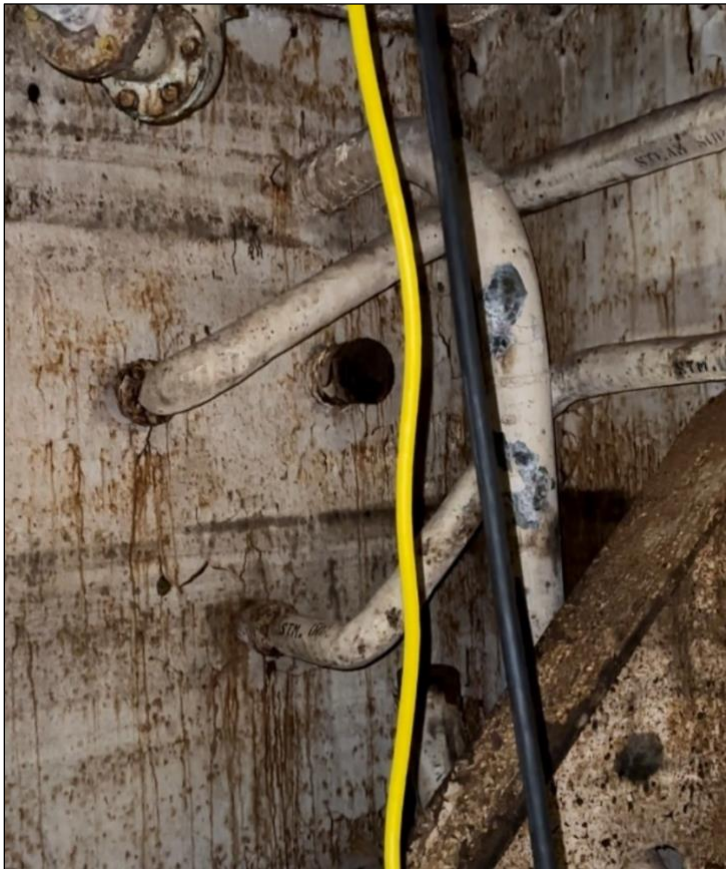
Figure 6. Piping to tank A-3F prior to removal. Photograph captured in A-704A.

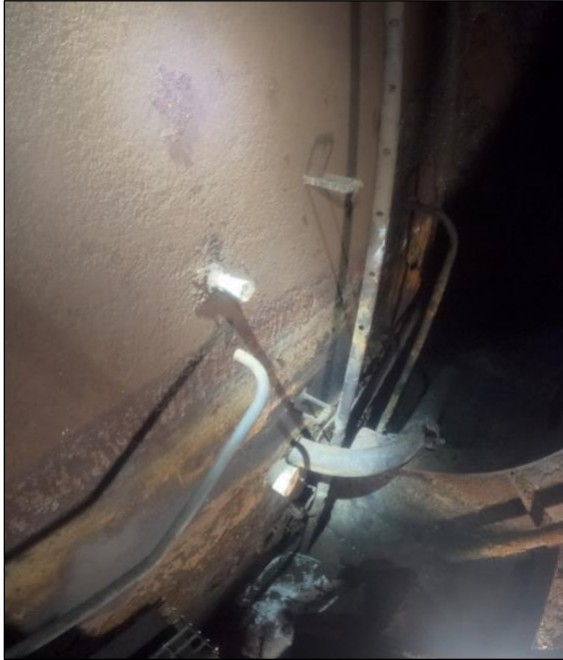
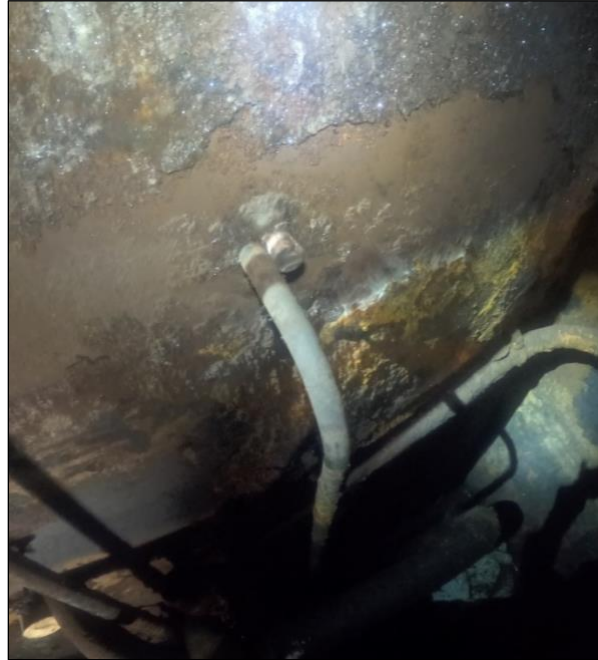
Figure 9. Condensate return (left) and steam supply (right) pipes cut and sealed in A-7F.

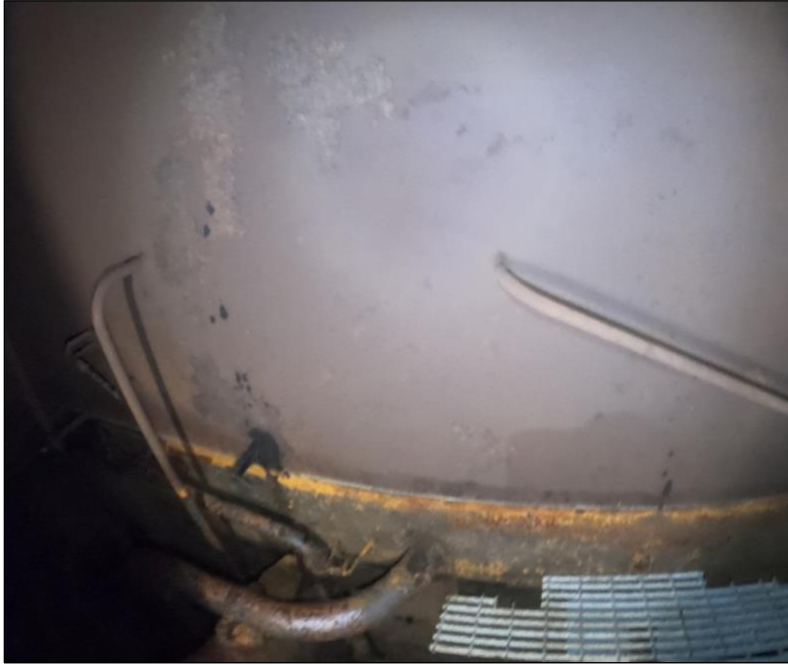
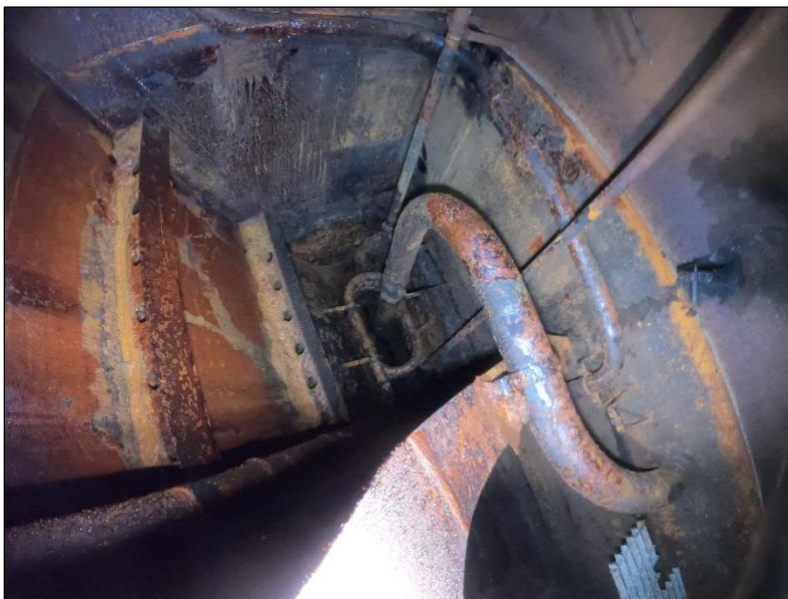
Figure 11. Piping in A-8F prior to removal.

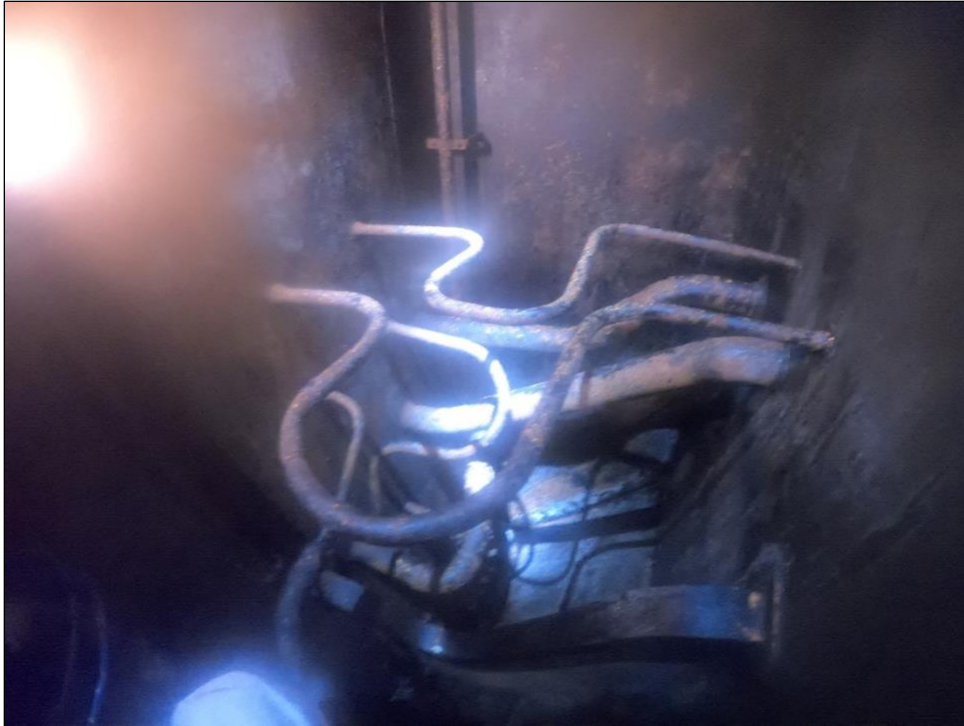
Figure 14. Piping in A-20F prior to removal.

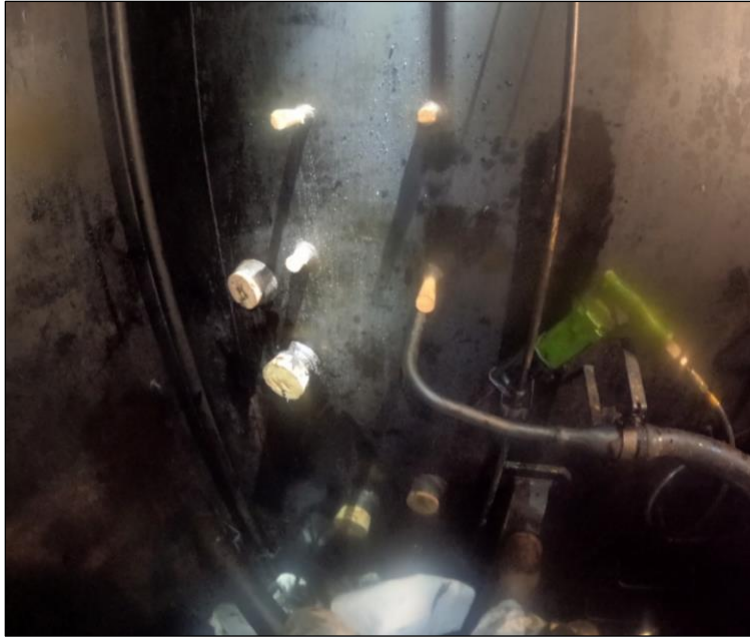
Figure 17. Penetrations sealed at the inboard bulkhead in A-21F.

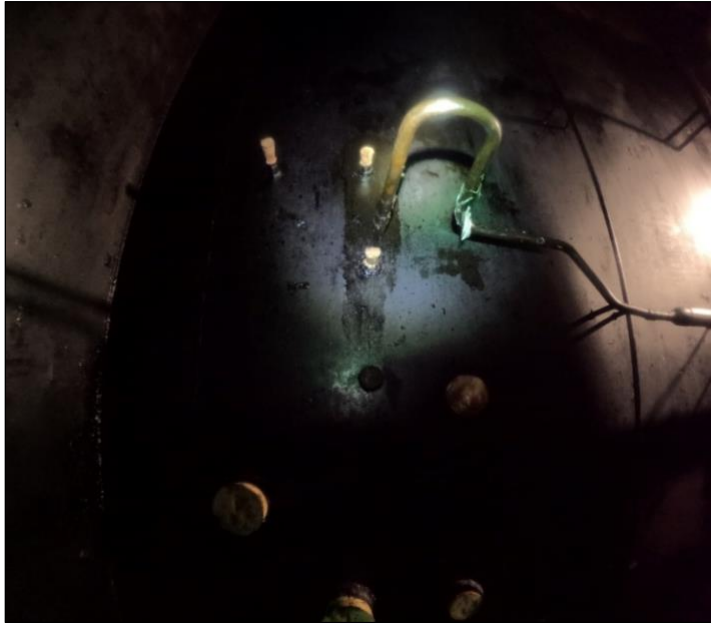
Figure 23. Penetrations sealed at the inboard bulkhead in A-21F.

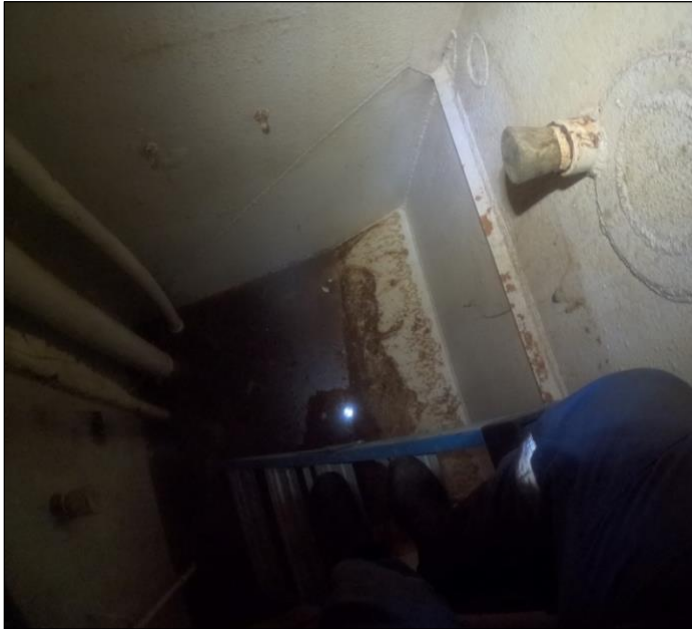
Figure 25. Two 2.5" penetrations sealed at both bulkheads in A-32F at FR 58.

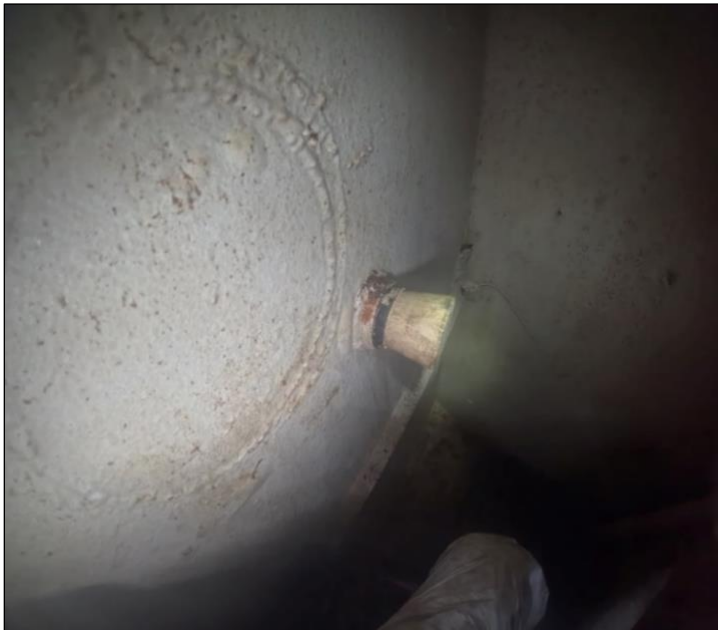
Figure 29. A 2.5" penetration sealed at the outboard bulkhead in A-33F at FR 55-56.

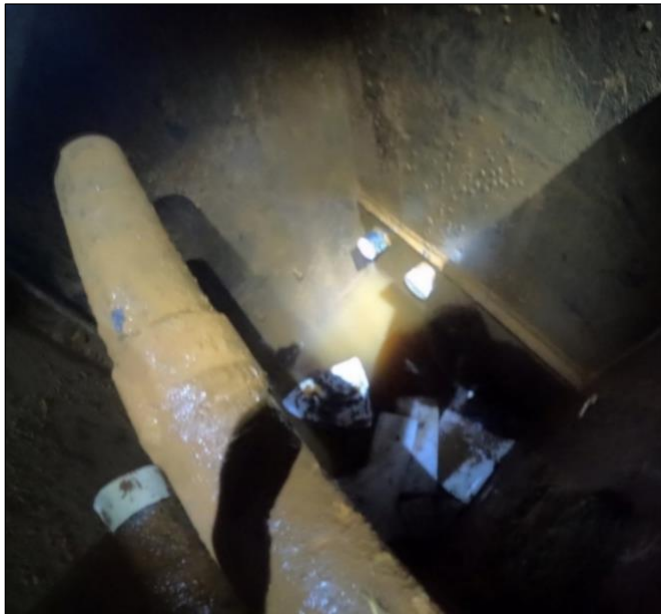
Figure 35. Ballast pipe and fuel oil pipe penetrations to A-46.5F sealed at the outboard bulkhead in A-44V. Photograph captured in A-44V.

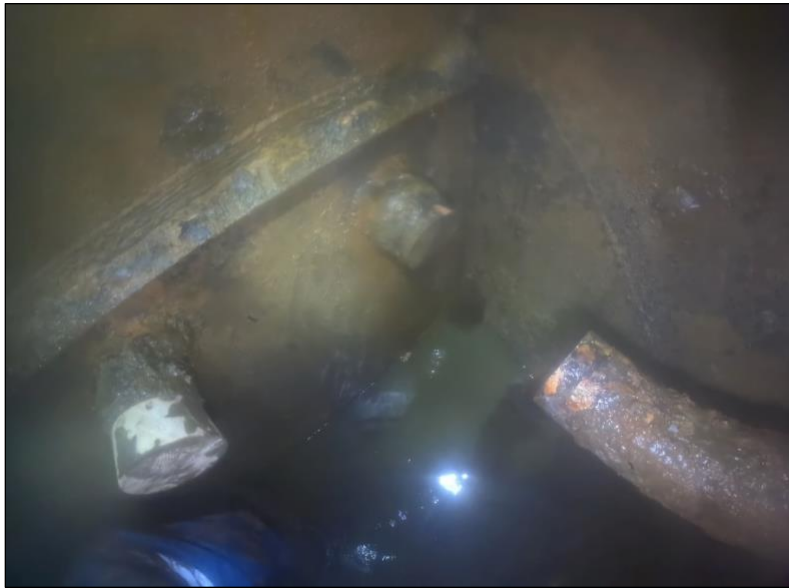
Figure 37. Ballast pipe and fuel oil pipe penetrations to A-47.5F sealed at the outboard bulkhead in A-45V. Photograph captured in A-45V.

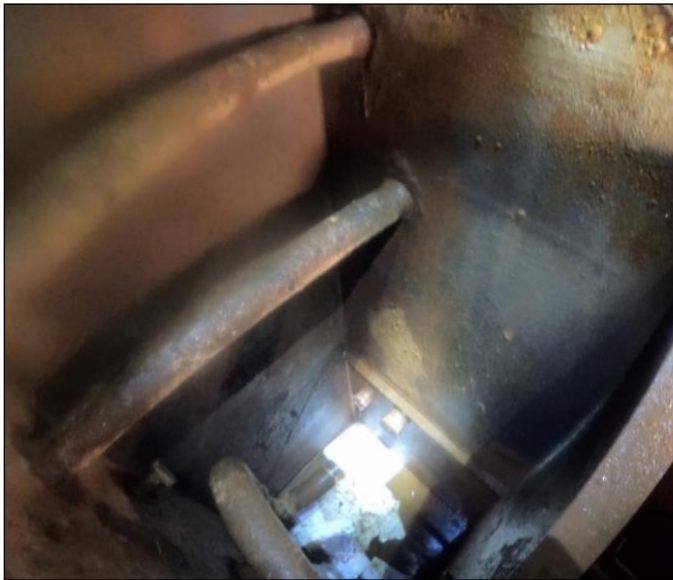
Figure 39. Ballast pipe and fuel oil pipe penetrations to A-54.5F sealed at the outboard bulkhead in A-52V. Photograph captured in A-52V.

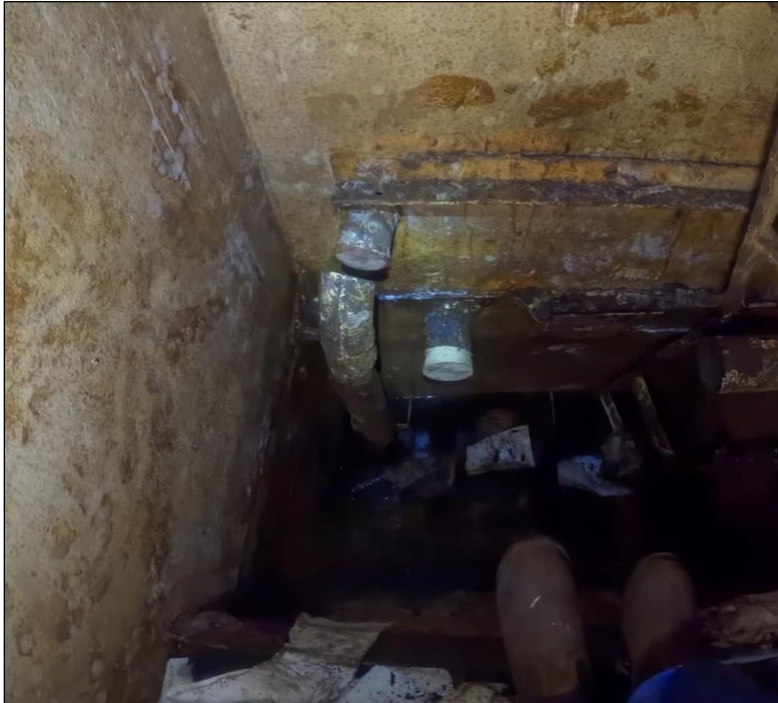
Figure 41. Ballast pipe and fuel oil pipe penetrations sealed at the inboard bulkhead in A-55F.  
Photograph captured in A-55F.

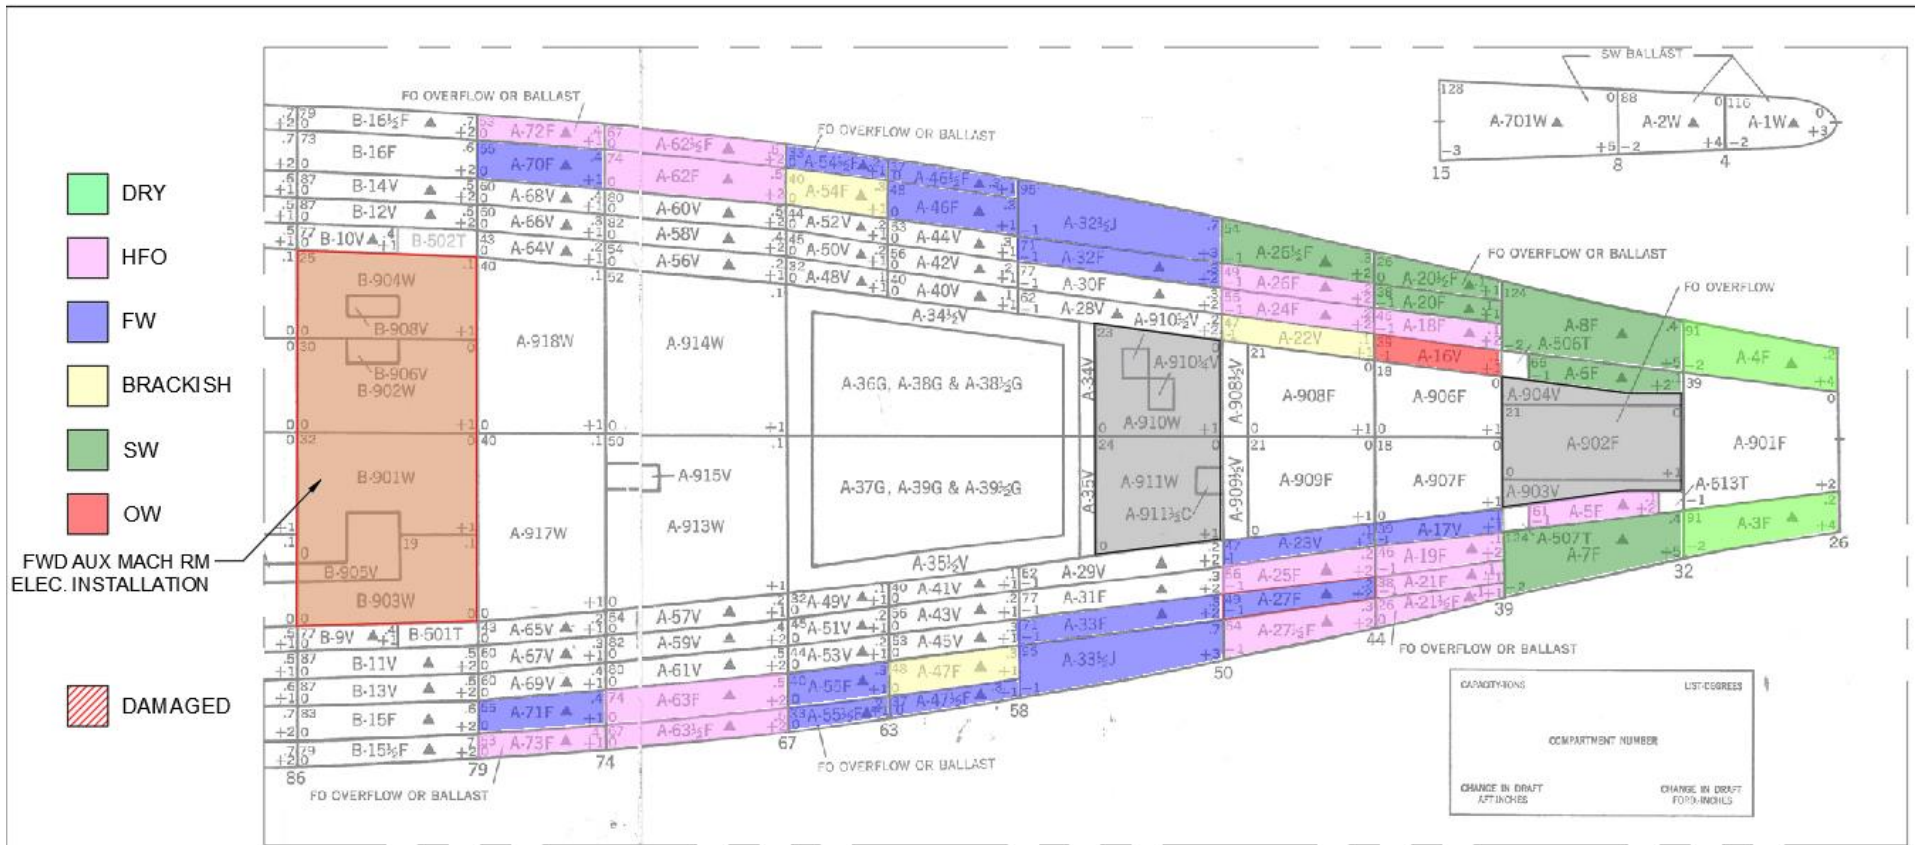
HFO = Heavy Fuel Oil  
 FW = Freshwater  
 Brackish = Brackish Water  
 SW = Salt Water  
 OW = Oily Water
