2022

BIOLOGY

ANNUAL REPORT

Central Arizona Water Conservation District
Water Transmission Division

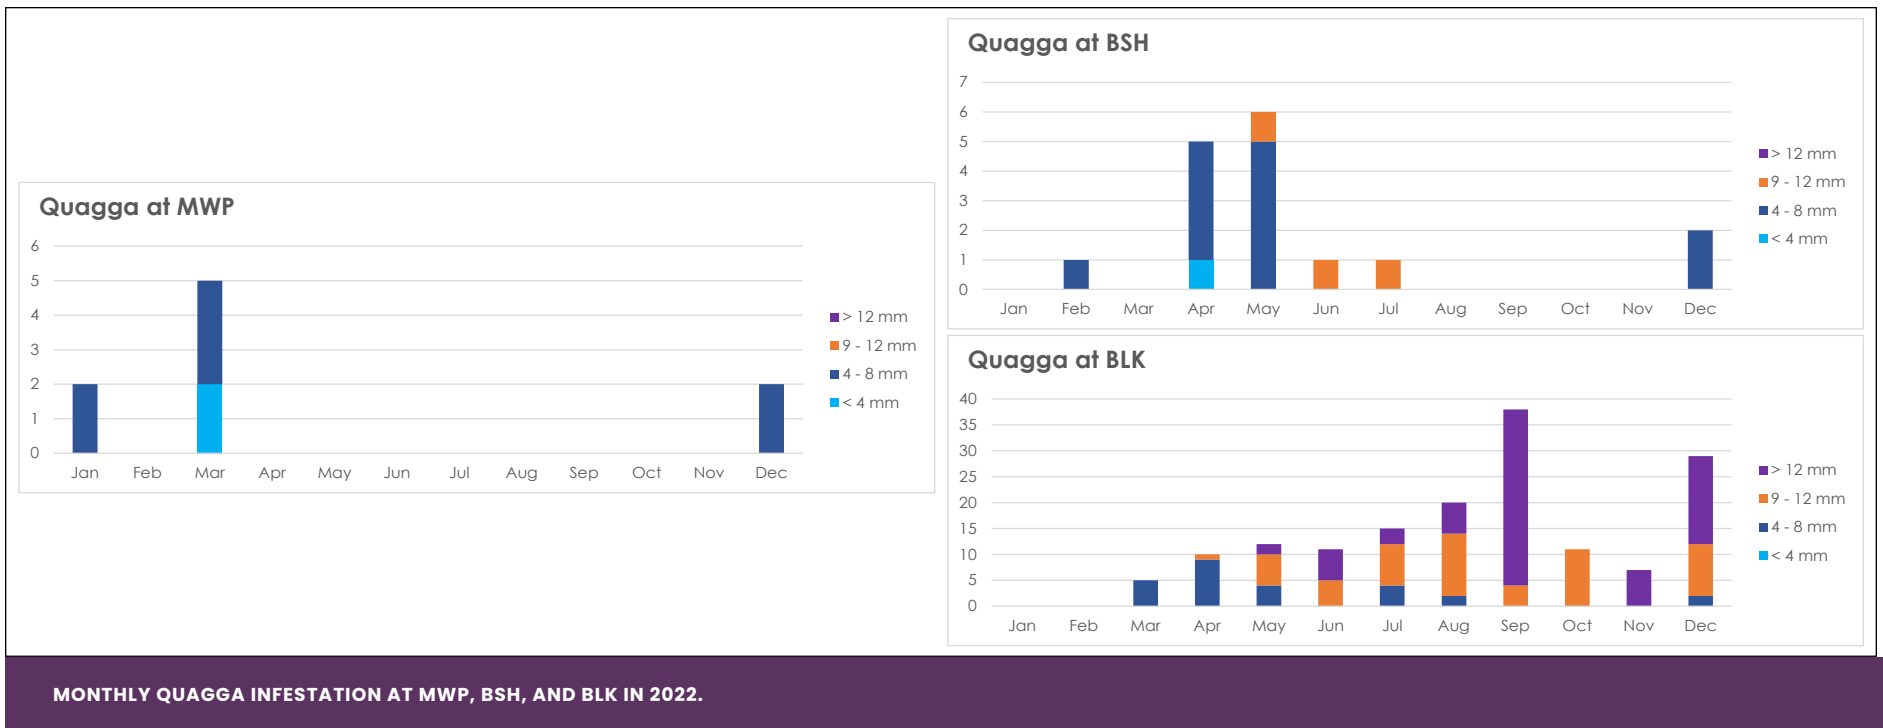
QUAGGA MUSSELS AND CLAMS IN MUD VALVE AT BSH

Within the remainder of the pumping plants, quagga were only observed in bio-boxes at BSH and BLK, with relatively low numbers at each of the two plants. Based on the size distribution of quagga at BLK, it appears that there may have been at least two, and probably three, reproductive events in the southern portion of the canal. However, since no other pumping plants experienced quagga infestations, the reproduction may have occurred just upstream of BLK, possibly in the Lower Raw Water Impoundment (LRWI). At BSH, in addition to quagga observed in bio-boxes, plant personnel also indicated that there was a large amount of quagga and clam shell debris in the unit mud valves that needed to be cleaned. However, there were no issues with pumping plant strainers or filtration.

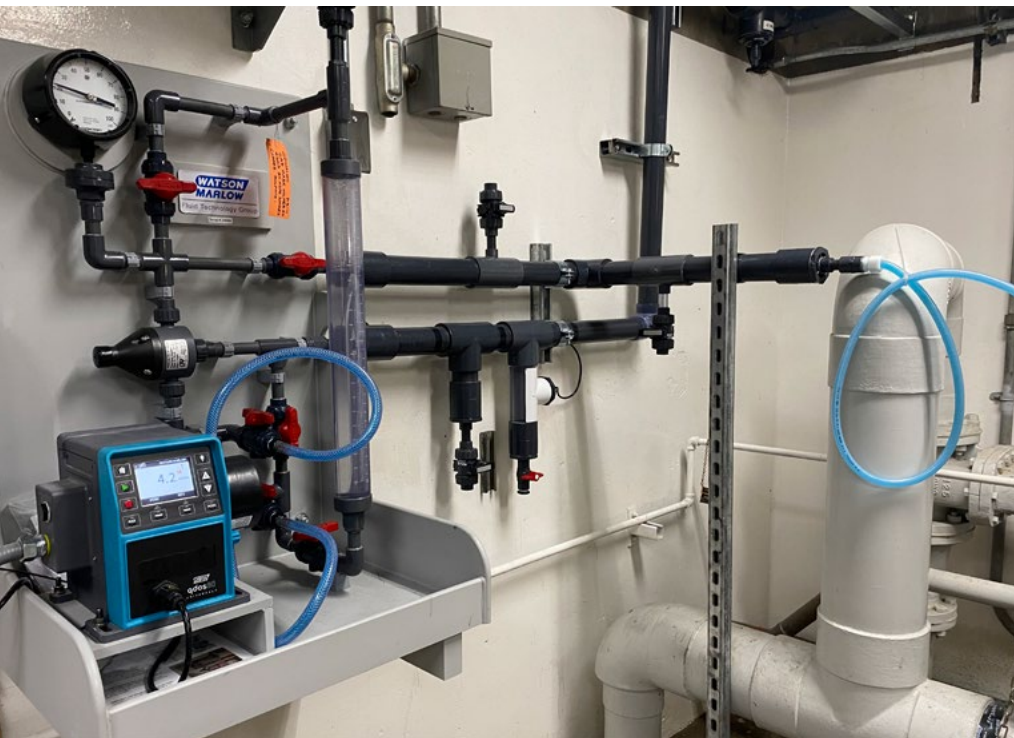
The chemical treatment system at MWP became operational in September 2021. Videoscope evaluations were conducted in January and December 2022 to determine the effectiveness of the treatment, as well as make any adjustments to the treatment rate. Overall, the treatment appears to be working as intended.

CHEMICAL INJECTION SYSTEM AT MWP

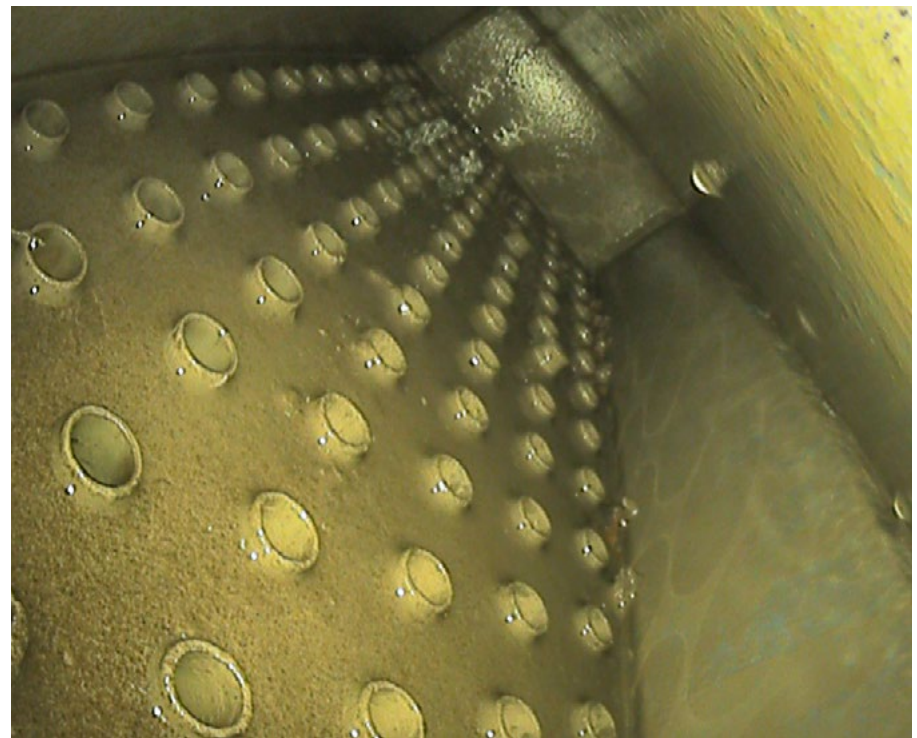
Unit 2 was power washed prior to initiation of the treatment, and 14 months later, there was no sign of quagga or hydroids in the cooling water system. Similarly, Units 4 and 5 were cleaned in July 2022, and after 5 months there was no quagga or hydroid infestation. Units, 1, 3 and 6 have not been cleaned in several years and there is significant buildup of quagga and other organic debris. The treatment appears to have killed the quagga and stopped further infestation, but the coolers need to be cleaned out to maximize their efficiency.

UNIT 2 COOLER AT MWP AFTER 14 MONTHS OF TREATMENT. COOLERS WERE CLEANED PRIOR TO INITIATION OF TREATMENT.

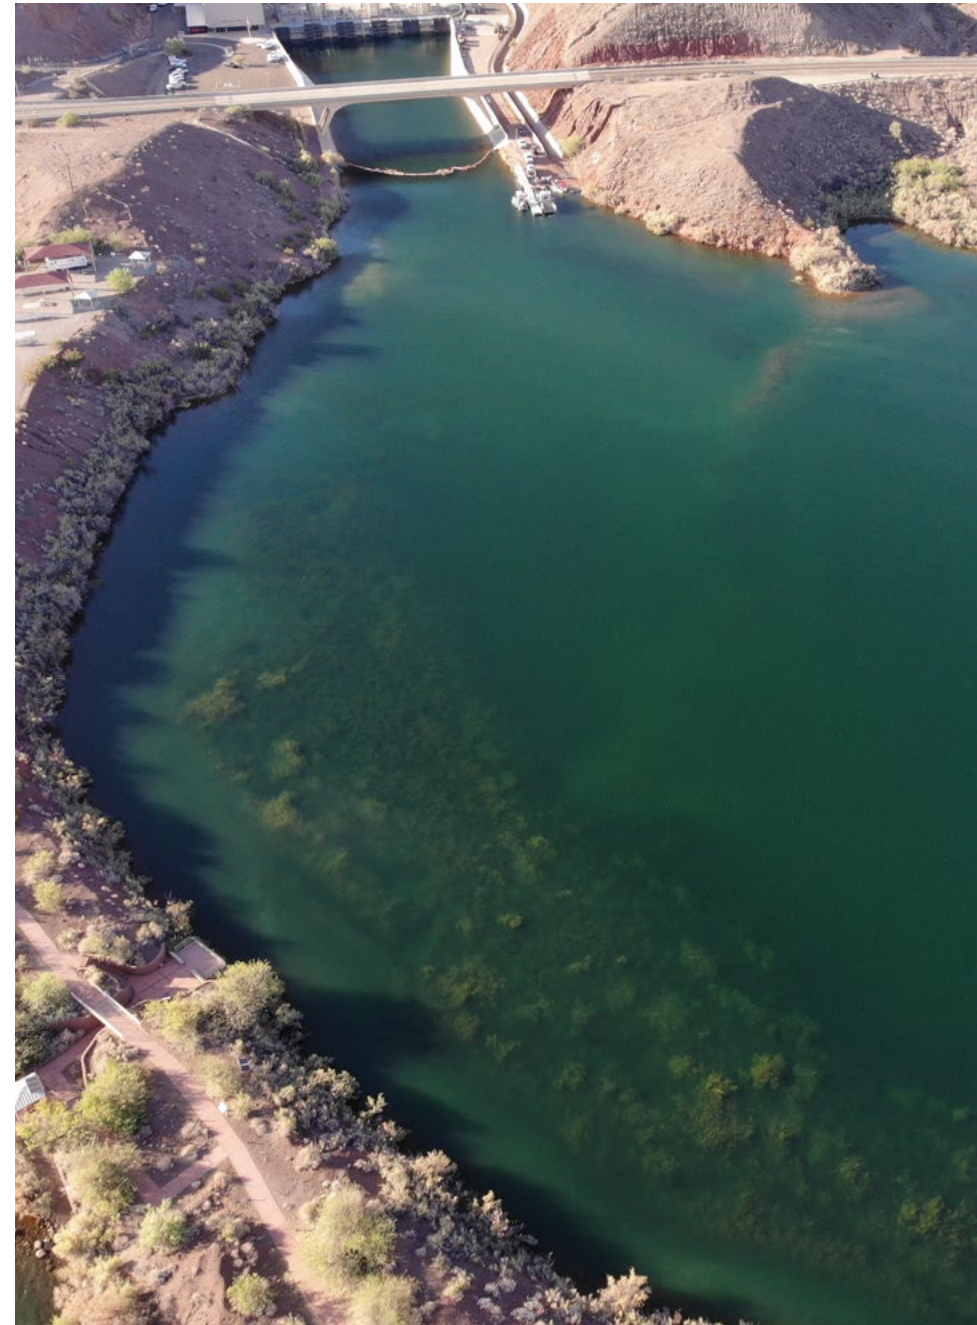
AQUATIC WEED GROWTH WITHIN THE MWP INTAKE CHANNEL IN JUNE 2022

Mapping of vegetation within the intake channel showed that vegetation growth continued to increase in density and distribution compared to previous years. Conversely, vegetation growth in the adjacent BWNWR appeared to have less vegetation growth than typical, and may be the result of high turbidity events after frequent summer monsoons.

In 2023, CAP will replicate the weed treatment from 2022, except it will be completed earlier in the season, when weed growth isn't as dense, and application hoses will be extended to reach the entire depth. Vegetation coverage and plant height will be mapped bi-weekly to evaluate the effectiveness of the treatments and monitor overall vegetation growth.

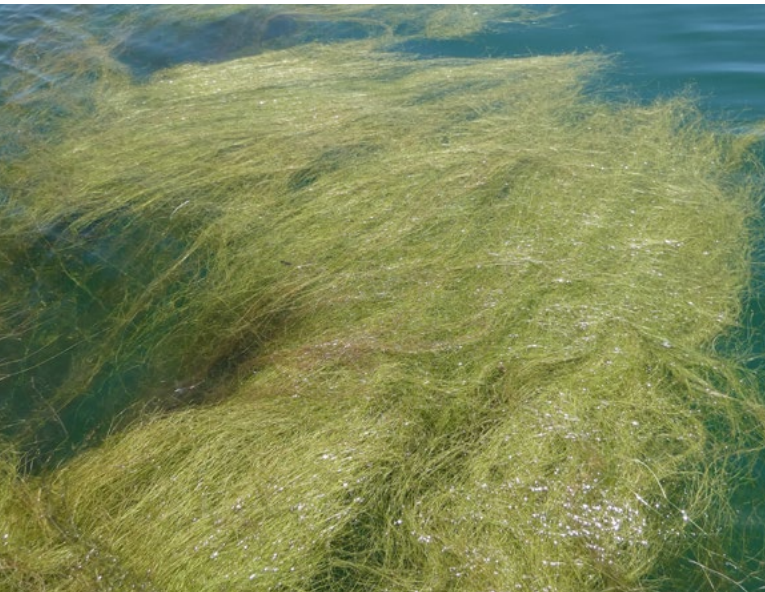
FLOATING WEED MATS WITHIN THE MWP INTAKE CHANNEL HAVE THE POTENTIAL TO OBSTRUCT FLOW AND THREATEN CAP'S ABILITY TO DELIVER WATER.

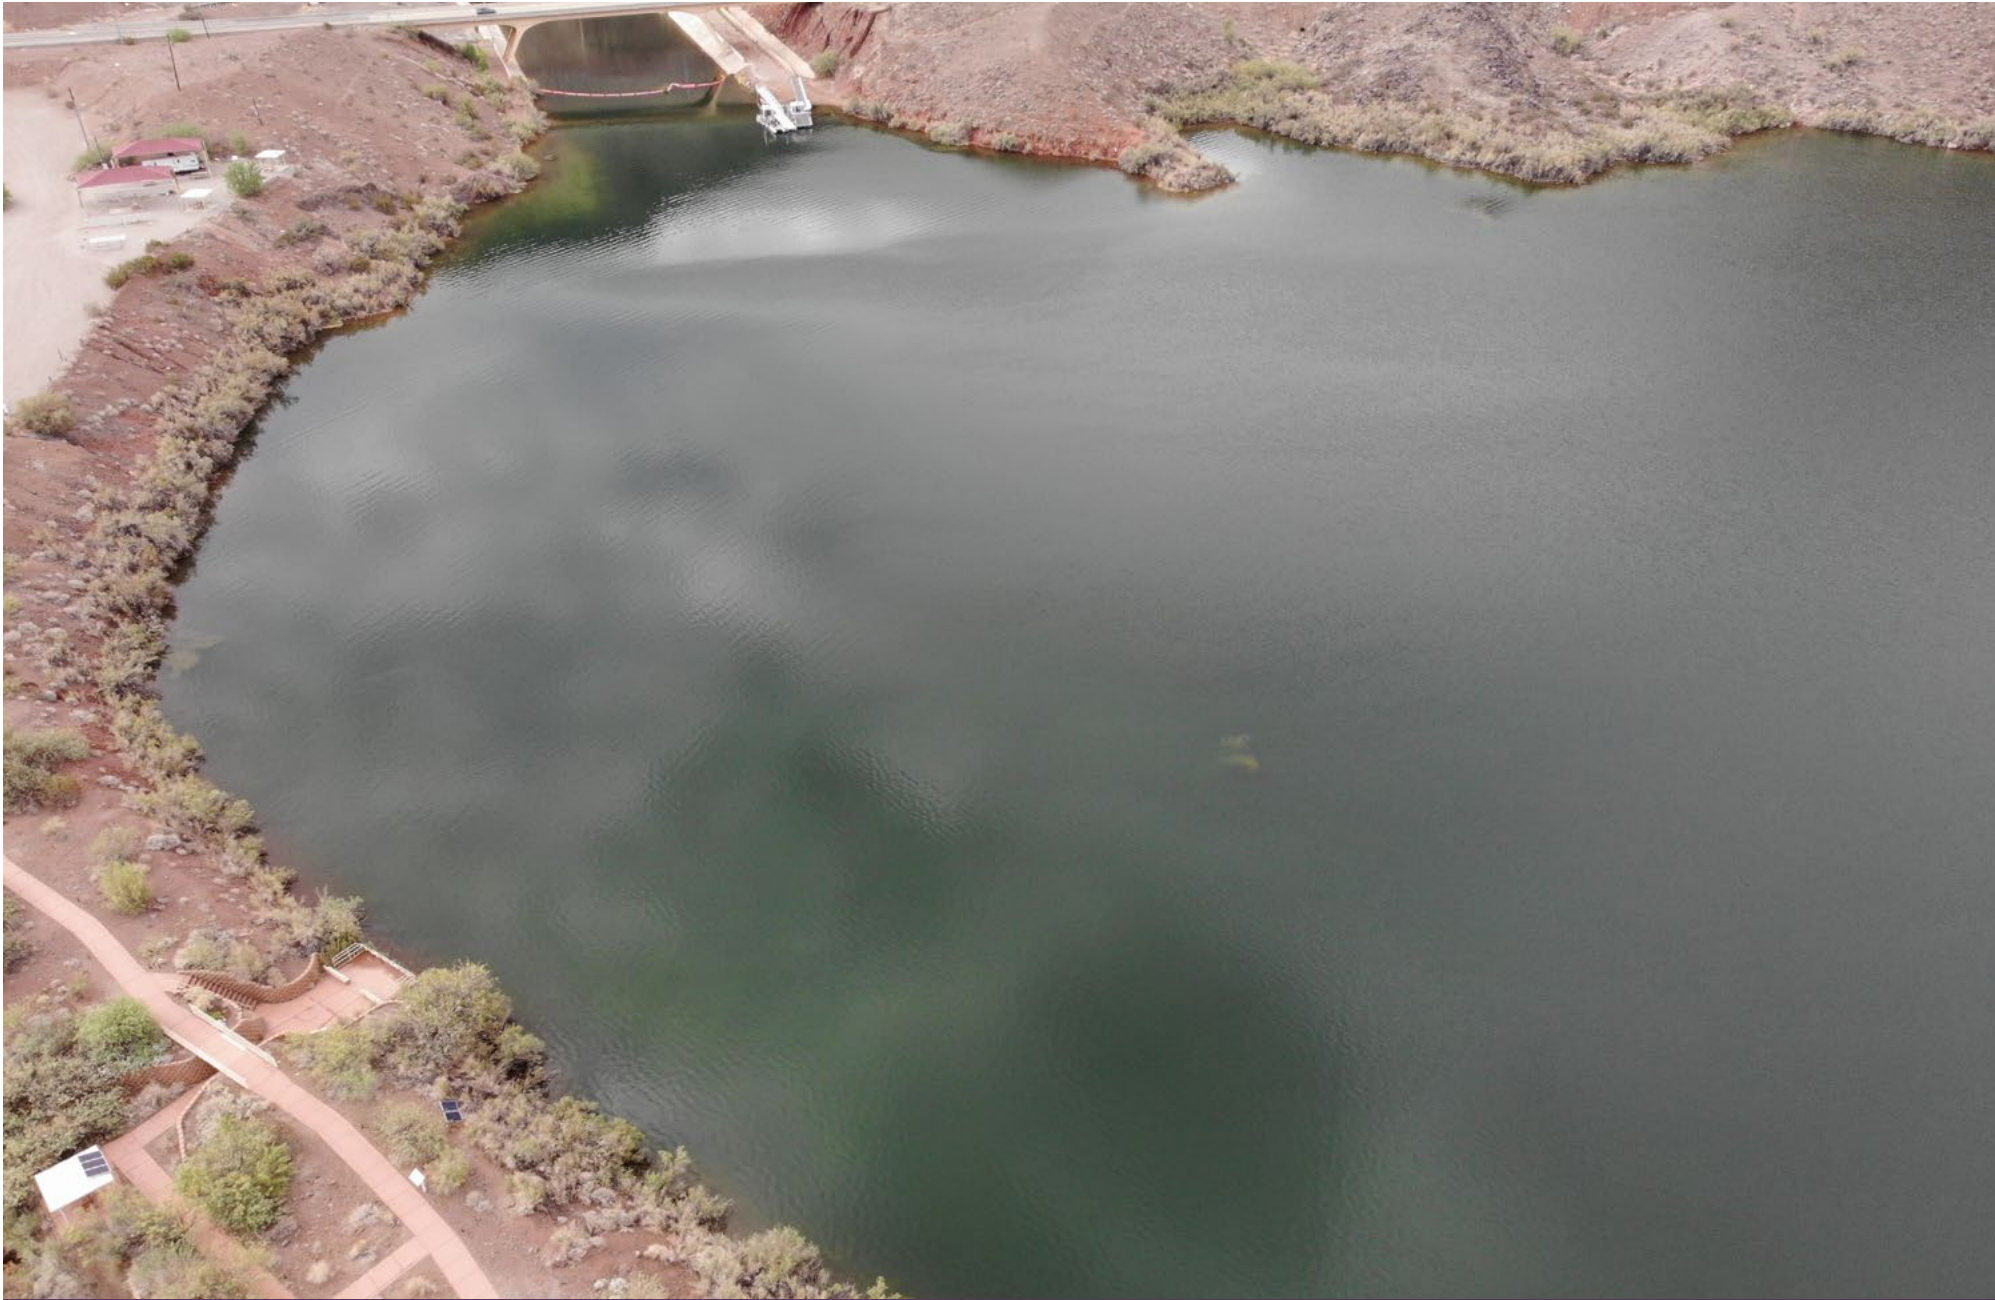
The weed treatment in 2022 was determined to be somewhat successful. Vegetation growth in the 5-acre area treated with Aquathol was completely eliminated, but areas treated with Cascade (~10 acres) only saw a modest reduction. This reduced effectiveness was attributed to extremely heavy vegetation growth (herbicide did not reach the entire plant) and application hoses that did not reach deep enough. The full report is available upon request.

DRONE PHOTOS IN AUGUST 2022 SHOW THAT A MAJORITY OF THE VEGETATION WAS ELIMINATED WITH THE HERBICIDE TREATMENT.

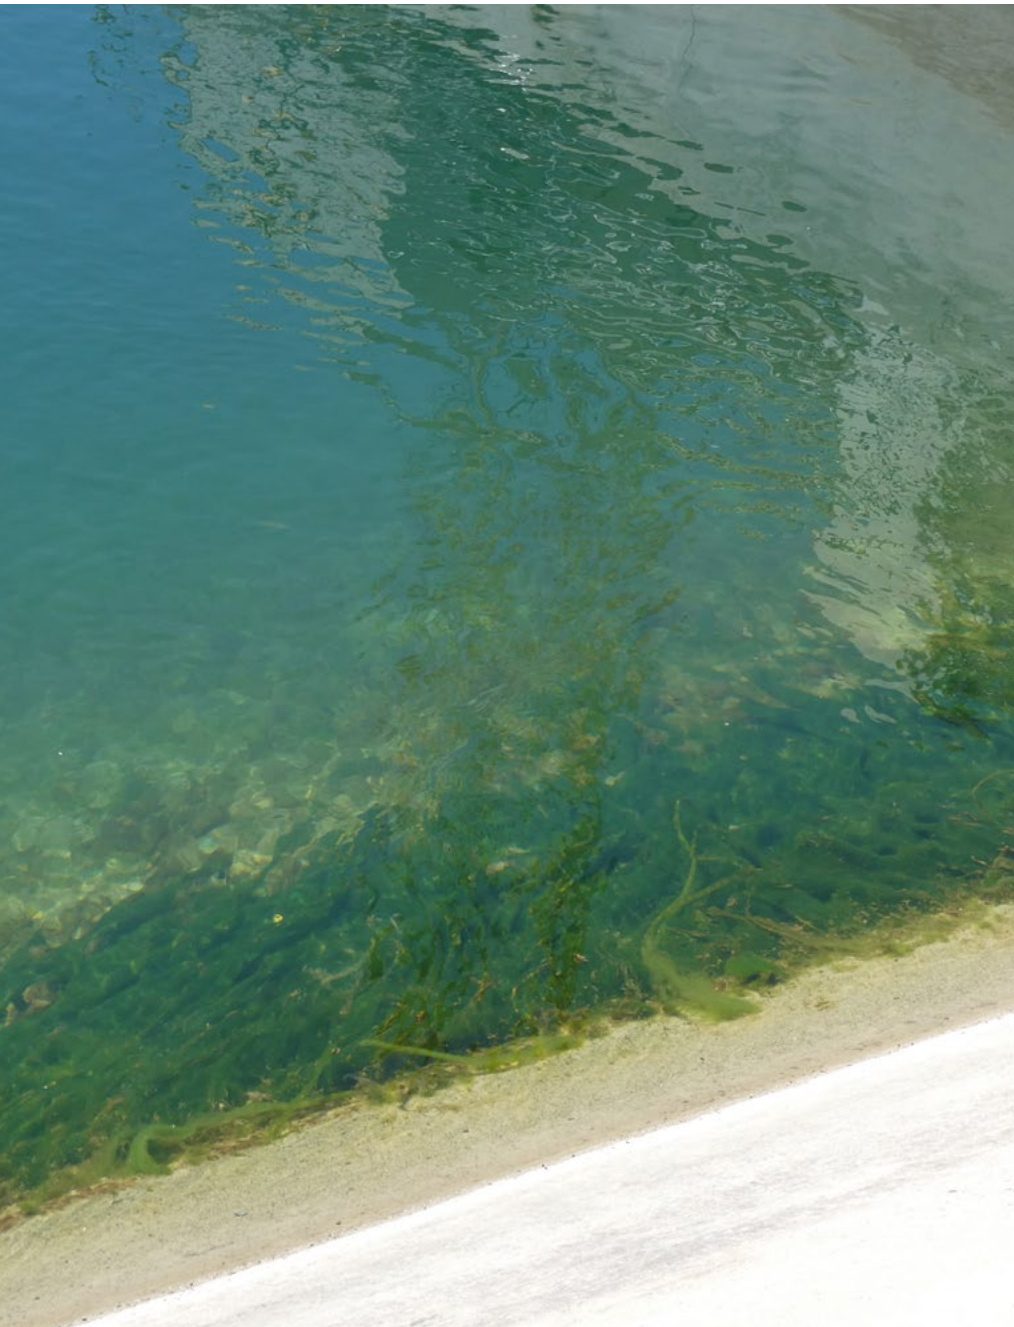
FILAMENTOUS ALGAE GROWTH IN THE WAD FOREBAY DURING AUGUST 2022.

The only rooted aquatic vegetation growth observed in the canal in 2022 was a familiar "island" of weeds growing in WAD forebay. These weeds broke off in September and fragments were seen floating in Waddell Canal. It is also interesting to note that vegetation was growing behind trash racks at WAD, as observed during annual inspections. It is apparent that the stocked grass carp are not staying in the forebay, so vegetation is not being controlled. If possible, additional fish may be stocked in summer to control this growth.

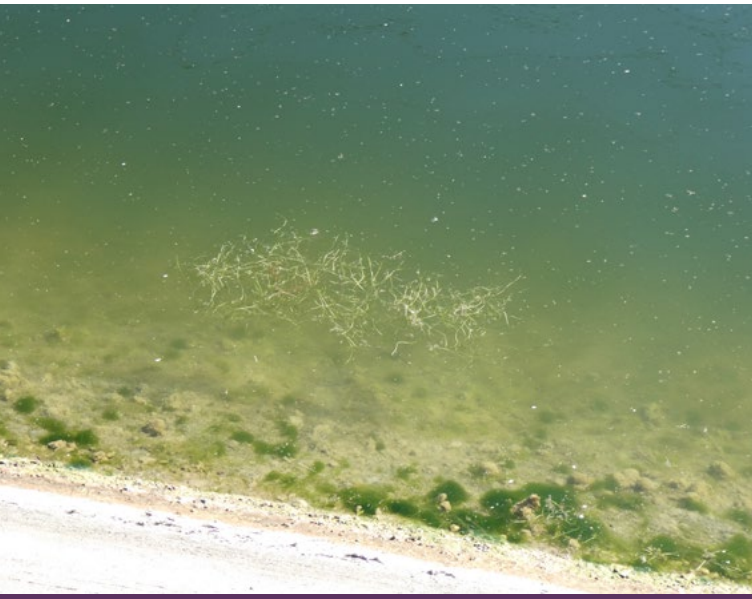
VEGETATION FRAGMENTS BROKE LOOSE FROM WAD FOREBAY AND WERE FLOATING IN THE WADDELL CANAL IN SEPTEMBER 2022.

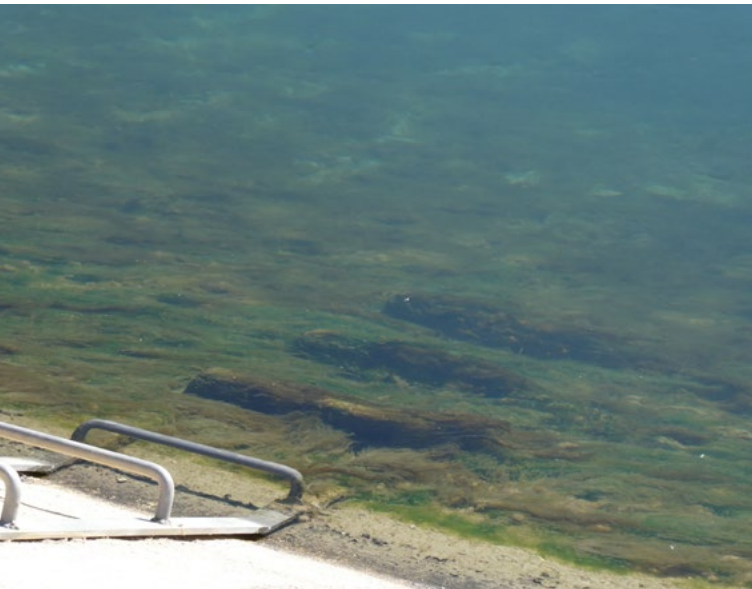
ALGAE GROWTH CAN BE THICK AT TIMES IN THE WADDELL CANAL

Filamentous algae was once again evident throughout Waddell Canal during summer months. Although it was dense at times, it did not cause problems downstream. Time-lapse photos show that the algae "bloom" occurred in late June and persisted until mid-September. *Cymbella* (rock snot) also grew during this same period, and appeared to out-compete the algae at times, but did not become problematic in 2022. The Arizona Center for Algae Technology and Innovation (AzCATI) at Arizona State University (ASU) is continuing their study of algae and *Cymbella* issues in the CAP System, which will conclude at the end of 2023.

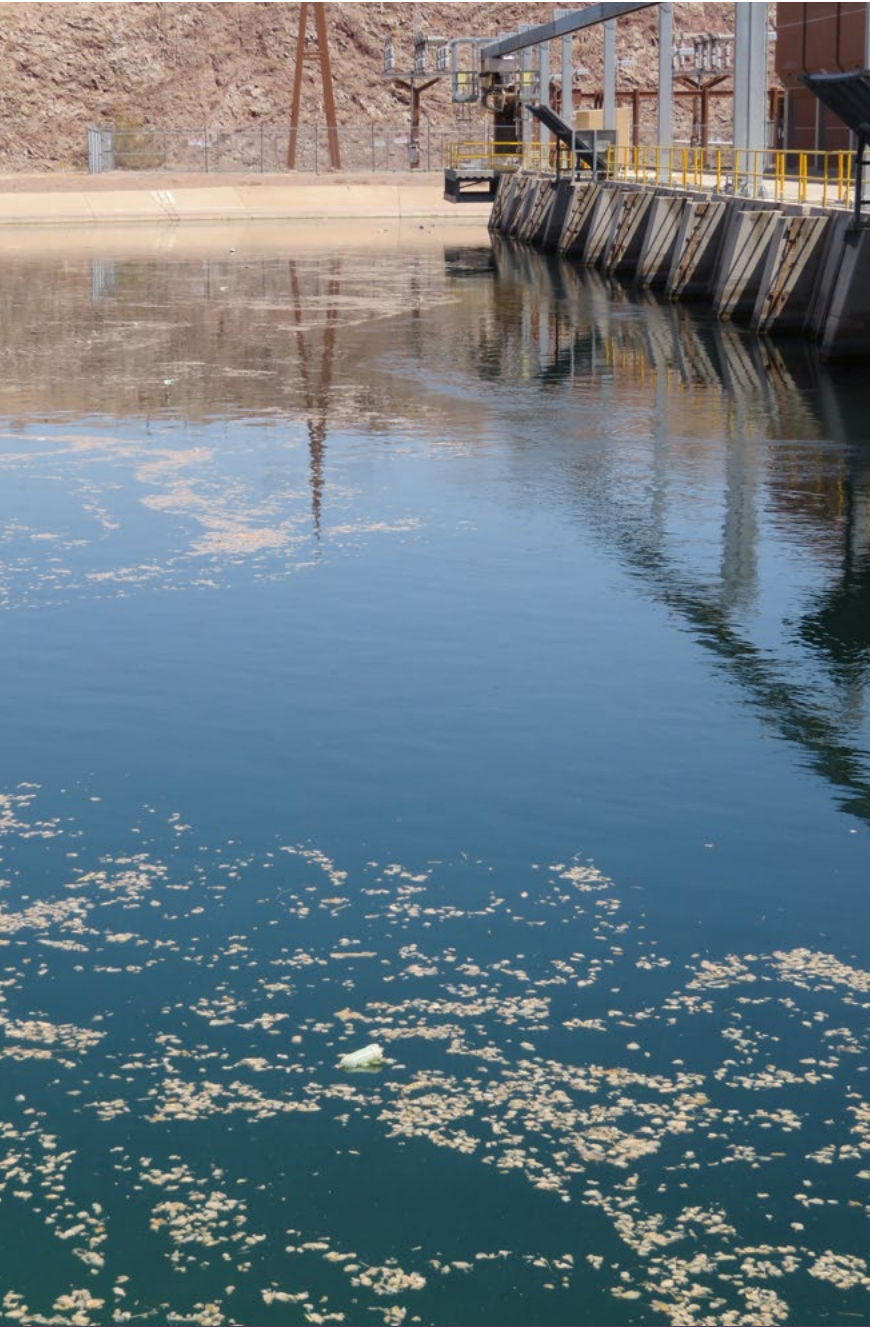
FLOATING CYMBELLA AT THE LHQ FOREBAY IN JUNE 2022

locations from April through July, it was less severe than the previous two years and did not appear to have a significant impact downstream of HSY. However, at LHQ and HSY, plant personnel were consistently called-in during early summer to clean filtomats and strainers. There were no impacts reported by stakeholders or pumping plant operators downstream of HSY.

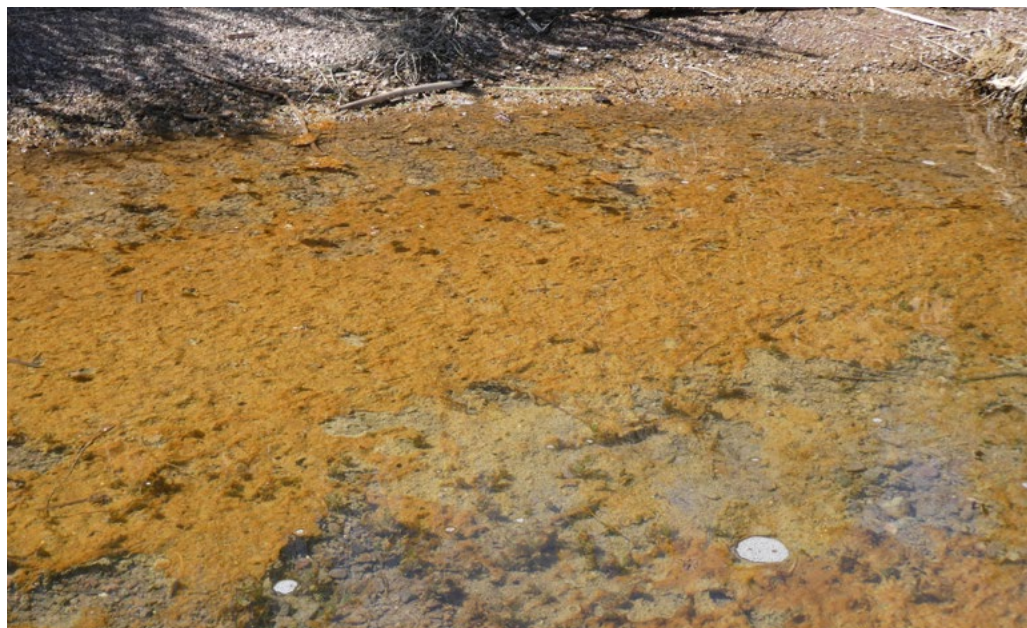
In June 2022, a significant rock snot bloom was noted on the shorelines of Lake Havasu. Although this may have been a different species of diatom than is typically encountered in the canal, the bloom left little doubt that Lake Havasu is likely the primary source of rock snot in the canal (as opposed to Lake Pleasant).

“ROCK SNOT” WAS PREVALENT ON THE SHORELINES OF LAKE HAVASU IN 2022

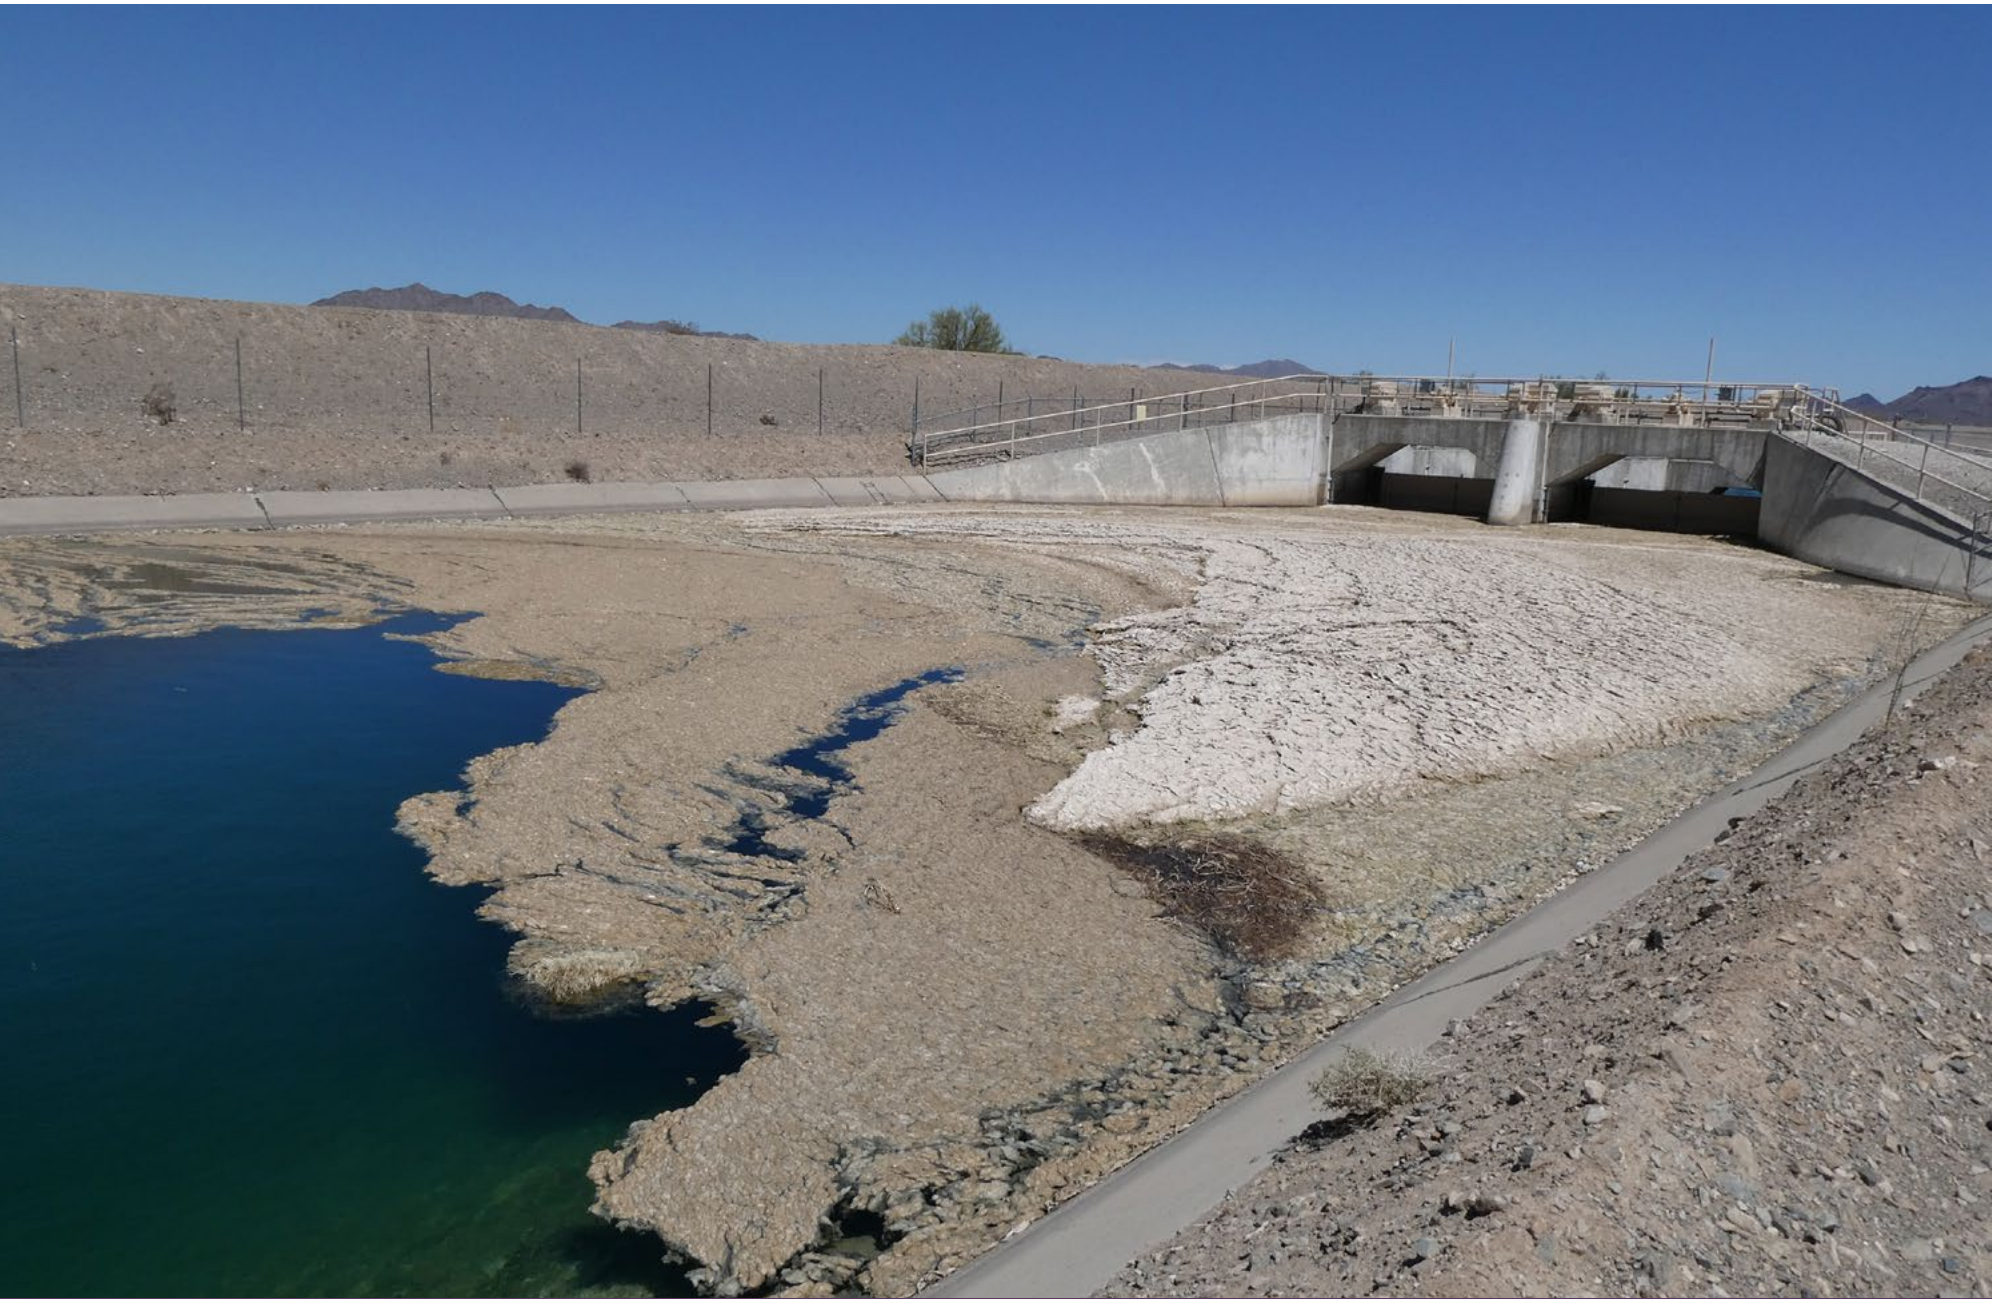
CYMBELLA ACCUMULATED UPSTREAM OF CHECK #3 WHEN FLOWS WERE CURTAILED IN JULY 2022. THIS MAY HAVE PREVENTED PROBLEMS WITH CLOGGED STRAINERS DOWNSTREAM AT LHQ.

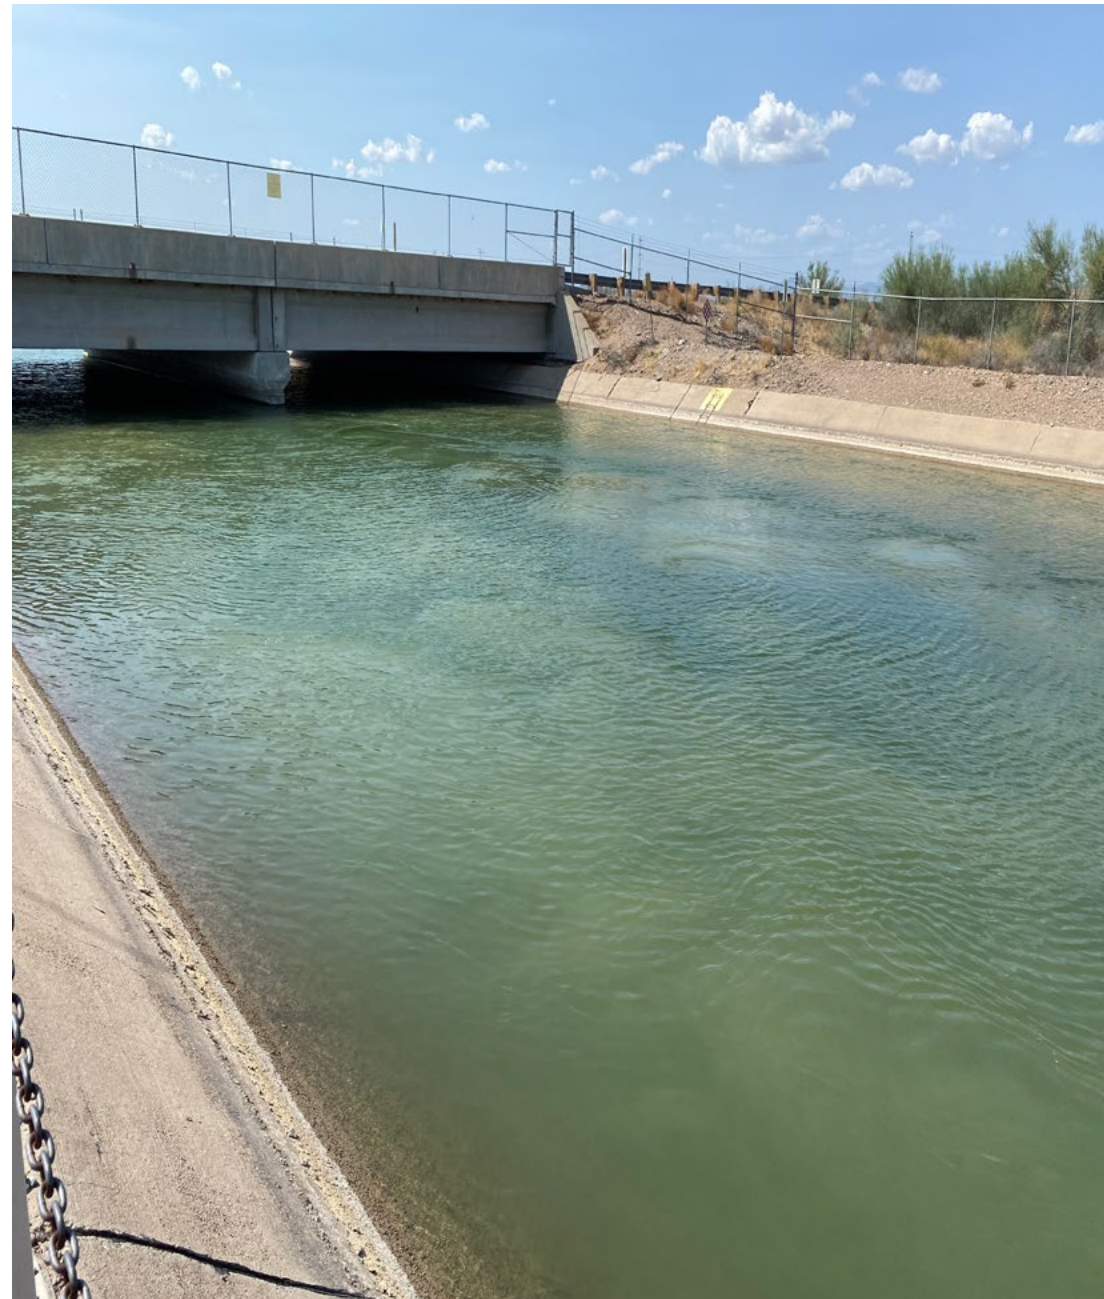
SEDIMENT (TURBIDITY) INCREASES WHEN PUMPS AT HSY ARE ACTIVATED AFTER SUMMER OUTAGE.

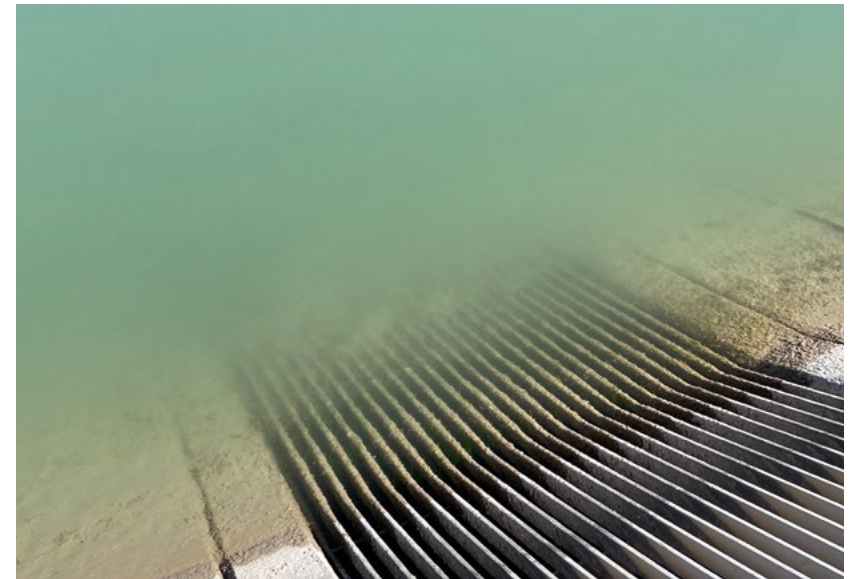
SEDIMENT TURBIDITY CAN BE EASILY OBSERVED AT TURNOUTS.

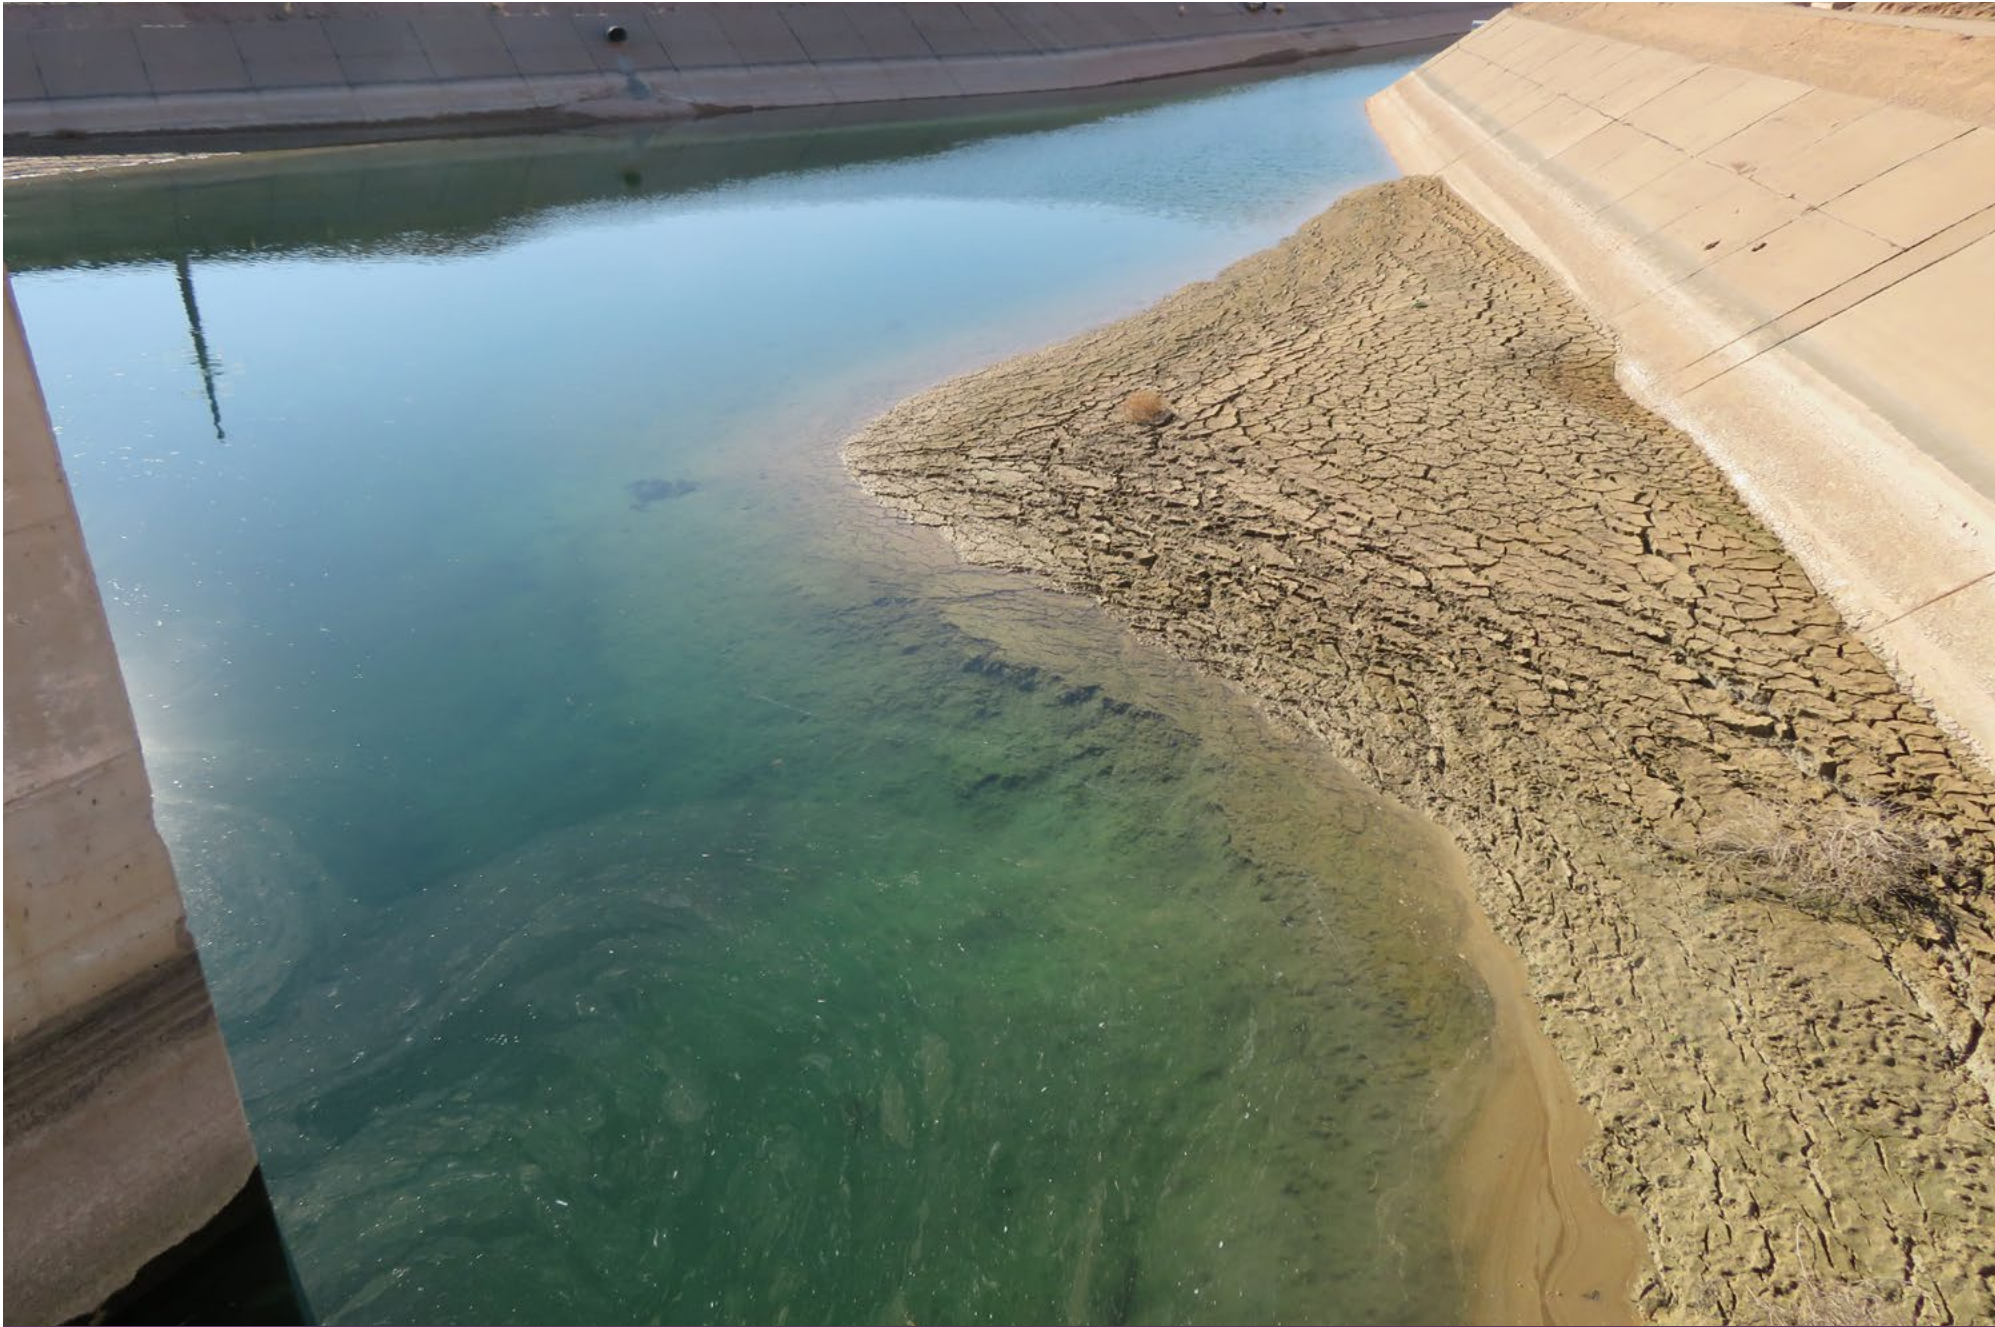
Sediment mapping and analysis in April 2022 showed an increase in sediment volume at all pumping plants except for BSH, which had an 11% decrease. HSY, SGL, PIC, BRW, and SXV all had increases of more than 20% since 2021. The SGL forebay, which was completely dredged in November 2019, had a sediment volume of over 11,000 cubic yards in 2022. This represents nearly 19% of the total available forebay volume and is 32% higher than in 2021. Two of the largest turnouts (SROTO and CMATO) continued to show a high level of sediment deposition, with over 60% of the total turnout volume being occupied by sediment. The third large turnout, SMATO, was slightly lower than in previous years, as it was dredged when Pool 34 experienced a breach in 2021 after strong storms. BRD, PIC, and SAN continued to have the highest percentage of sediment deposition in forebays, ranging from 34–41% of total forebay volume.

SEDIMENT DEPOSITION AT BRD; SHOWN HERE WITH LOW WATER LEVELS.

A sediment management plan, which includes triggers for removal efforts, should be developed in 2023.
