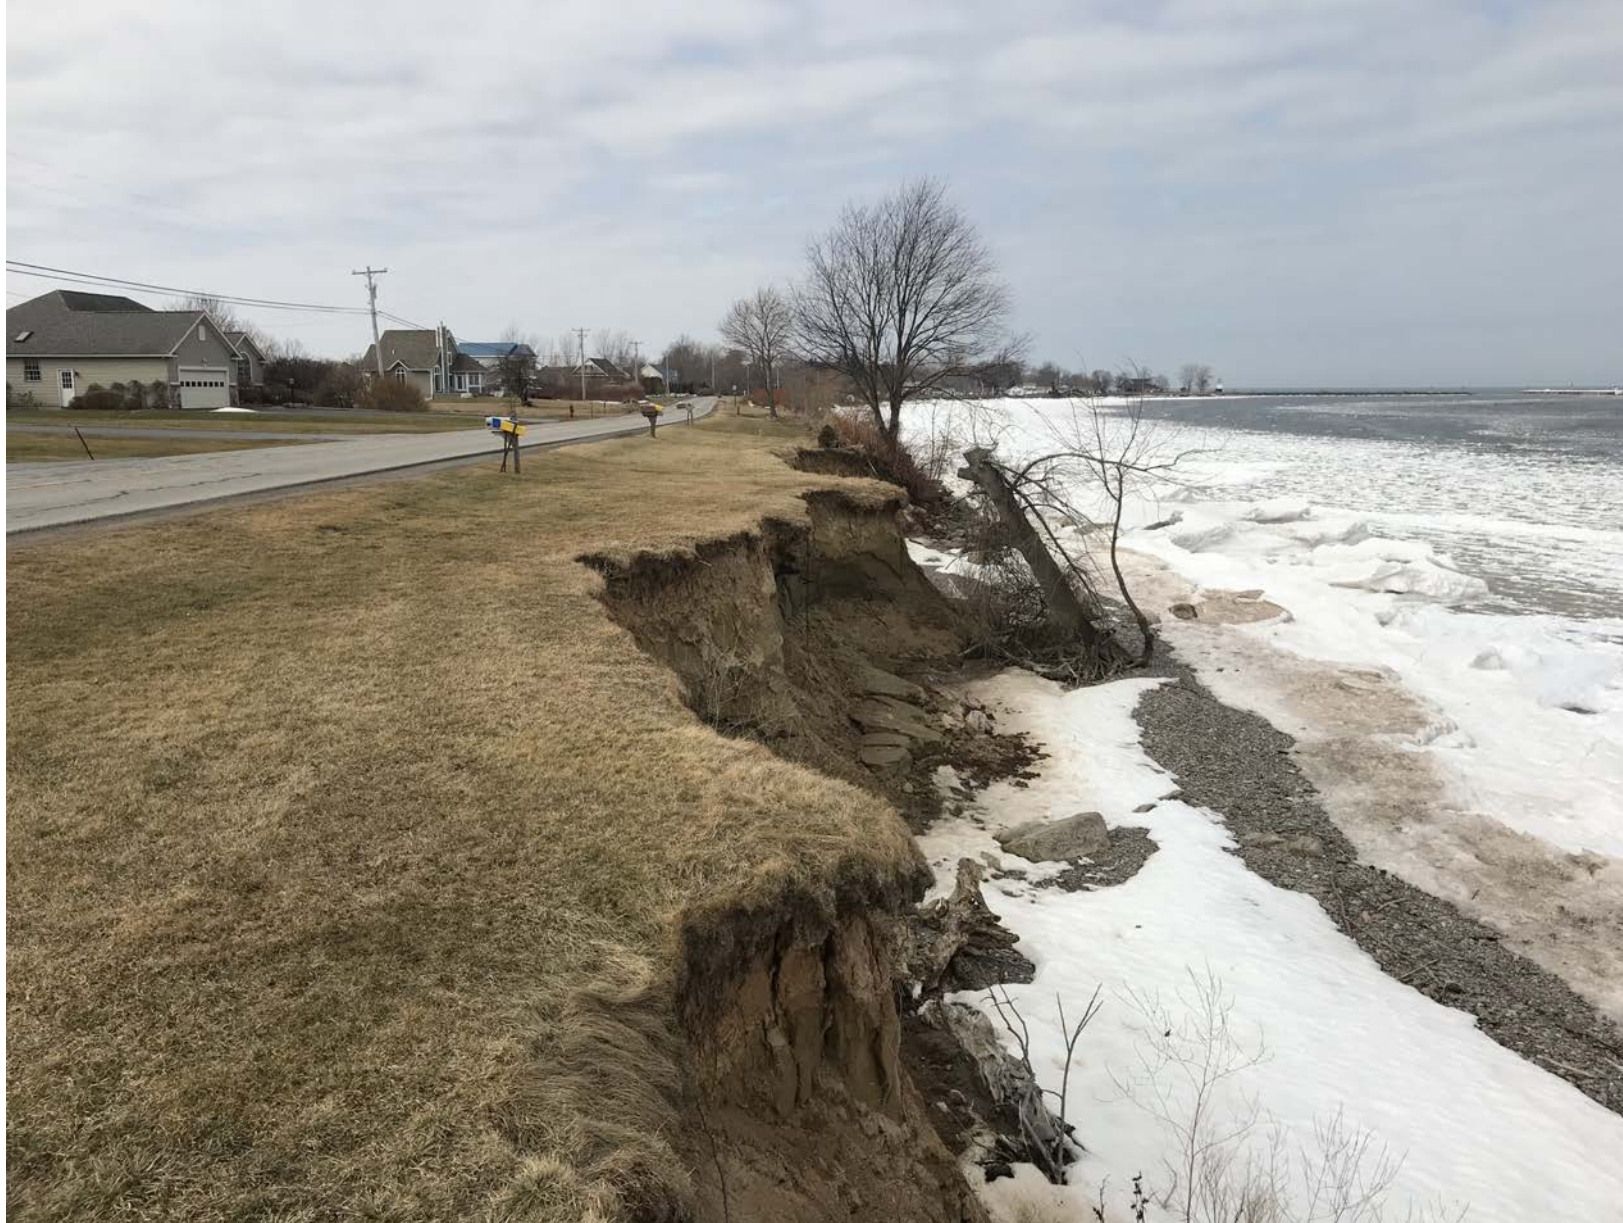
Pictured above, erosion of original Lakeside Park Road West access road, in the town of Carlton. The road was degraded due to repeated flooding events.

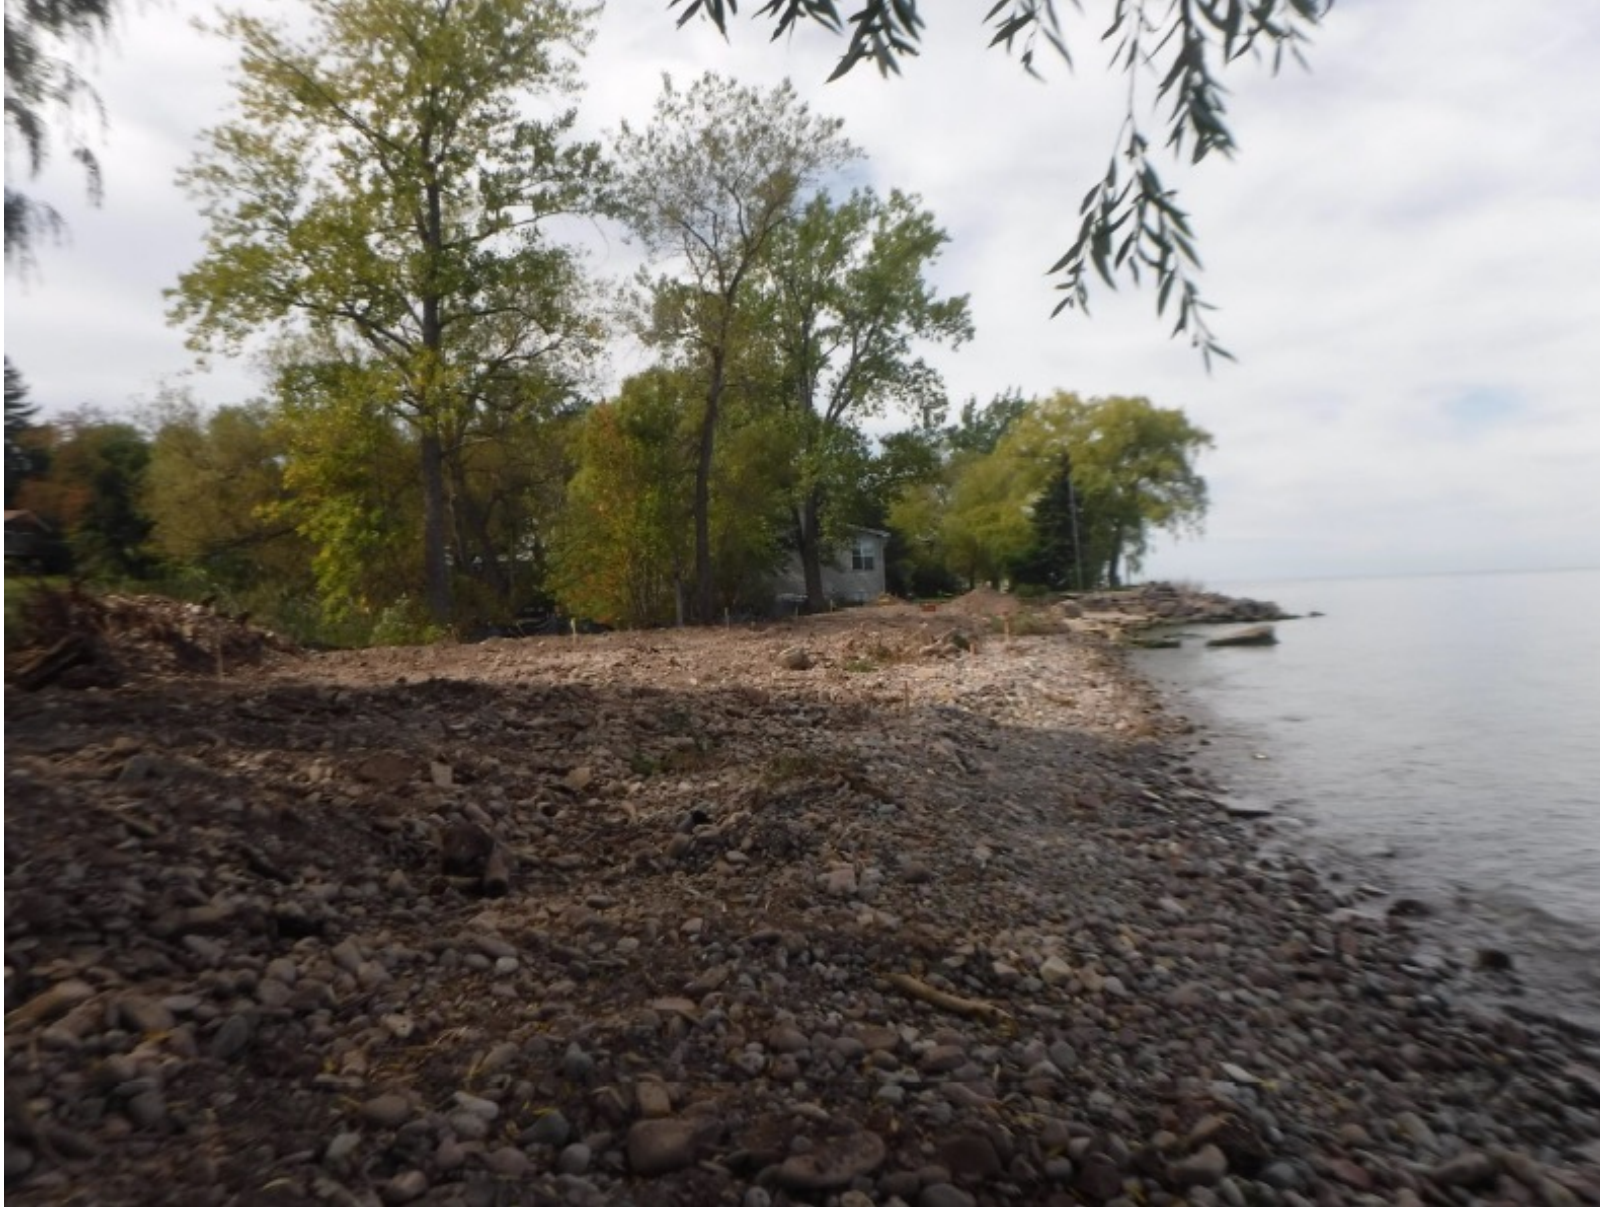
Pictured above, the bluff along Lakeshore Road, in the town of Carlton, eroded due to wave, ice, and severe storm events.
