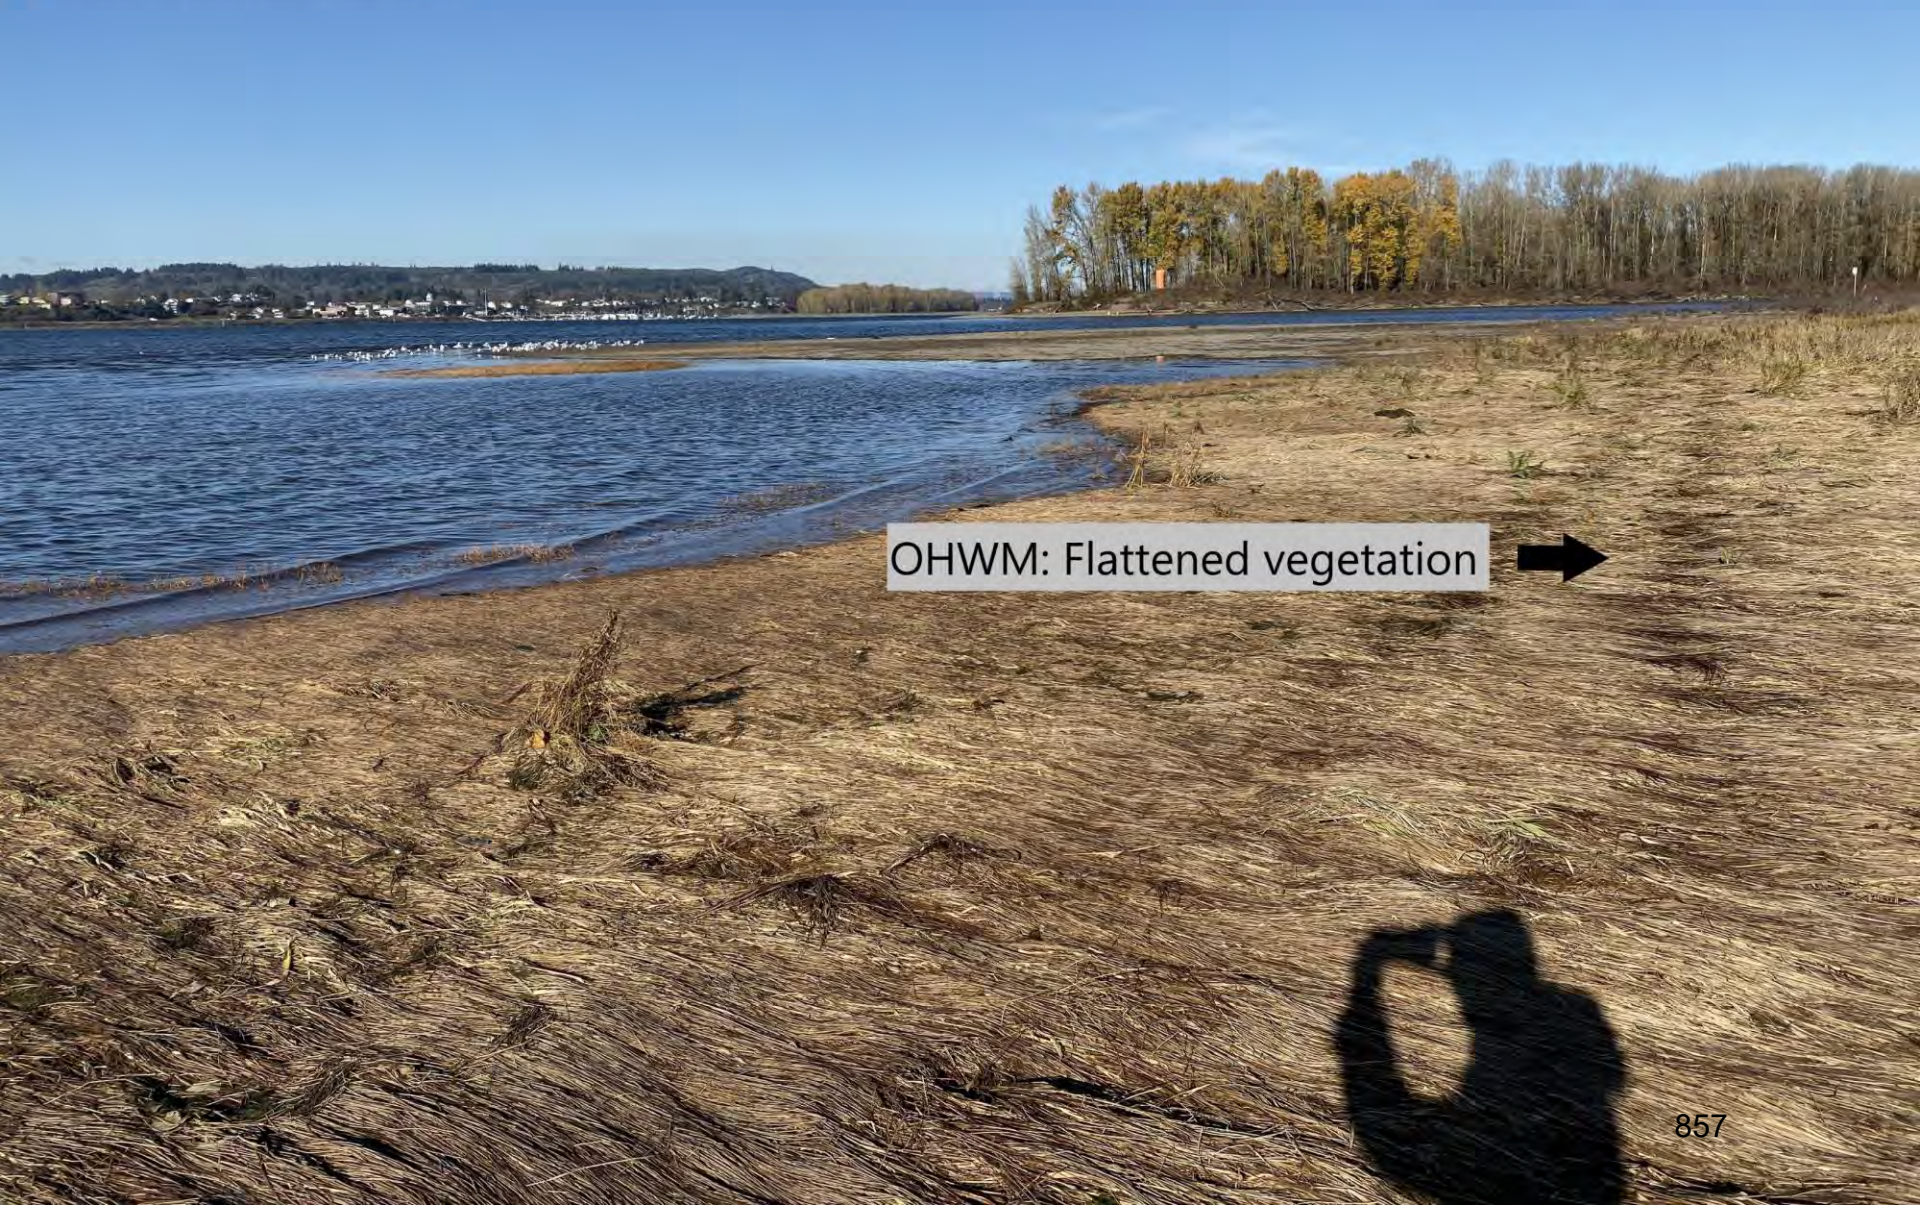
Exhibit 22 Part 3 GR-B-(1-3)

OHWM: Flattened vegetation

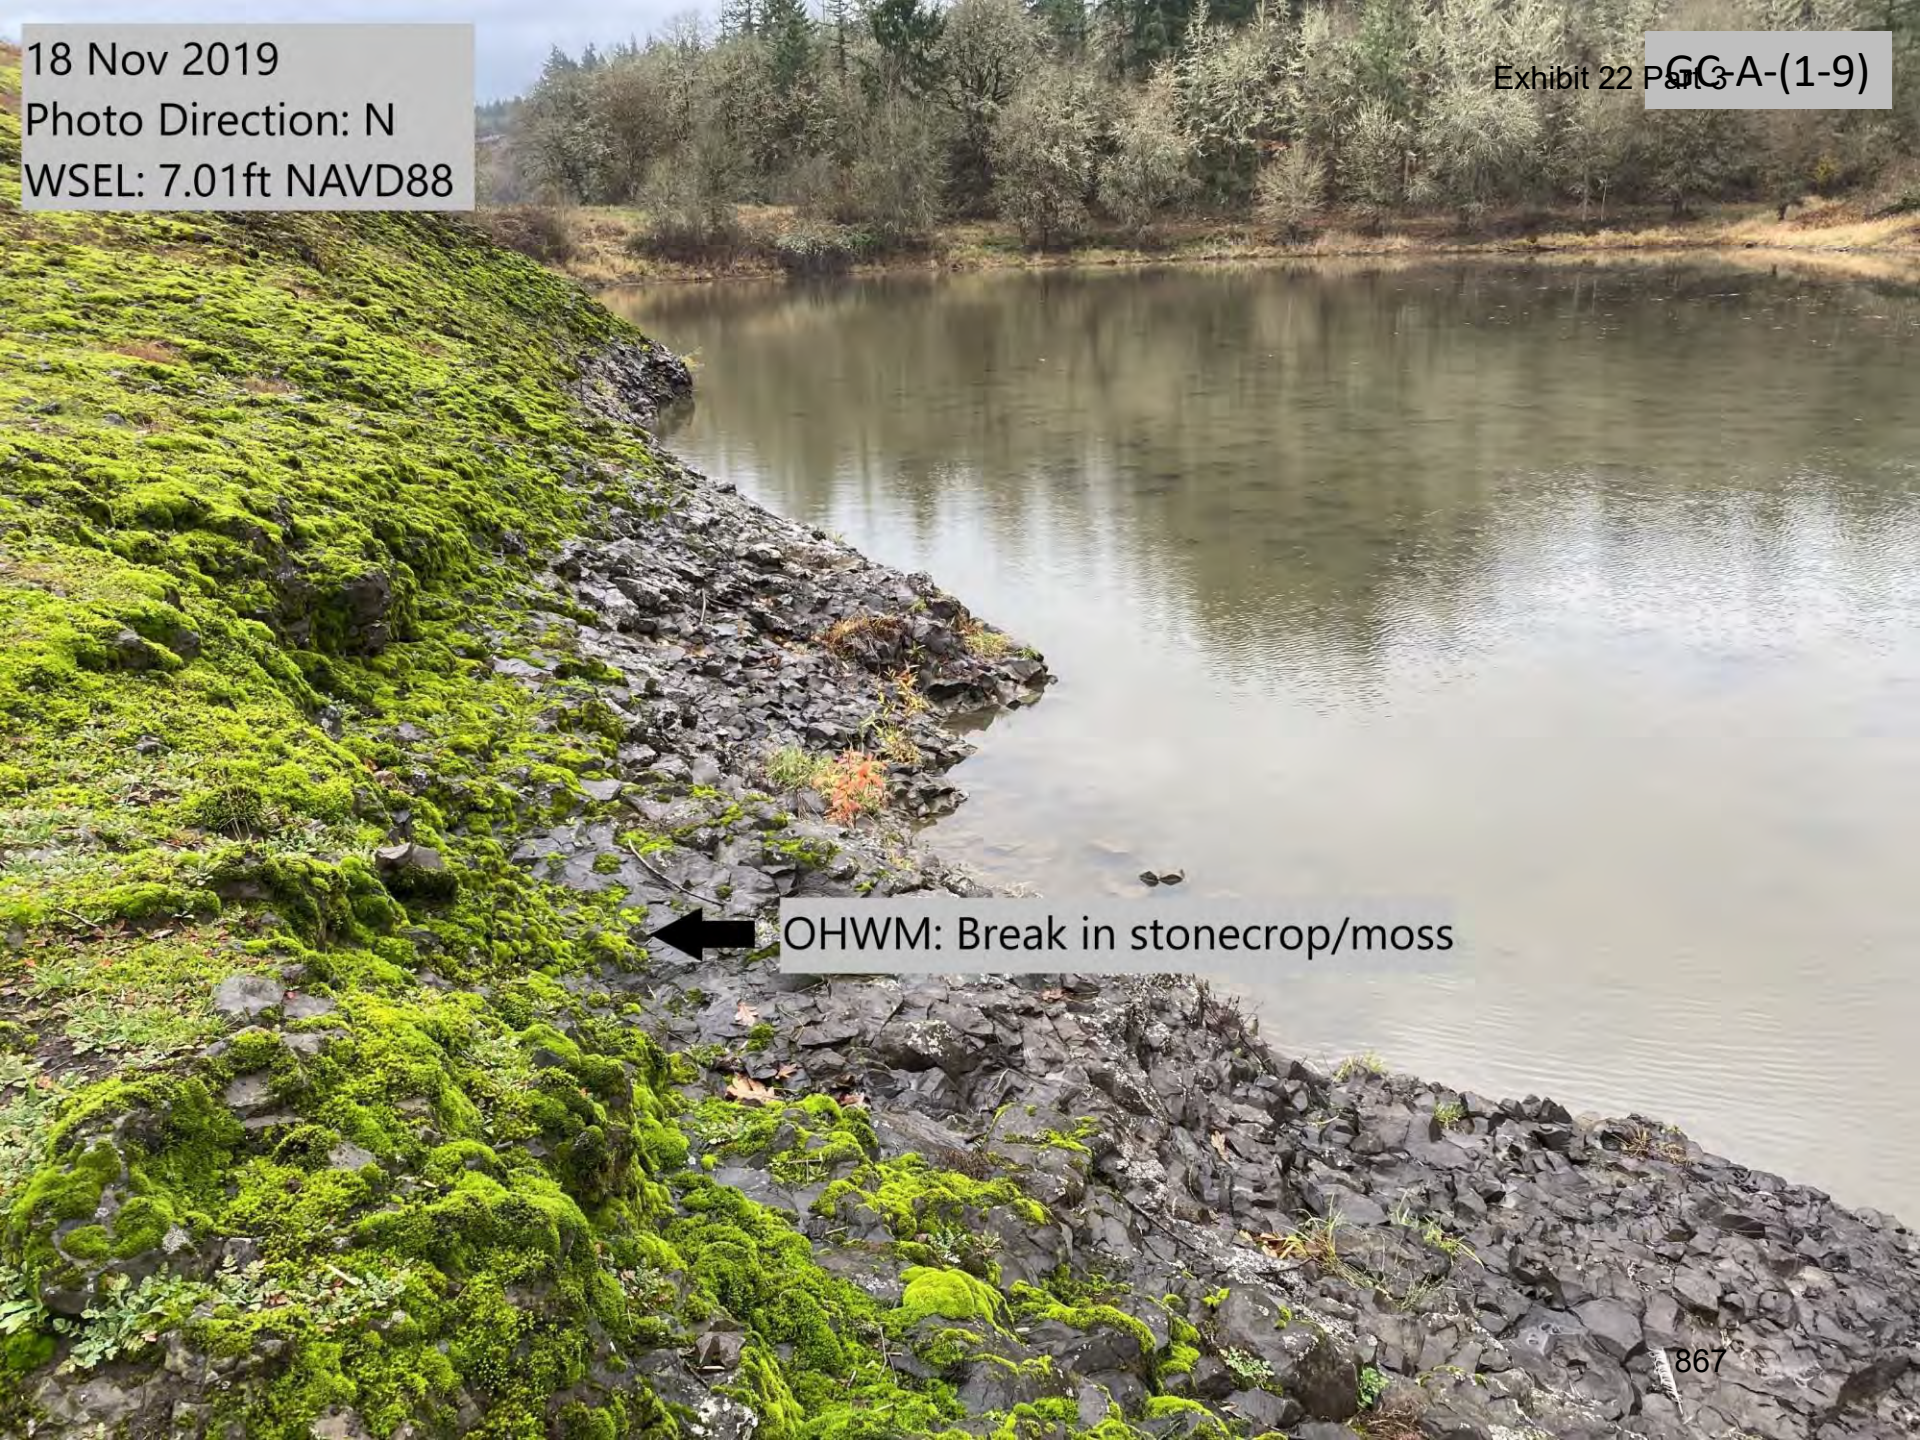
CGA-(1-9)

OHWM: Break in stonecrop/moss

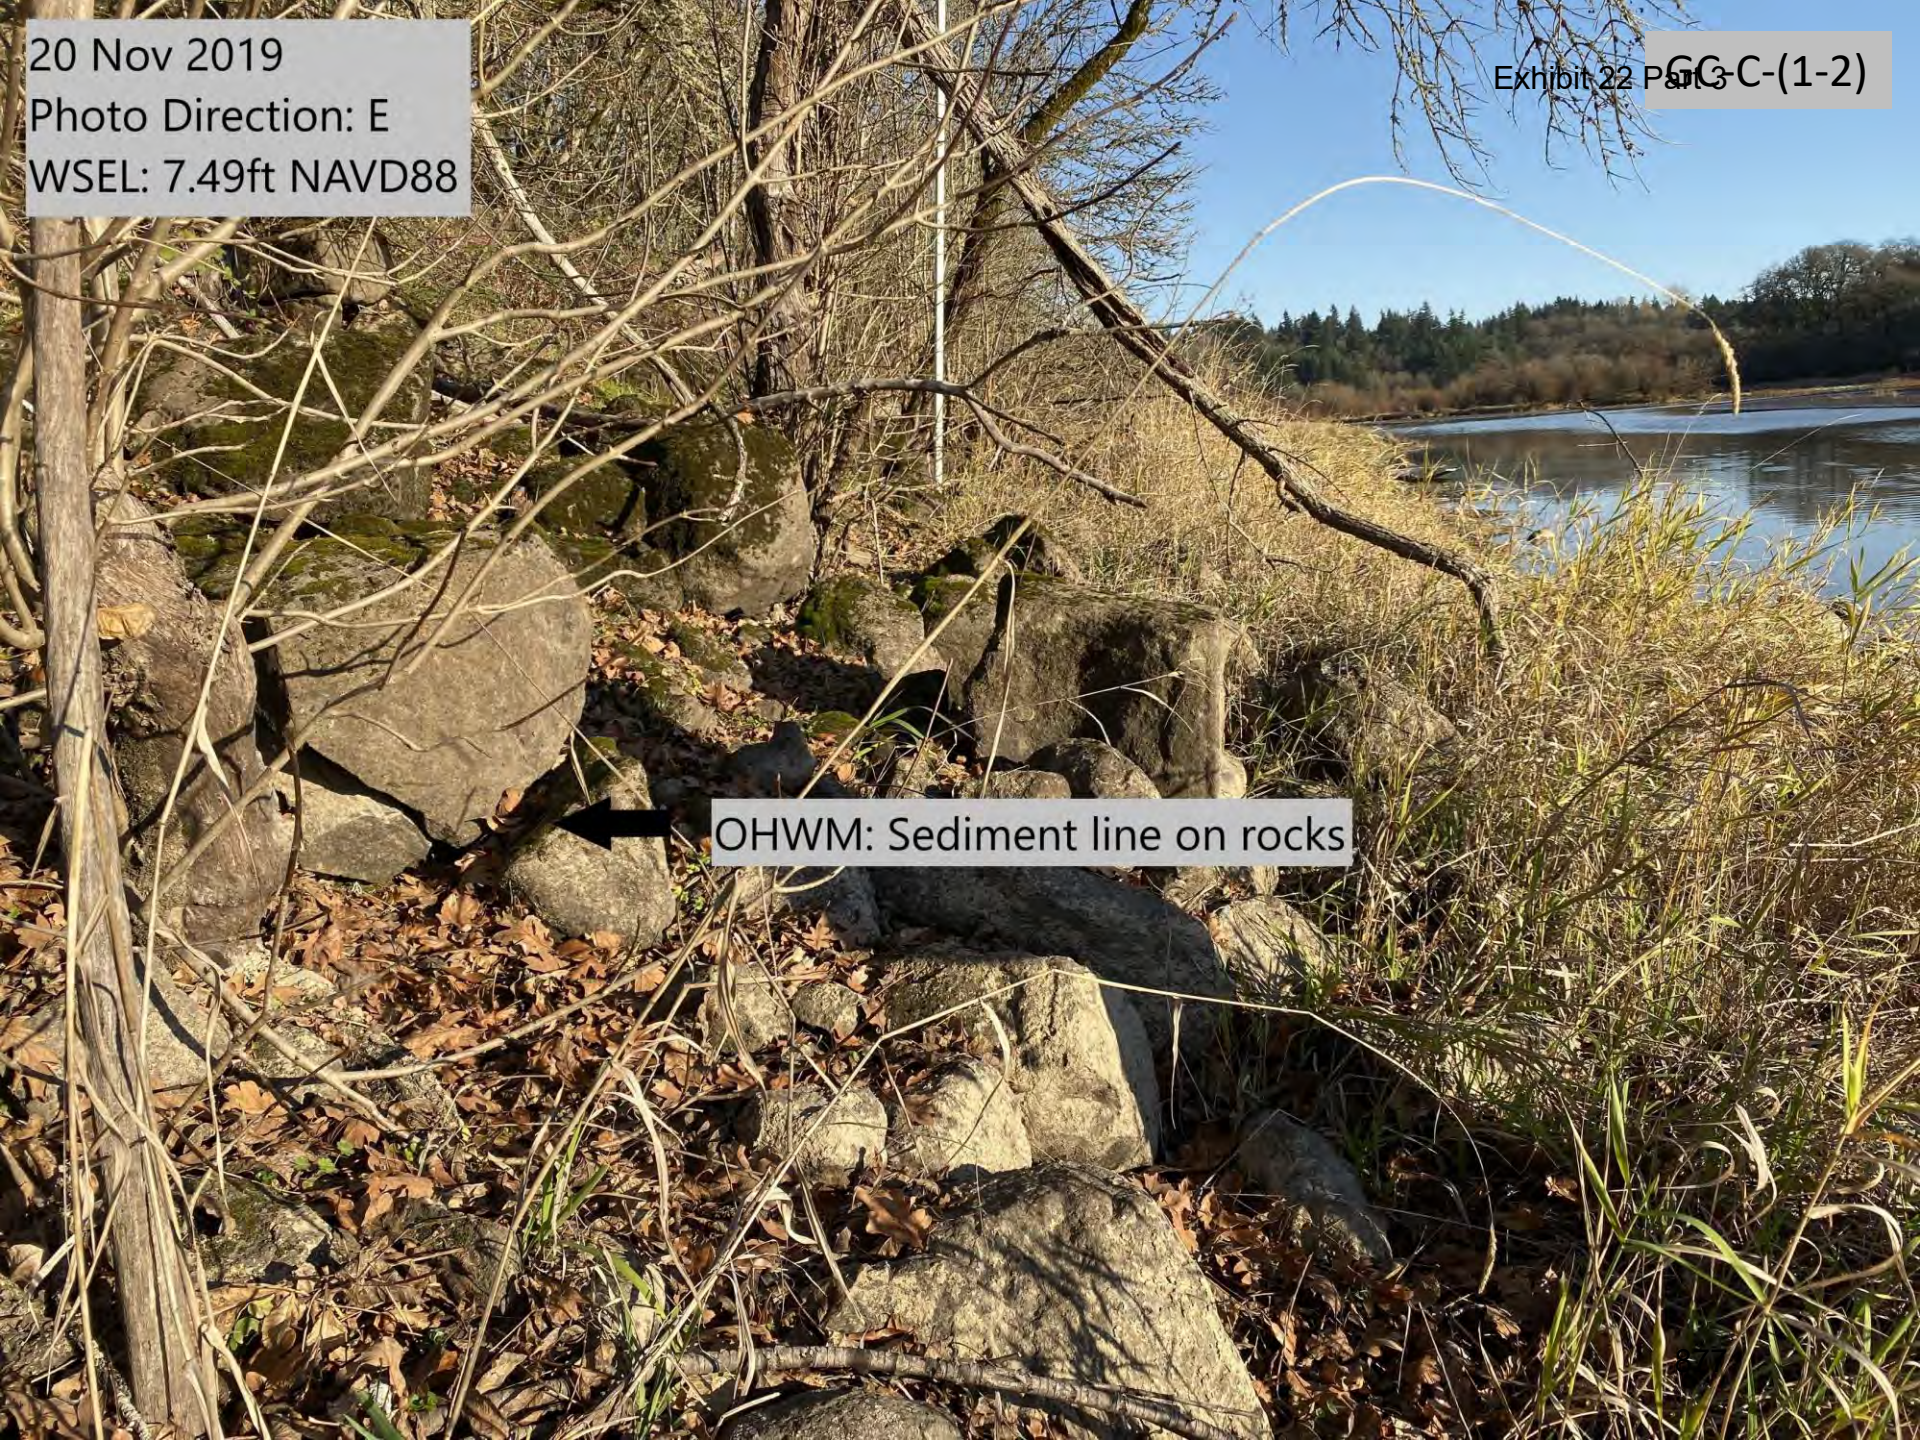
Exhibit 22 Part 3  
GG-C-(1-2)

← OHWM: Sediment line on rocks

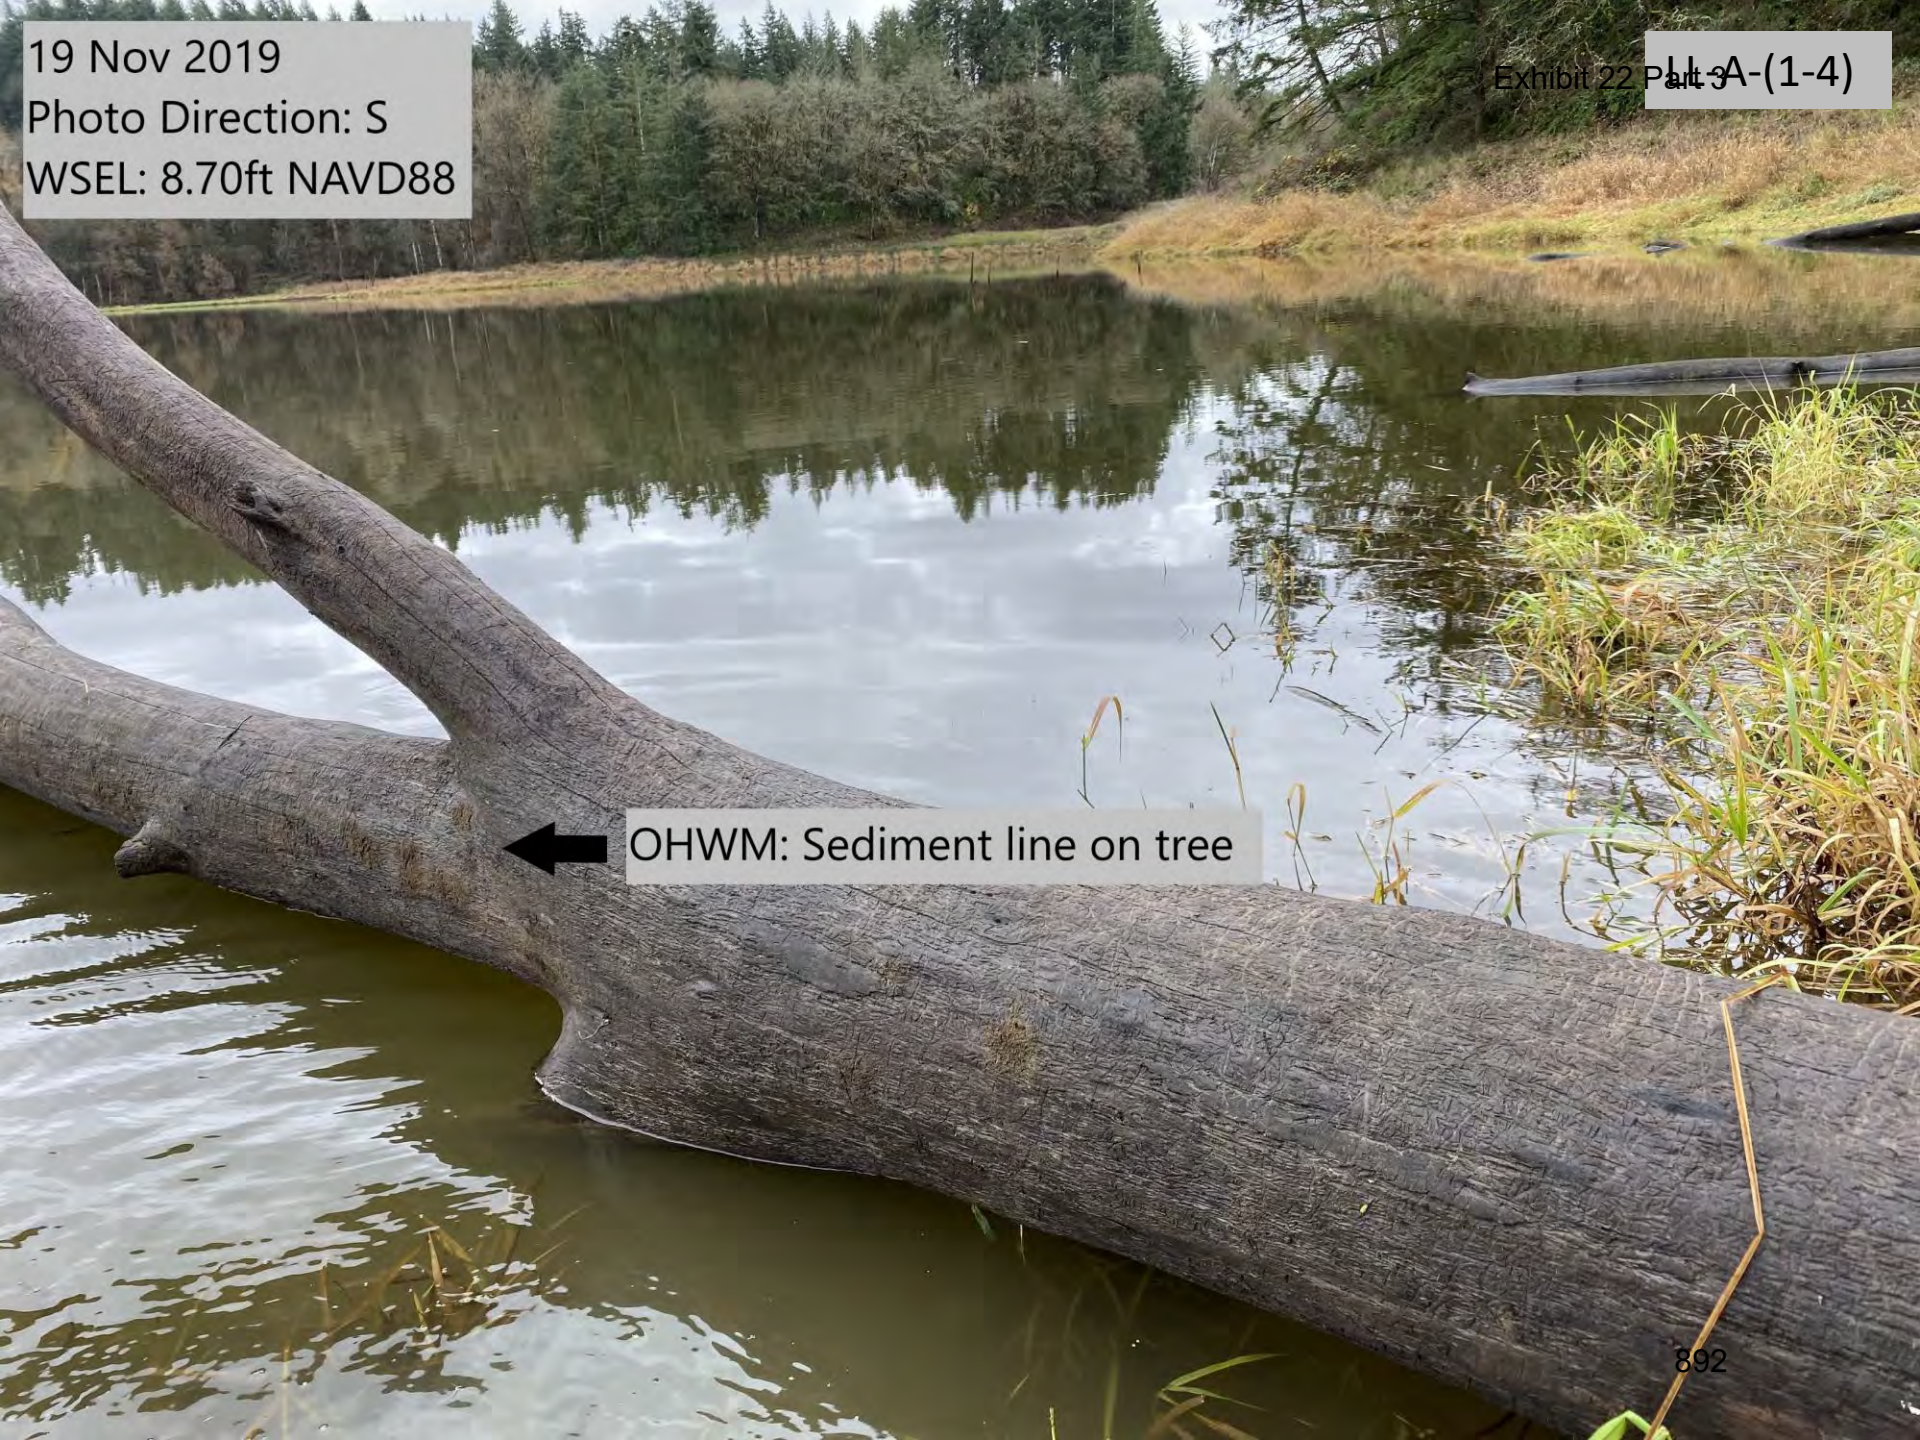
Exhibit 22 Part 3  
11-A-(1-4)

← OHWM: Sediment line on tree

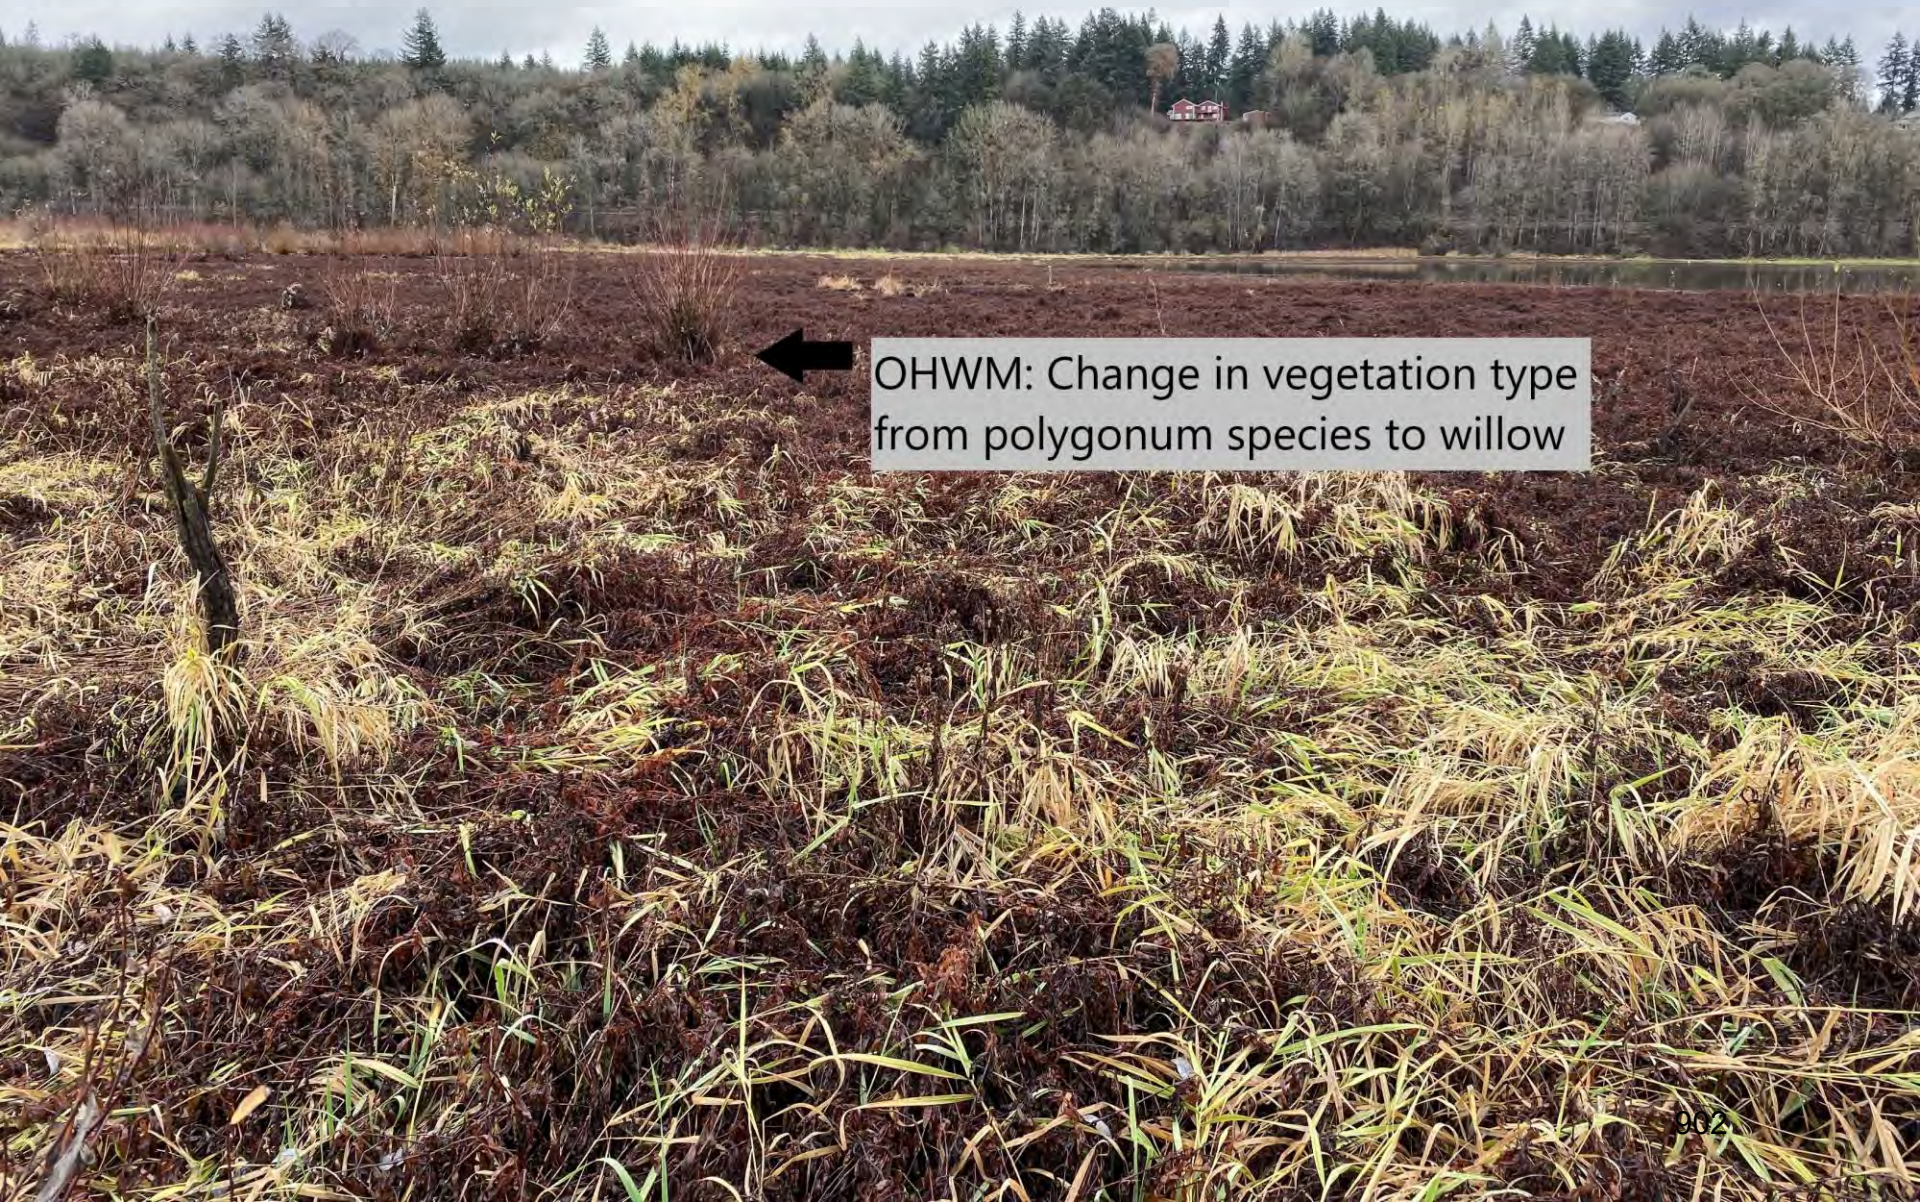
Exhibit 22 Part 3 U-C-(1-6)

OHWM: Change in vegetation type  
from polygonum species to willow

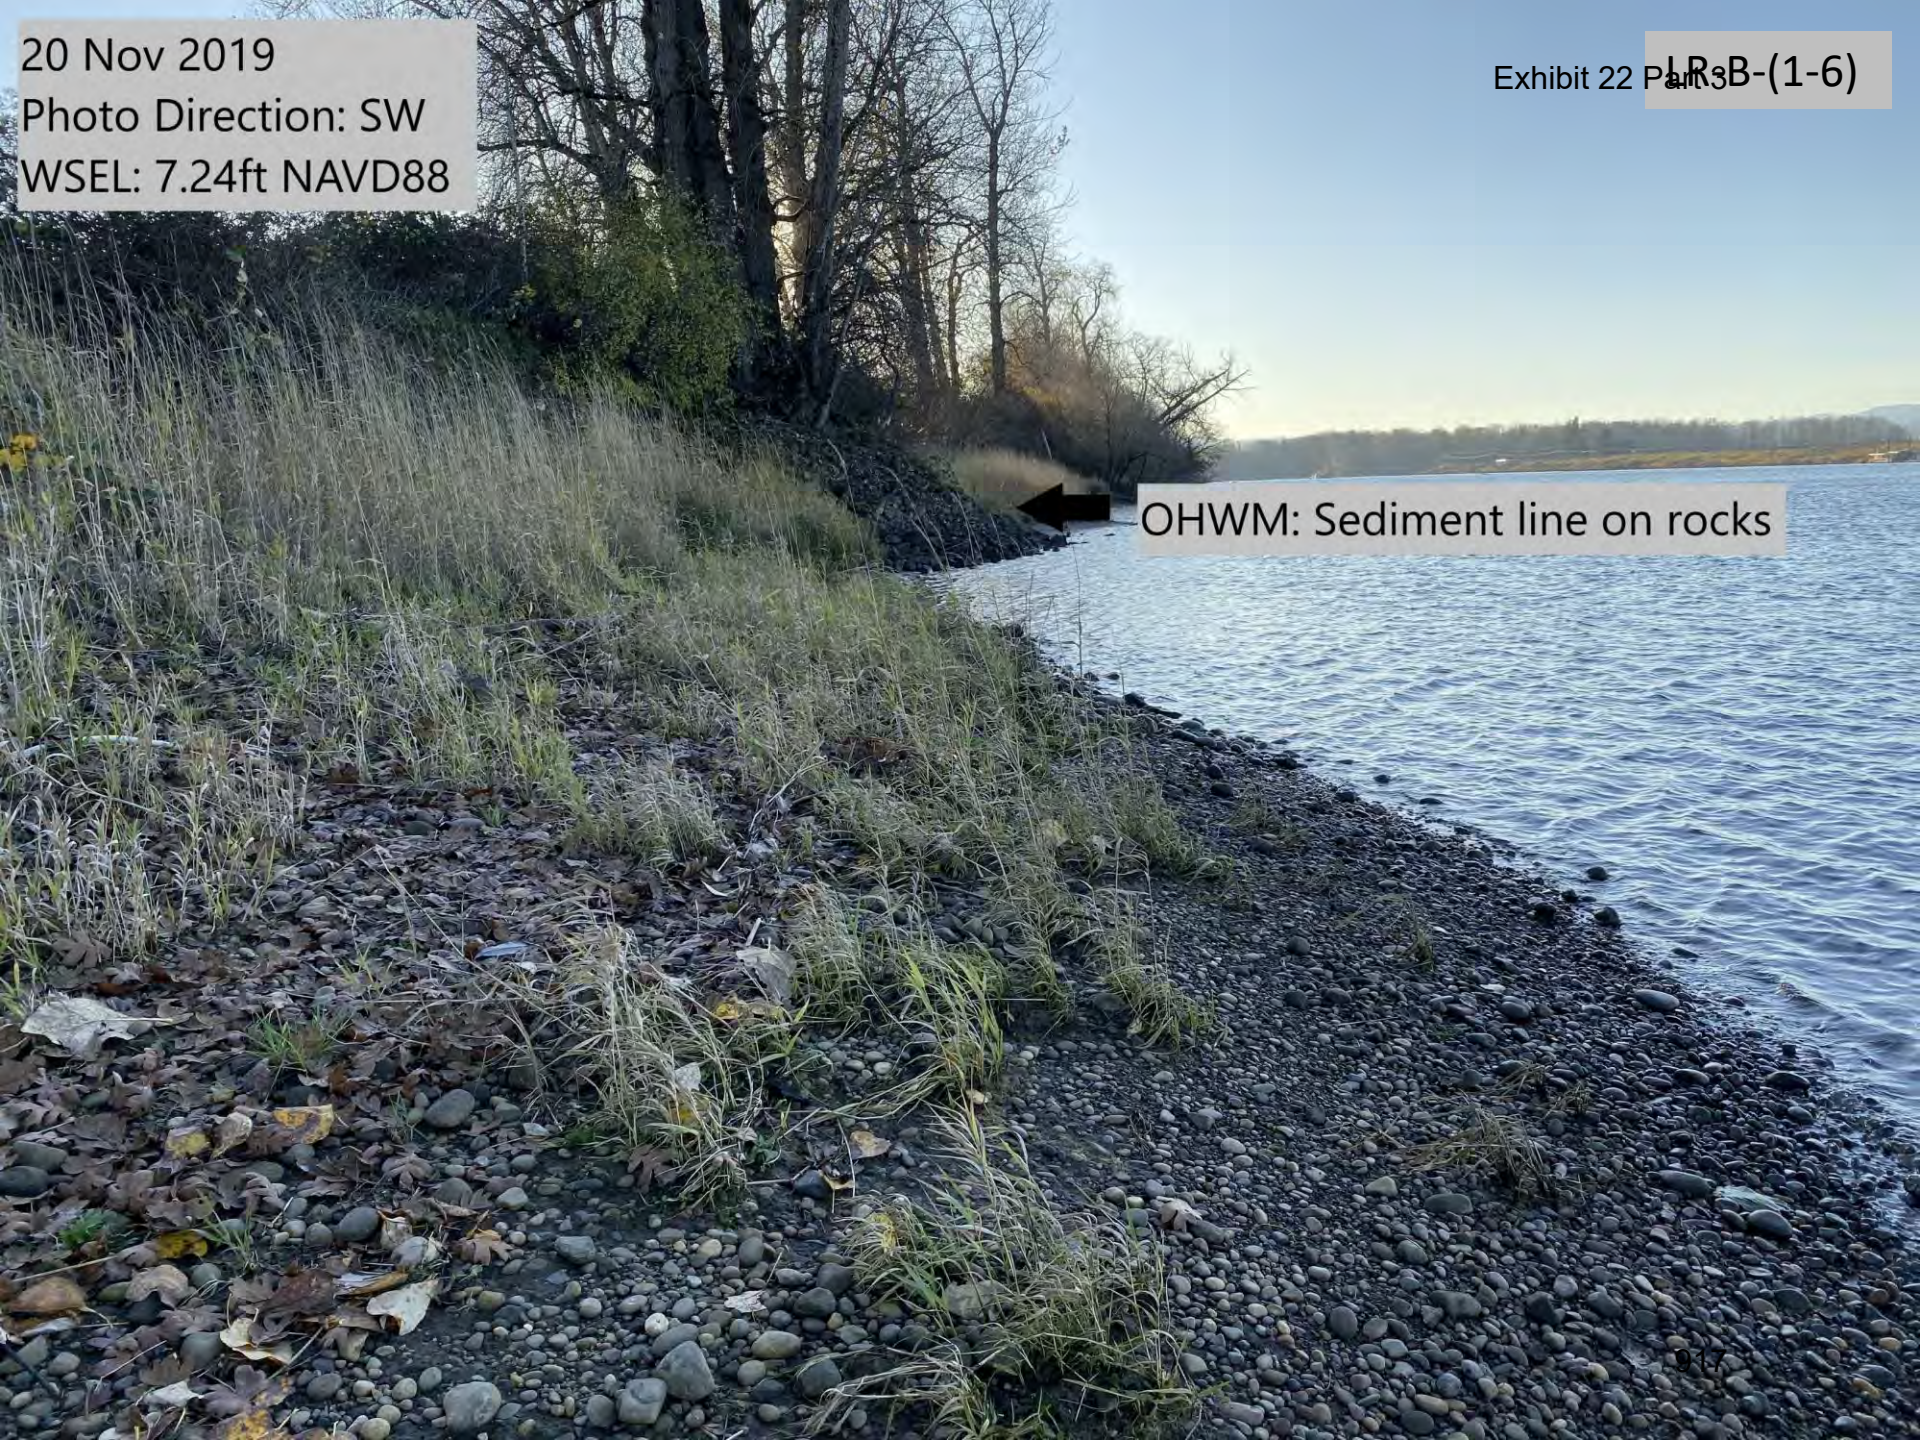
OHWM: Sediment line on rocks
