# TMDL for *Escherichia coli* (*E. coli*) in the North Fork Virgin River Watershed

Prepared by:  
Utah Department of Environmental Quality  
Division of Water Quality

January 2018

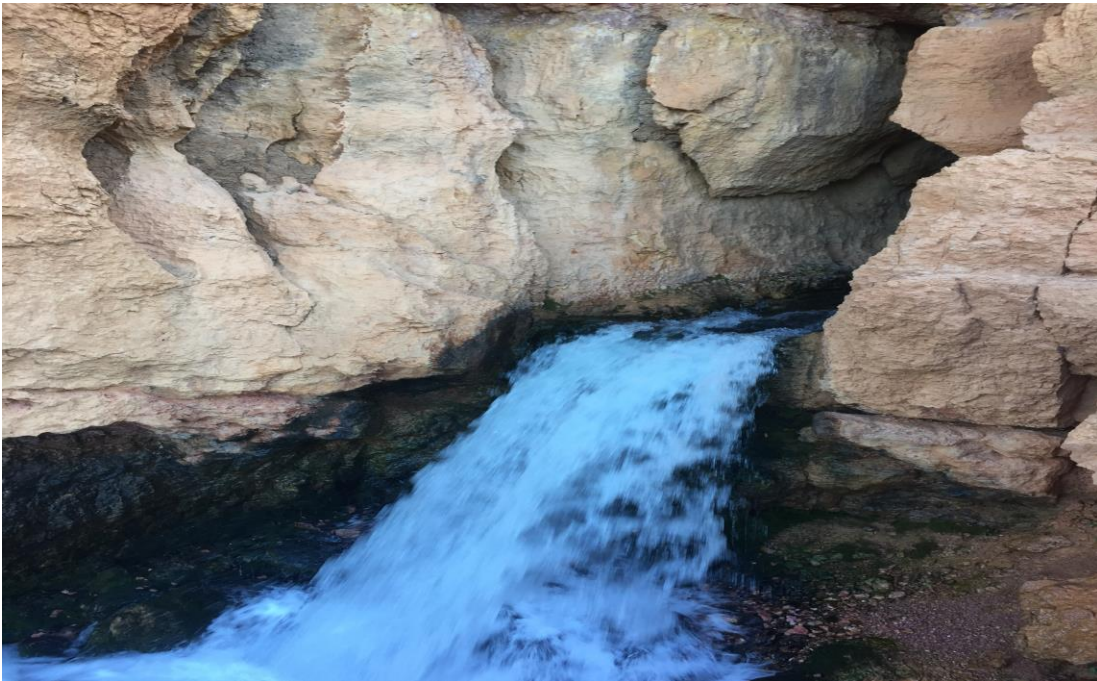
**Figure 2: Cascade Falls discharges from the limestone beds of the Clarion Formation. August 2017**

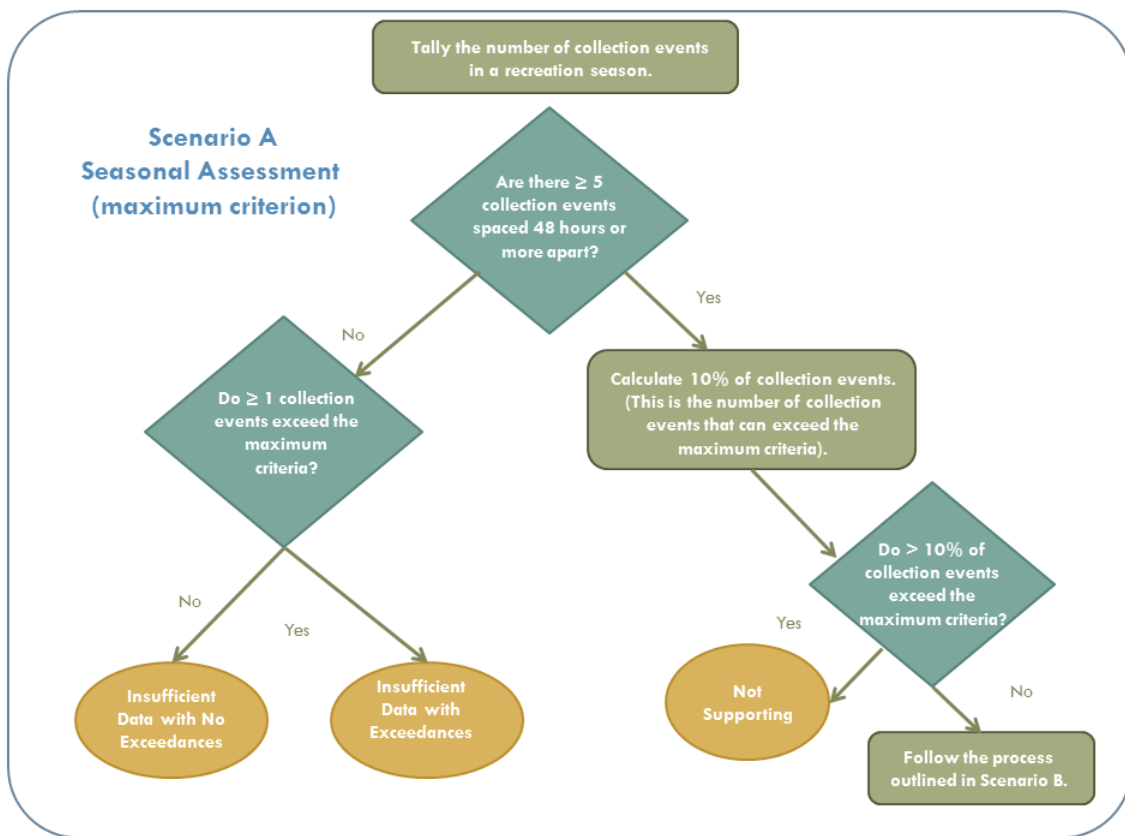
**Figure 3: Seasonal assessment against maximum criterion**

- Scenario A: Seasonal assessment against maximum criterion.  
For each AU with >5 collection events in any recreation season, no more than 10% of samples collected from May 1<sup>st</sup> through October 30<sup>th</sup> may exceed 409 MPN/100 mL for 2A waters or 668 MPN/100 mL for 1C/2B waters throughout the most recent six years.

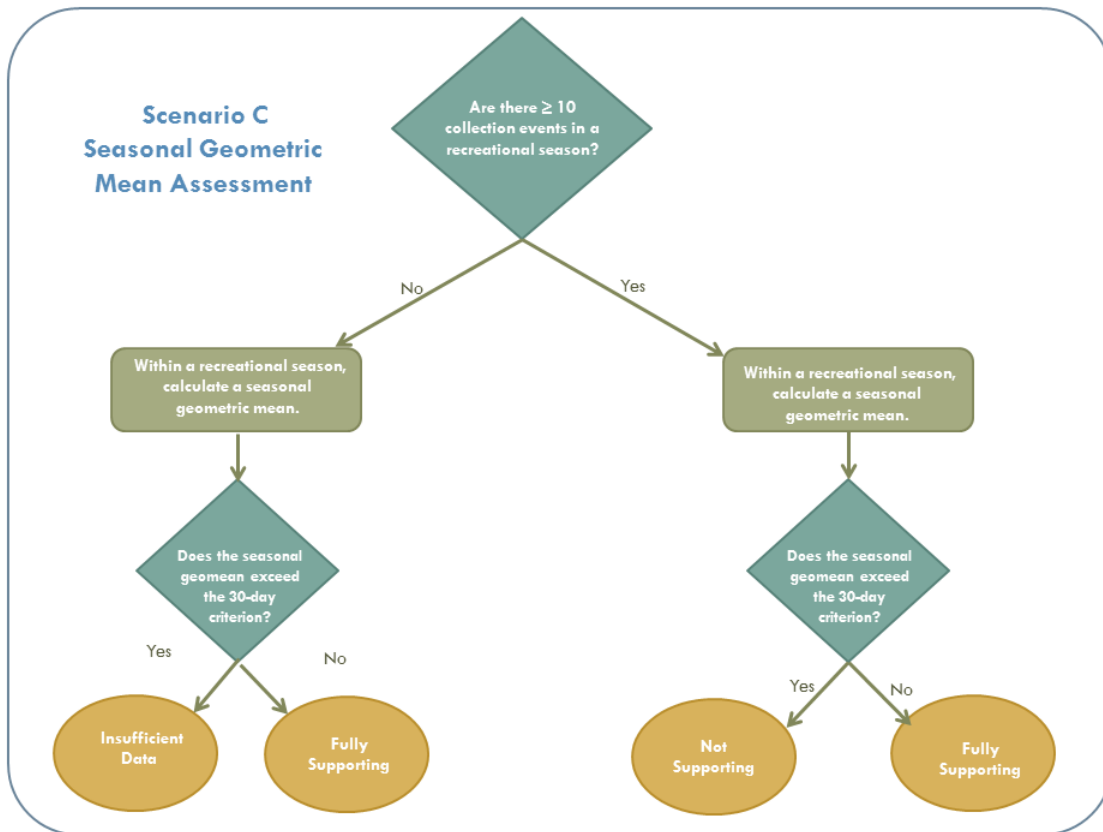
**Figure 5: Seasonal geometric mean assessment**

waters or 206 MPN/100 mL for 1C/2B waters throughout the most recent six years of recreation seasons.

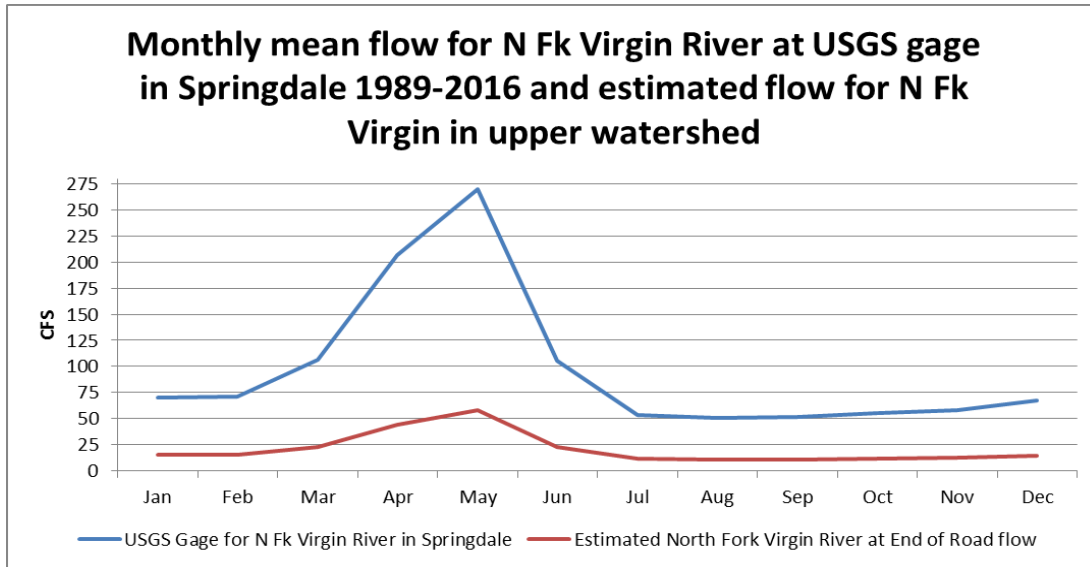
**Figure 6: Monthly mean flow (CFS) for North Fork Virgin River in Springdale and estimated flow for North Fork Virgin River at End of Road**

value of 0.215 which was calculated by comparing flow measurements in the upper watershed at the End of the Road monitoring location to the gage flow data. Figure 6 shows monthly mean flow at the USGS gage in Springdale from 1989-2016 and corresponding estimates of mean monthly flow for the North Fork in the upper watershed at the End of the Road monitoring location.

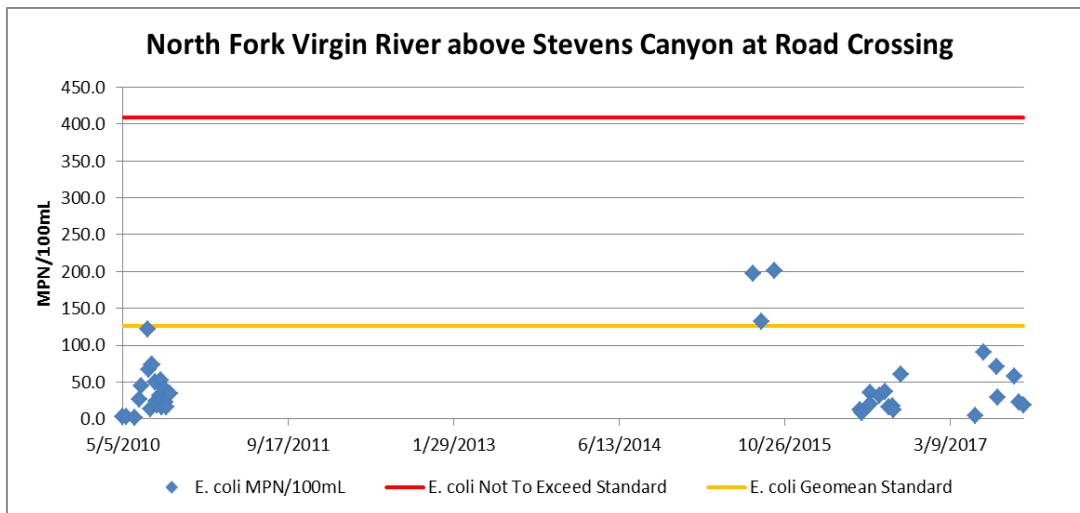
**Figure 9: *E. coli* concentrations measured at North Fork Virgin River above Stevens Canyon at Road Crossing from 2010-2017.**

concentrations were measured at downstream locations. The Stevens site was added back to see how far upstream the exceedances could be measured. All 2016 and 2017 *E. coli* samples were below 100 MPN/100mL.

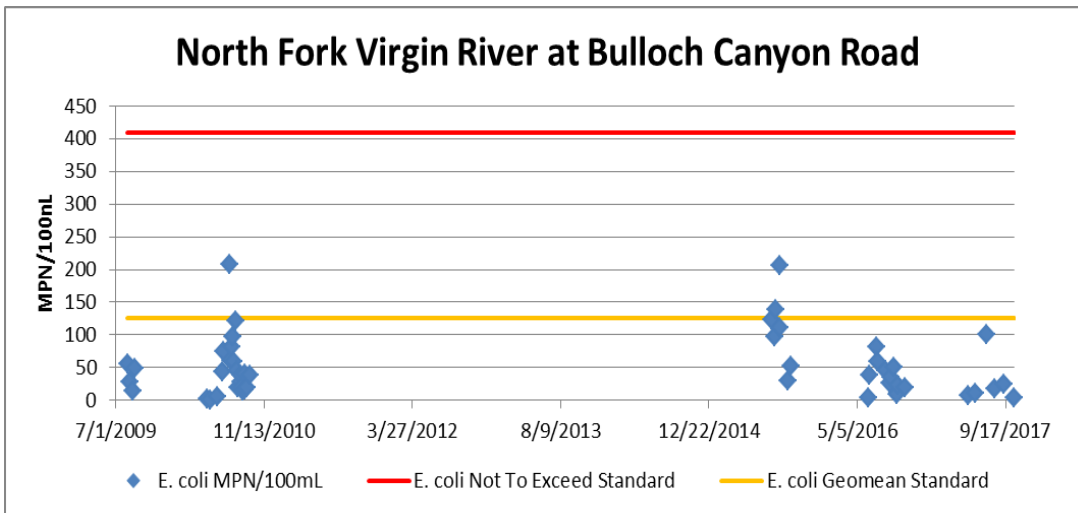
**Figure 10: *E. coli* concentrations measured at North Fork Virgin River at Bulloch Canyon Road from 2009-2017.**

Similar to the Stevens Canyon site, the Bulloch Canyon site was sampled intensively in 2010 with no exceedances of the maximum criterion measured. It was omitted from the sampling schedule until 2015. All 2016 and 2017 samples were below 100 MPN/100mL.

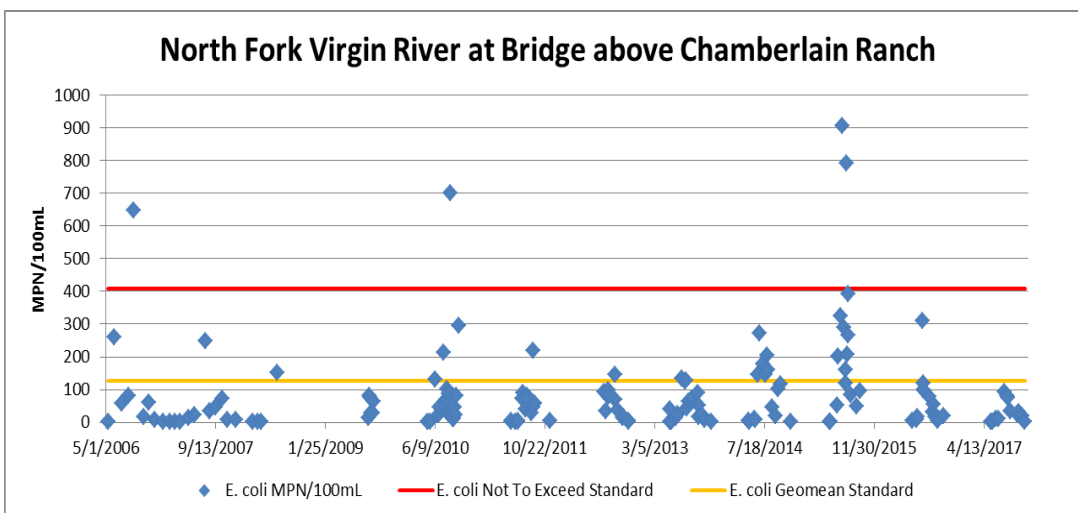
**Figure 11: *E. coli* concentrations measured at North Fork Virgin River bridge above Chamberlain Ranch from 2006-2017.**

The North Fork Virgin River at Bridge monitoring location has a very robust data set with samples dating back to 2006. Only 4 of 140 samples have exceeded the maximum criterion of 409 MPN/100mL. Immediately downstream is where exceedances were consistently measured.

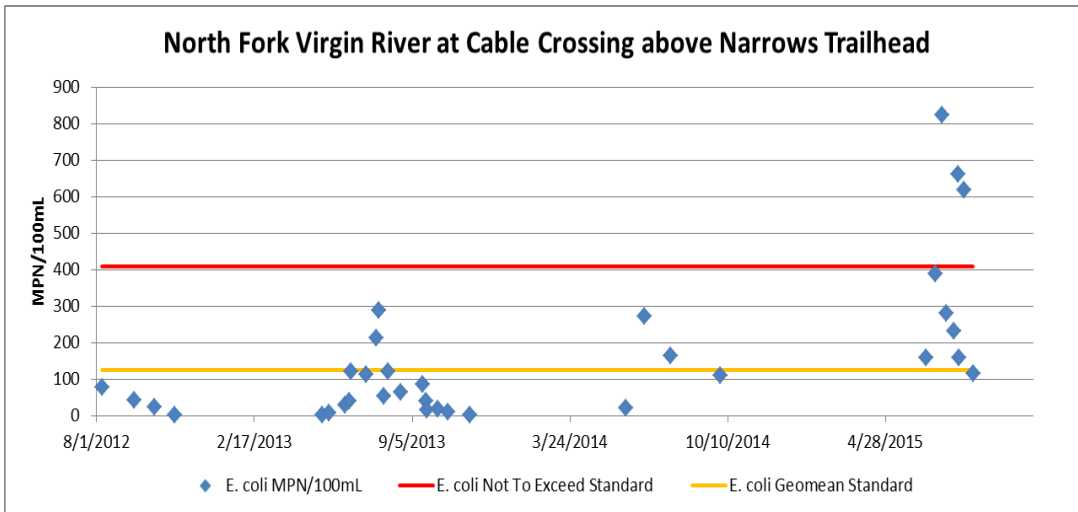
**Figure 12: E. coli concentrations measured at North Fork Virgin River at cable crossing above Zion Narrows trailhead from 2012-2015.**

The Cable Crossing site and the above Narrows Trailhead site which follows are located downstream of the North Fork Bridge site and upstream of the Narrows Trailhead. The Cable Crossing site is at the upstream end of the first irrigated pasture where no irrigation return flows should have reached the river. The next site downstream is below where the first substantial return flows join the river.

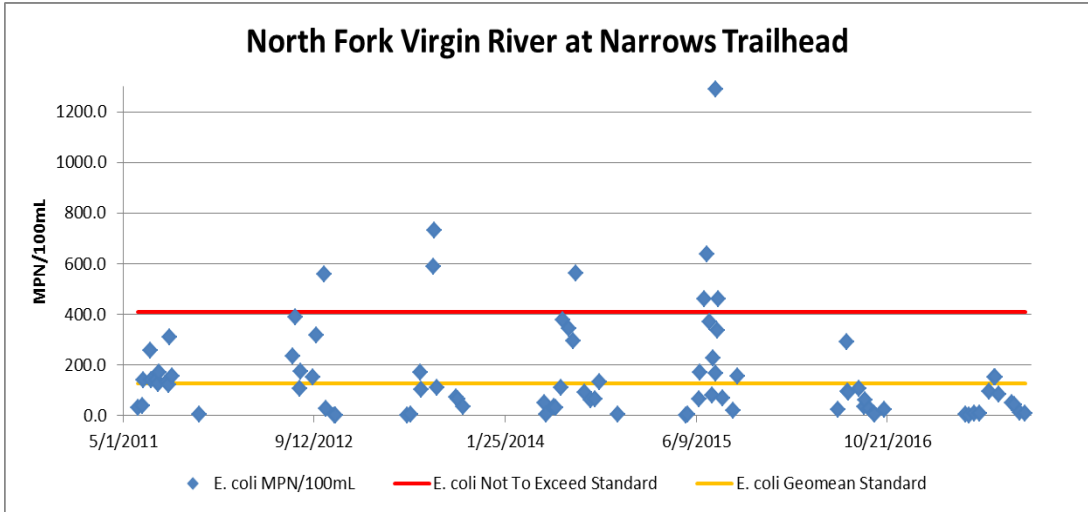
**Figure 14: *E. coli* concentrations measured at North Fork Virgin River at Zion Narrows Trailhead from 2011-2017.**

The North Fork Virgin River at Zion Narrows Trailhead monitoring location is where hikers begin the Zion Narrows hike. It is located downstream of some flood irrigated pastures and grazing. A pit toilet was installed near the trailhead in 2011 after observations of a persistent problem with human waste at this location. Note the drop in concentrations in 2016 and 2017, during which no exceedances of the maximum criterion were measured. This drop in *E. coli* concentration is attributed to a change in management of the property that limited grazing and irrigation for a season to see if that resulted in any improvements in water quality.

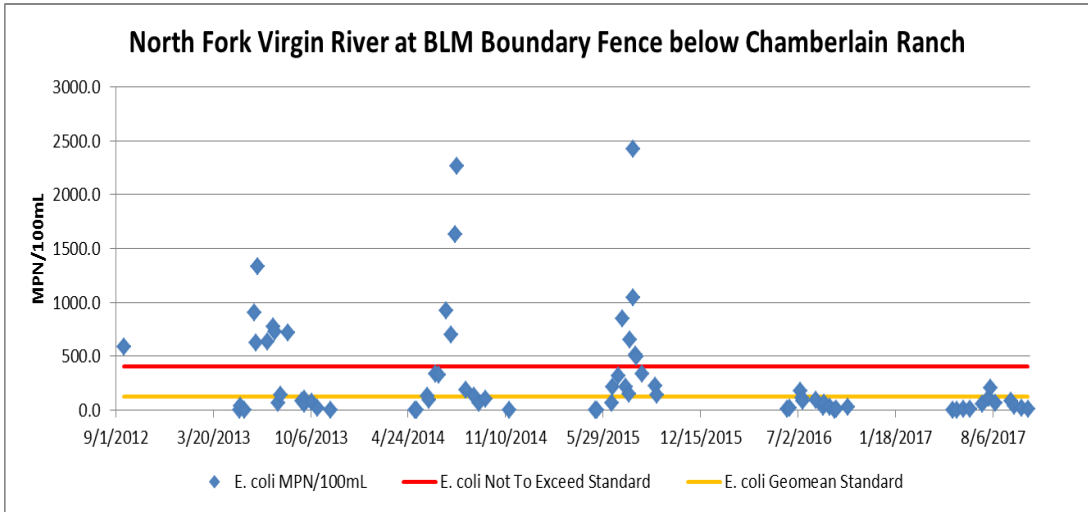
**Figure 15: *E. coli* concentrations measured at North Fork Virgin River at BLM Boundary Fence below Chamberlain Ranch from 2012-2017.**

The North Fork Virgin River at BLM Boundary Fence monitoring location was added in late 2012 to determine *E. coli* concentrations from private property. It is located at the boundary between private lands upstream and BLM administered pastures downstream. Results for 2013-2015 showed beneficial use impairment at that this location but 2016 and 2017 results are all below the maximum criterion standard. The observed decrease in *E. coli* levels is most likely due to the changes in grazing and irrigation management on the private pastures upstream.

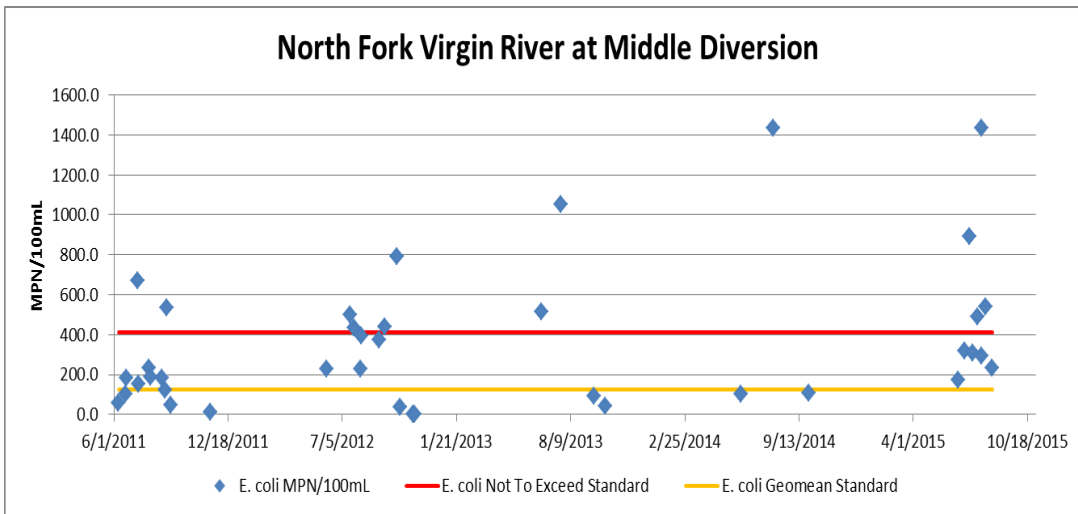
**Figure 16: *E. coli* concentrations measured at North Fork Virgin River at Middle Diversion from 2011-2015.**

The Middle Diversion monitoring location is on BLM property. Exceedances were measured in 2011-2015. The site was removed from the sampling plan in 2016 because the BLM fence site is a superior location.

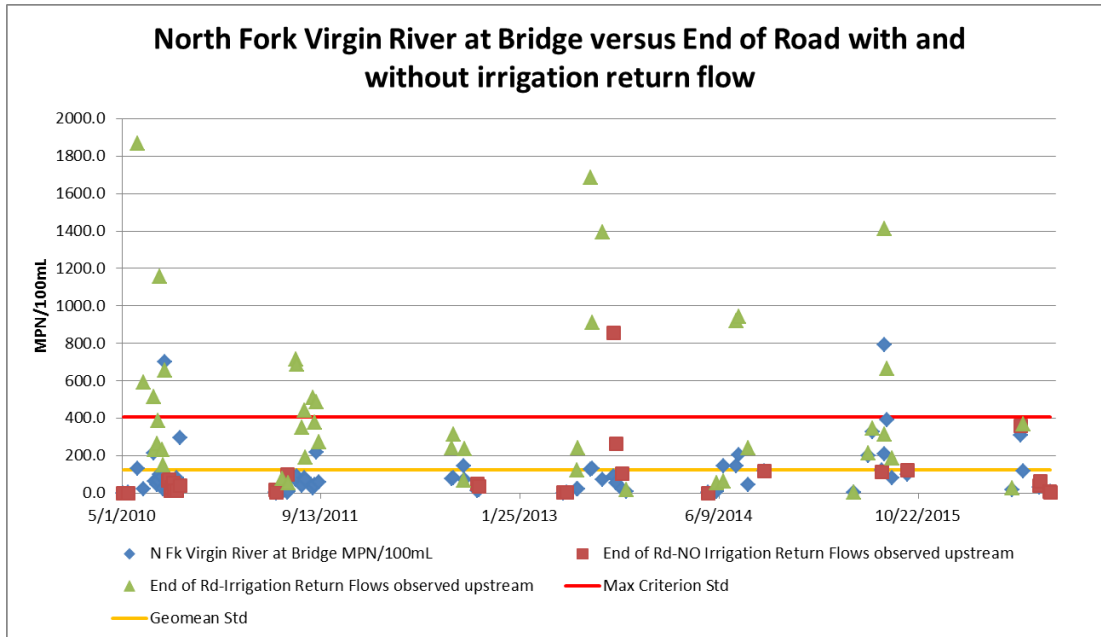
**Figure 18: *E. coli* concentrations at Bridge site versus End of Road site with and without return flow.**

standard at the Bridge site above the pastures, concentrations exceeded the standard just 3 miles downstream at the End of the Road if return flows were occurring. Concentrations of return flows were likely dependent on how long the water had been flowing over the pastures and how recently they had been grazed by cows and wildlife.

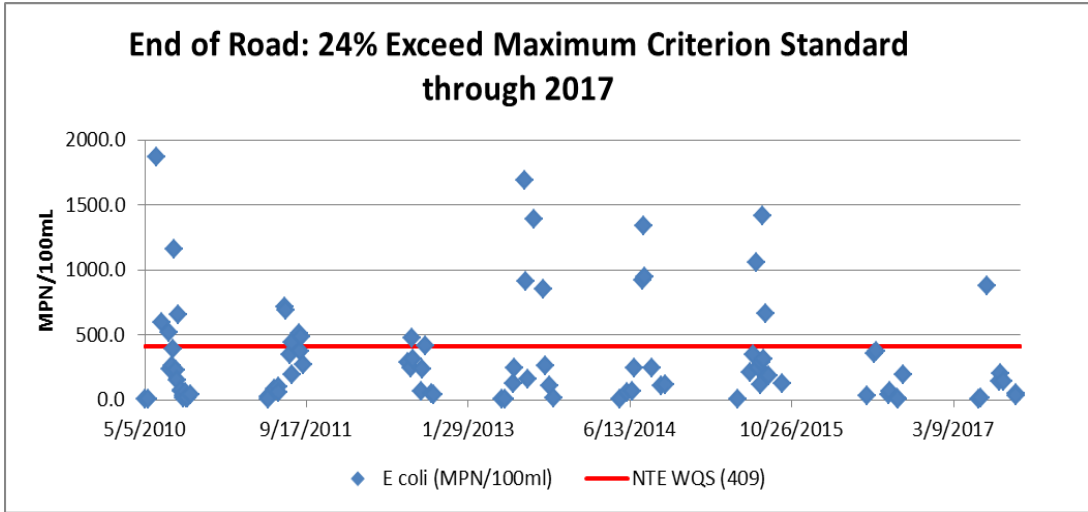
**Figure 19: *E. coli* concentrations above maximum criterion at North Fork Virgin River at End of Road site**

Exceedances of the maximum criterion for 2A waters have been measured at the End of the Road monitoring site since 2010. Since then, 24% of all collection events during the May-October recreation season exceed the maximum criterion. This has resulted in the North Fork Virgin River-2 being assessed as not supporting its frequent primary contact beneficial use and its inclusion on Utah's 303(d) list since April 2010.

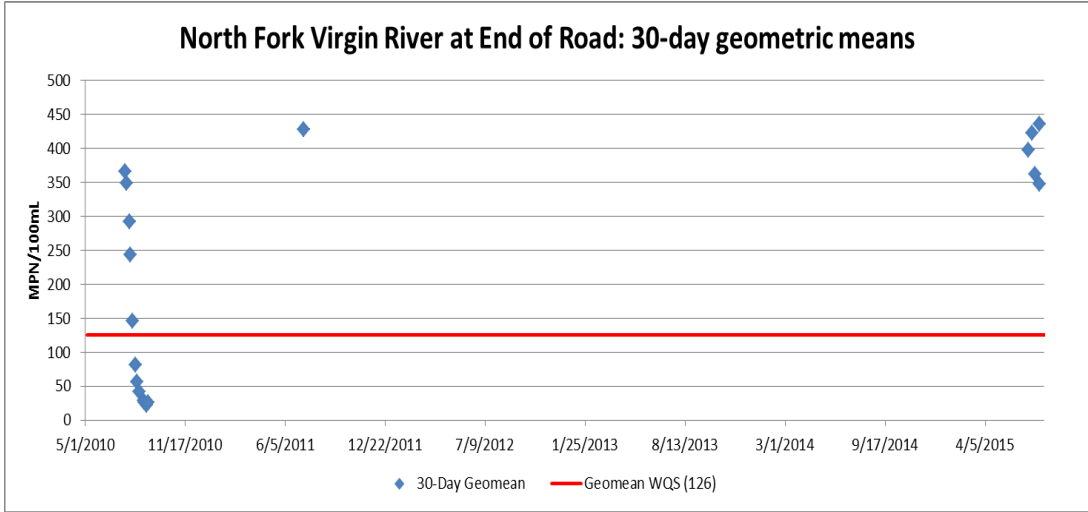
**Figure 20: 30-day geometric means of *E. coli* concentrations for North Fork Virgin River at End of Road site**

To assess against the 30-day geometric mean scenario there must be a minimum of 5 samples collected in a 30-day period, which requires very intensive monitoring throughout the entire recreation season. Exceedances of the 30-day geometric mean at the End of the Road monitoring site occurred five times in 2010, once in 2011 and five times in 2015.

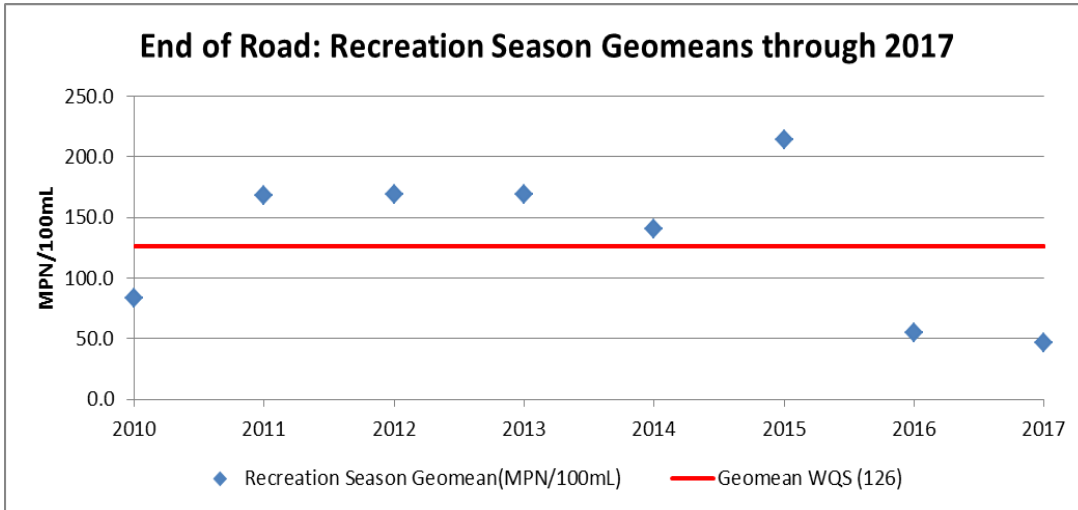
**Figure 21: Geometric means of *E. coli* concentrations during recreation season (May-October) from 2010-2017 at North Fork Virgin River at End of Road site**

This has resulted in that site's repeated failure to support the frequent primary contact beneficial use.

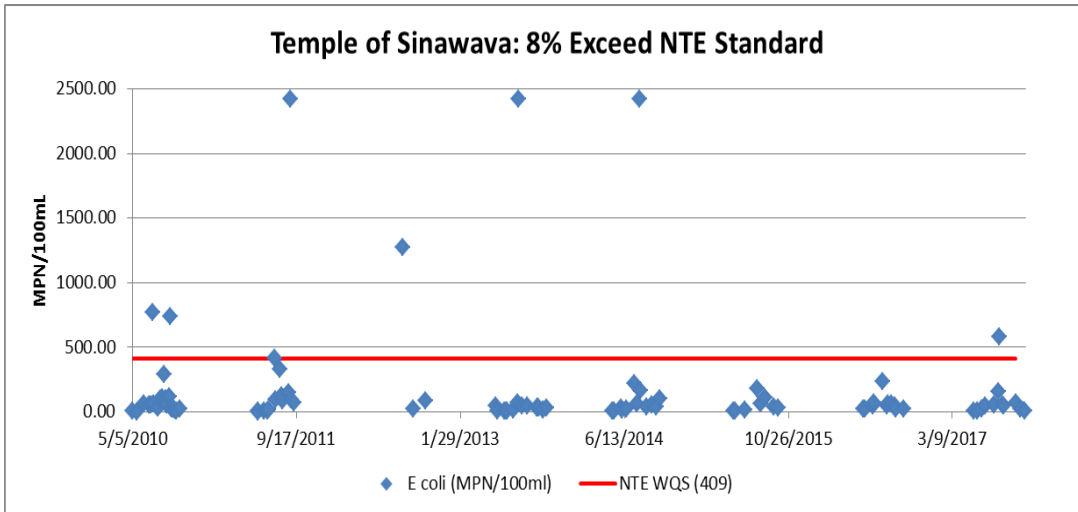
**Figure 22: *E. coli* concentrations in North Fork Virgin River at Temple of Sinawava site above maximum criterion**

Exceedances of the maximum criterion for 2A waters have rarely been measured at the Temple of Sinawava monitoring site since 2010. When considering all collection events during the recreation season (May-October) from 2010-2017, 8% exceed the criterion which is not enough to result in impaired status for the lower North Fork Virgin River-1 AU.

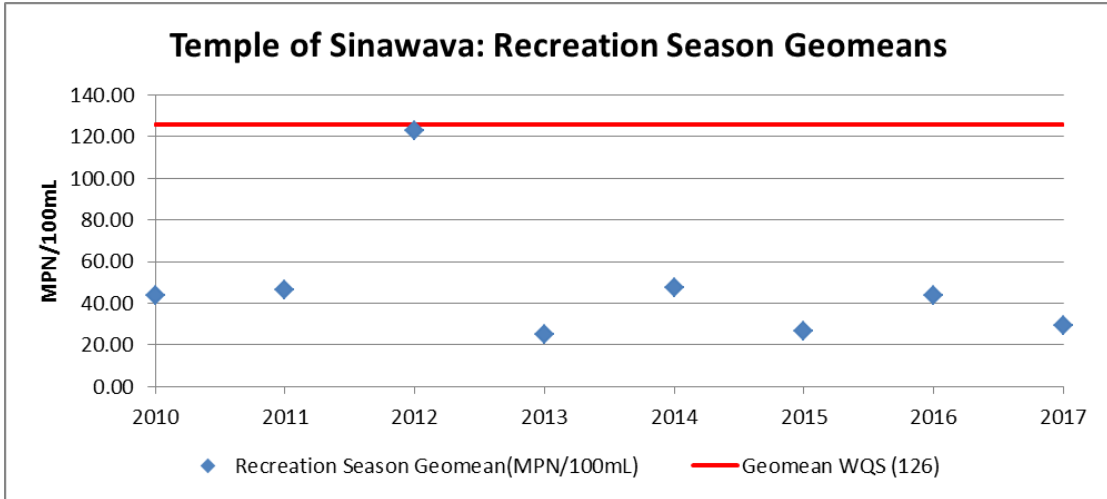
**Figure 24: Geometric means of *E. coli* concentrations during recreation season (May-October) from 2010-2017 at North Fork Virgin River at Temple of Sinawava site**

No exceedances of the chronic recreation season geometric mean for 2A waters have been measured at the Temple of Sinawava monitoring location.

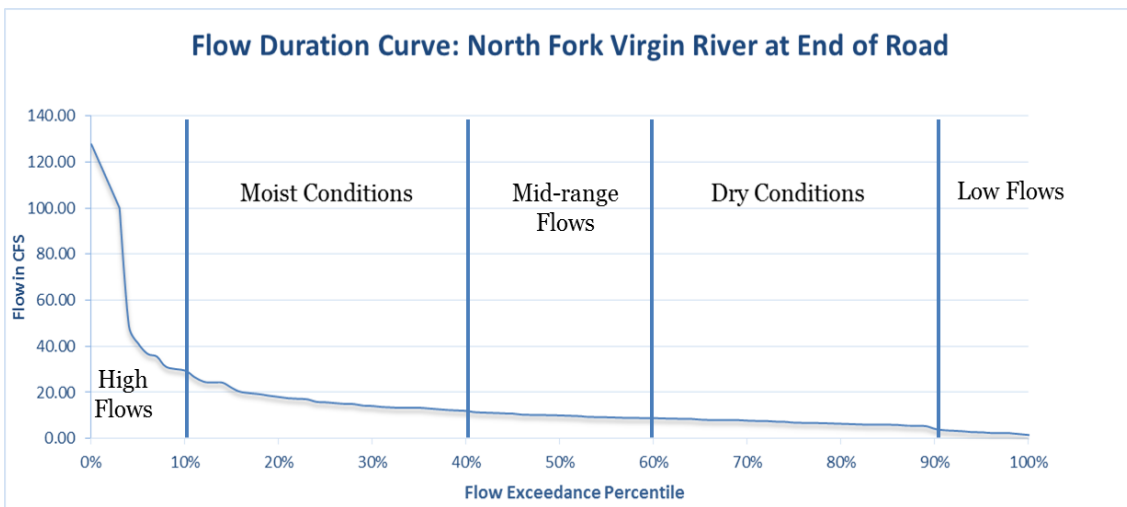
**Figure 25: Flow duration curve for the North Fork Virgin River at the End of the Road**

Observed flows from May 2009 through October 2016 were ranked in order of magnitude and each flow was assigned a percentile that reflects the chance of a flow greater than or equal to it. Each flow was then multiplied by the 126 MPN/100 mL standard (geometric mean) to calculate a corresponding maximum loading limit for each flow. The individual lines were plotted to present a loading capacity line by flow percentile, as shown in Figure 27.

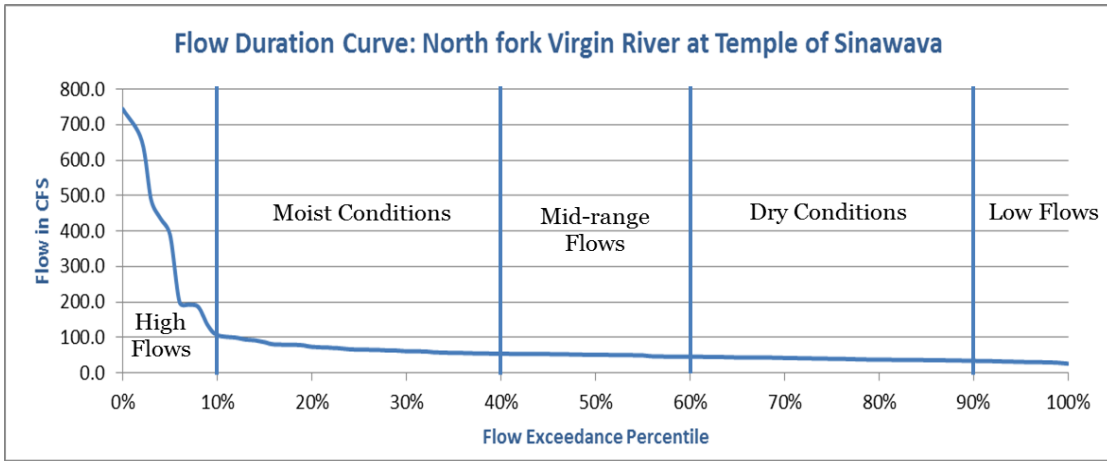
**Figure 27: Flow duration curve for North Fork Virgin River at Temple of Sinawava site.**

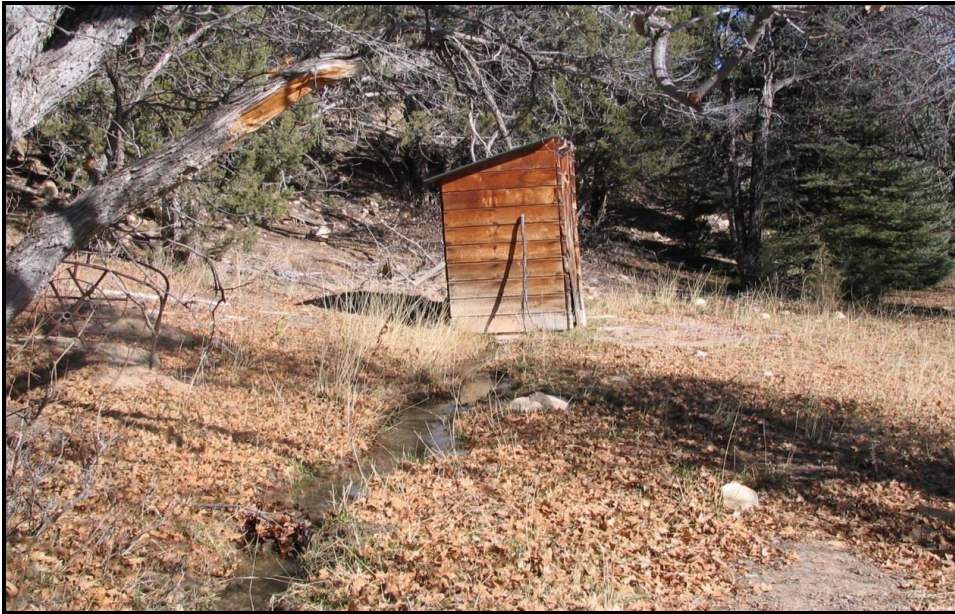
**Figure 32: Outhouse constructed over irrigation canal. This structure was removed in 2015.**

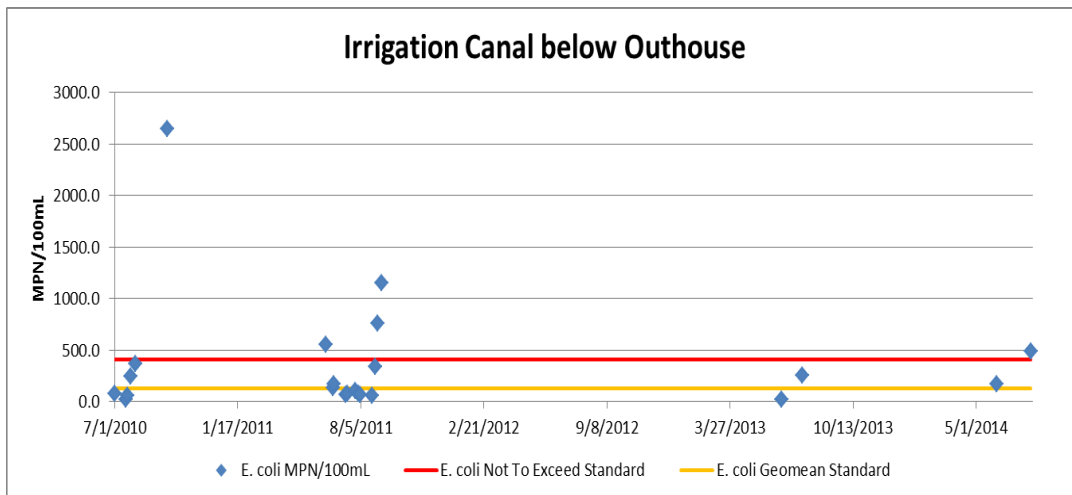
**Figure 33: *E. coli* concentration in the irrigation canal below the outhouse.**

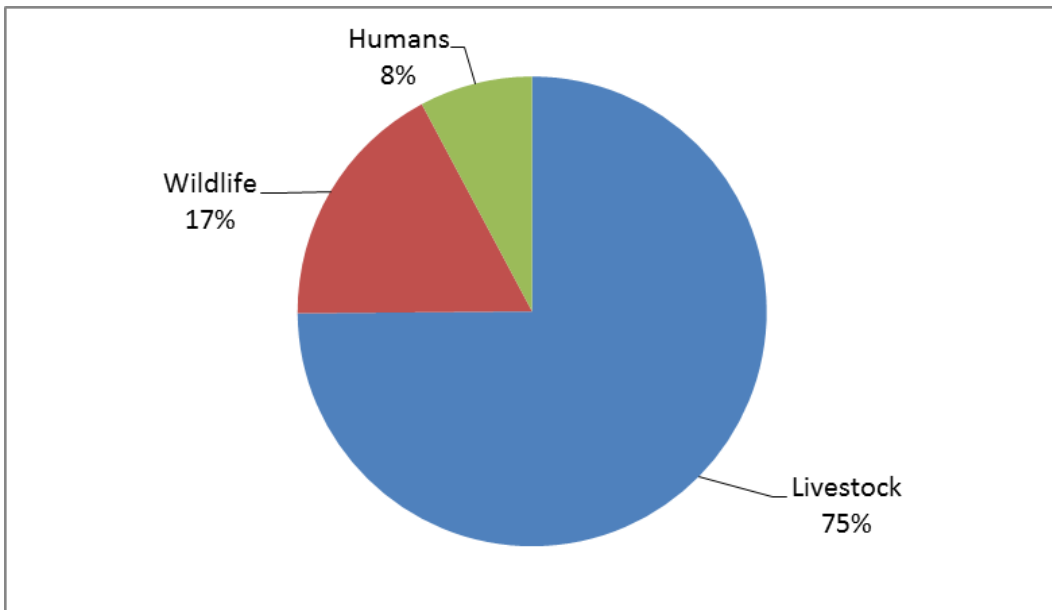
**Figure 34: Estimated bacteria contribution by source during the recreation season.**

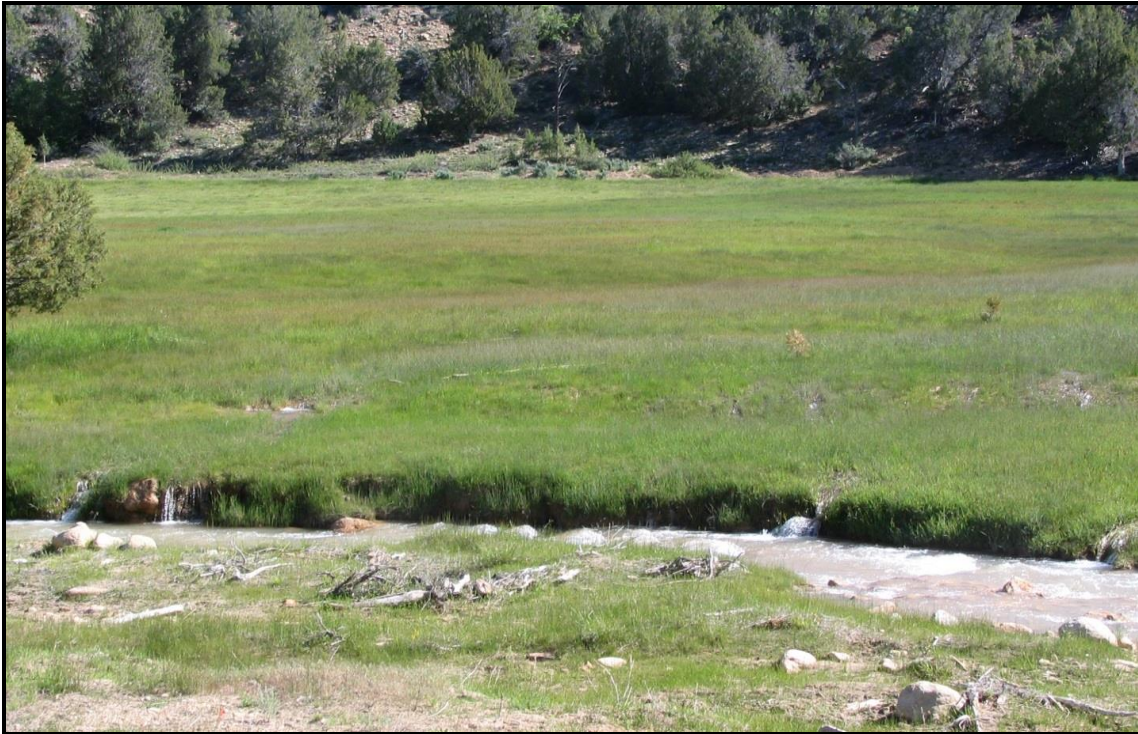
**Figure 35: Irrigated pasture with return flows along the North Fork Virgin River (note return flows cascading over the banks and into the river at several locations in the photograph).**

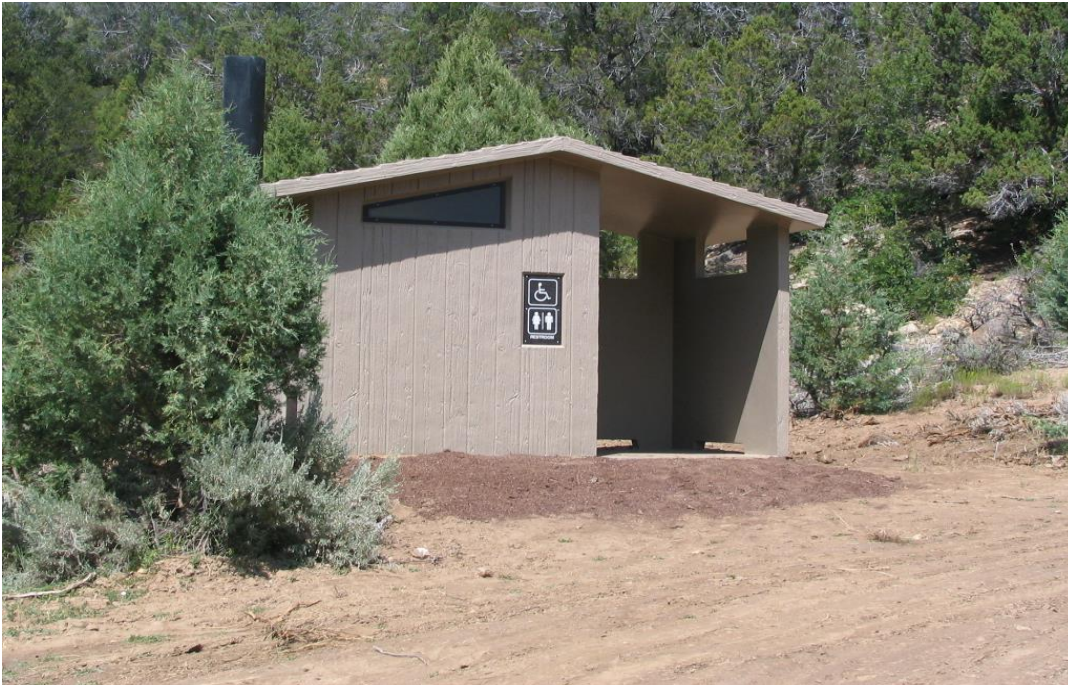
**Figure 36: Chamberlain Ranch trailhead pit toilet installed in 2011.**

The Division of Water Quality awarded a nonpoint source grant to the Kanab BLM field office to install a vault toilet at the Chamberlain Ranch trailhead in 2011. This is the area where hikers begin the popular 16 mile Zion Narrows hike. Prior to the toilet installation the area was littered with fecal matter and toilet paper. It was not only a threat to public health and a possible source of bacteria to the river during precipitation events, but it was aesthetically unpleasant as well. The vault toilet is maintained by the guide services that shuttle hikers to the trailhead. As a result of this project the overall conditions at the trailhead have greatly improved.

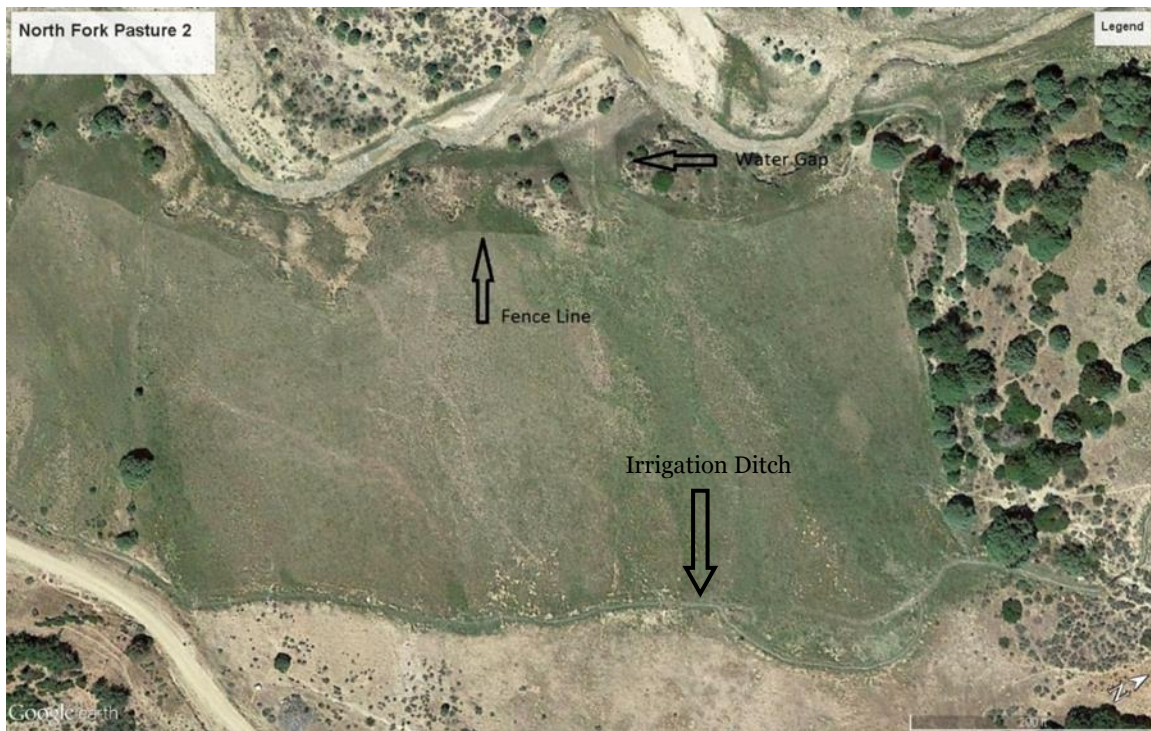
While no attempt was made to quantify the change in riparian vegetation, the improvements were noticeable throughout the season. The change was also noticeable on Google Earth imagery that was updated during the implementation of the grazing plan. The following image shows the improvements along the edge of one of the pastures as a darker shade of green indicating dense cover of pasture grasses.

**Figure 37. Improvement in riparian condition along pasture as part of grazing management plan.**

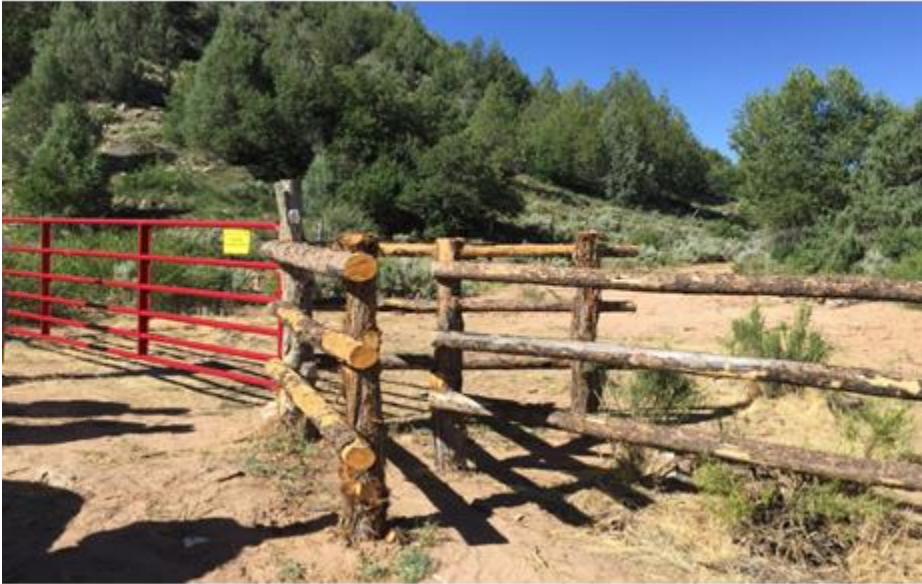
**Figure 38. Hiker maze constructed at boundary of private and BLM pastures**

About one mile into their Narrows hike, people must pass through a fence that separates the private and BLM pastures, and that gate being left open was a chronic problem. Finding the stray cattle and moving them back to their appropriate pasture was a regular problem for the ranchers, and the cattle on the wrong pasture negated some of the rotation pasturing that was being attempted. In 2016 the BLM installed a hiker "maze" in their boundary fence that permits

hikers to pass but excludes cattle, eliminating the need for hikers to open and close a gate.

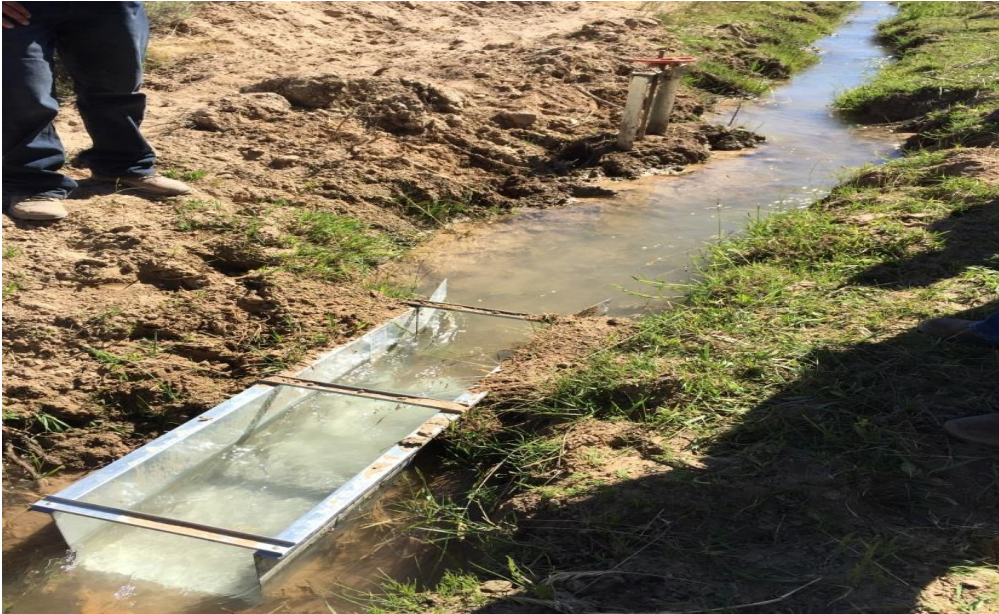
**Figure 39. New flume and flow measurement device on irrigation diversion**
