City Council Action and Executive Summary

Title: A RESOLUTION APPROVING A NUISANCE, SUBSTANDARD DWELLING OR STRUCTURE IN NEED OF ABATEMENT AT 1045 SOUTH MAIN STREET WITHIN THE CITY LIMITS OF LAS CRUCES, NEW MEXICO, SO RUINED, DAMAGED, AND DILAPIDATED AS TO BE A MENACE TO THE PUBLIC COMFORT, HEALTH, PEACE, OR SAFETY AND THAT IS REQUIRED TO BE REMOVED.

REPORT OF LARRY NICHOLS
CITY OF LAS CRUCES CHIEF BUILDING OFFICER

PROPERTY REPORT
1045 South Main / The Kilby Motel
Aug 10, 2022

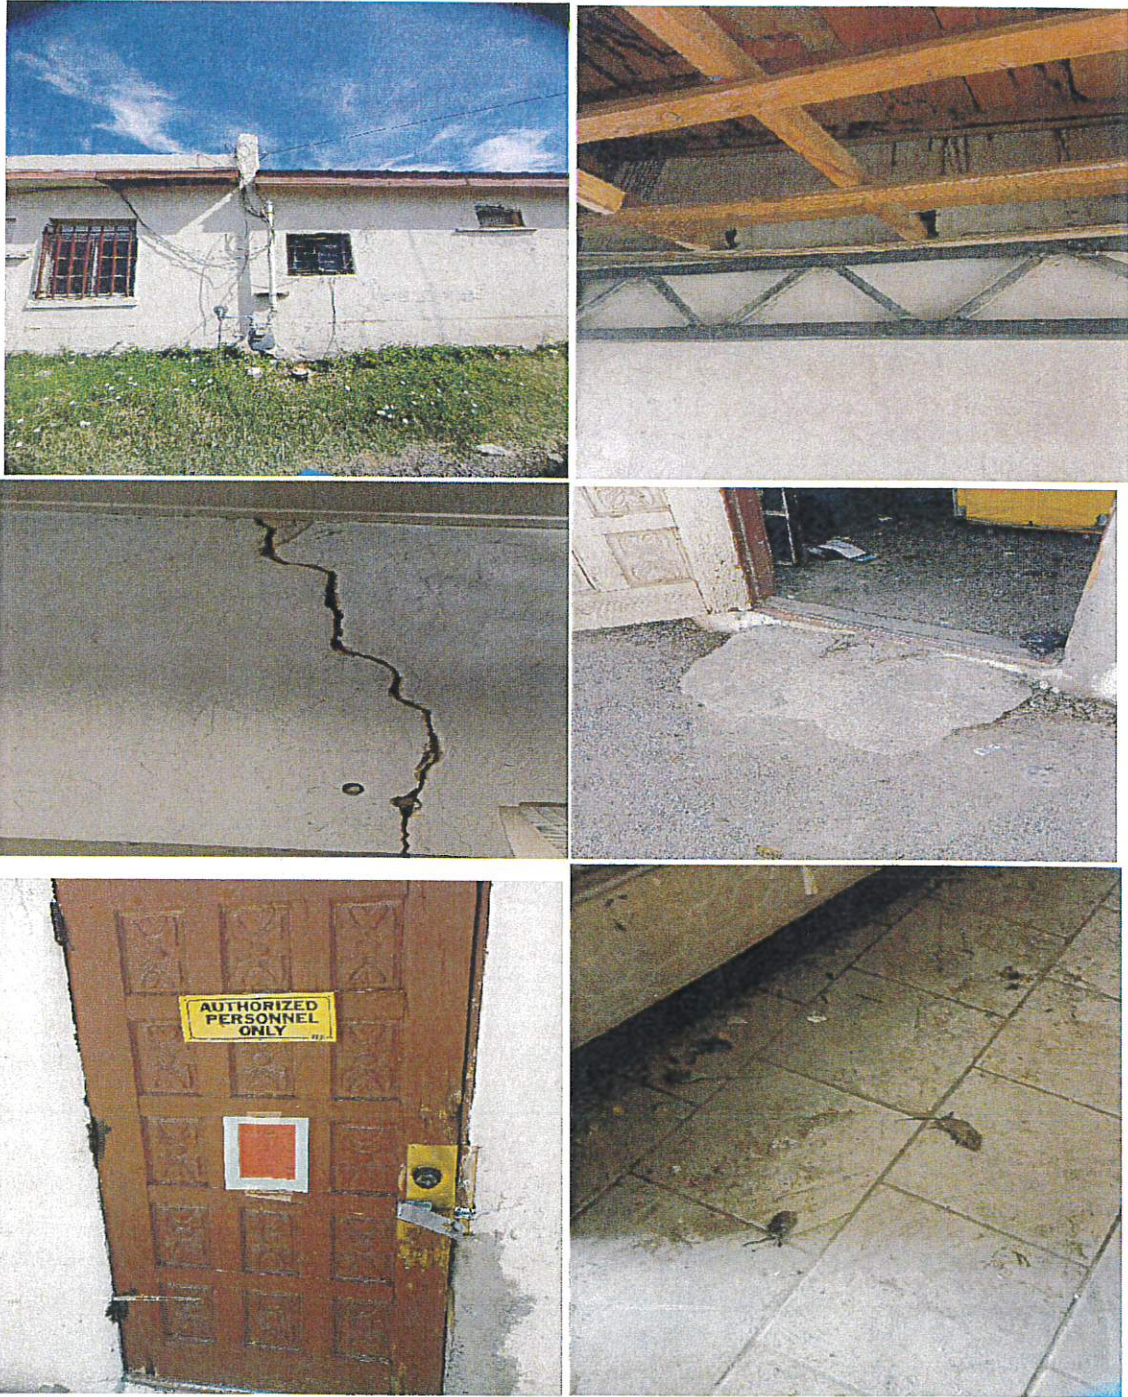
1. Property driveways and parking are not stabilized by impervious surface materials
2. Stormwater management – urban drainage LCMC Chap 34 Article 3
3. ADA parking not provided, and signage not posted.

4. Office access and egress non- compliant with ADA standards.
5. Office did not have public restrooms (ADA non- compliant).
6. Structural deficiencies on ceiling, roof, and beam framing. Structural issues seen throughout property.

7. Means of egress from sleeping units was not present, all windows barricaded with no panic hardware.
8. Sleeping units are missing proper fire walls (2 hour rated assemblies).

9. Rodent infestation within the interior of sleeping units and Office.
10. Faulty weather protection due to several broken windows, door weatherstrip and missing exterior door thresholds.

11. Sleep units and office lacking proper locksets.
12. Existing repairs are non- compliant with building codes and were conducted without proper permits or NM licensed contractors.

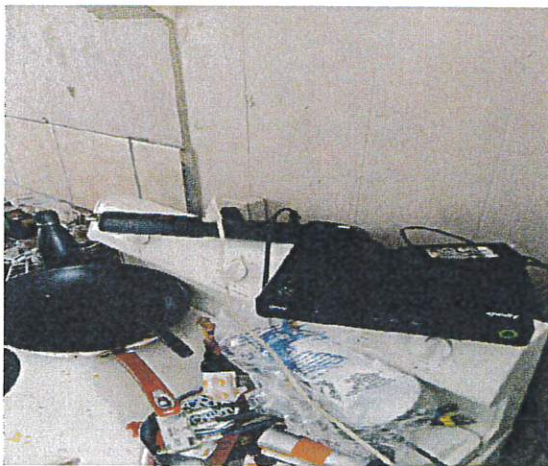
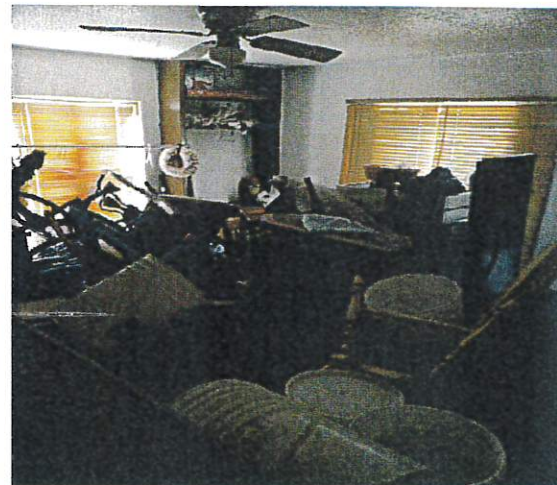
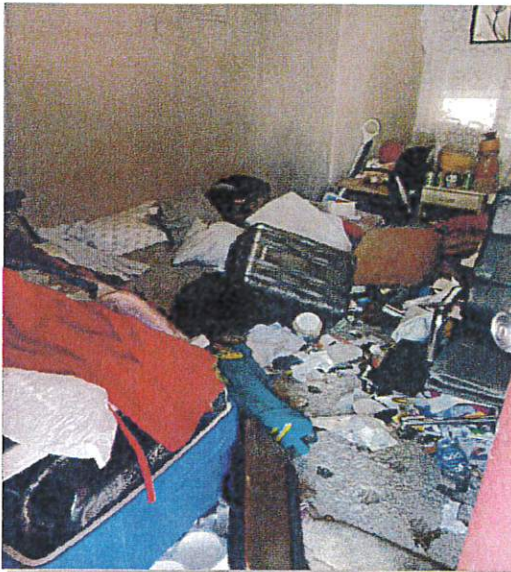
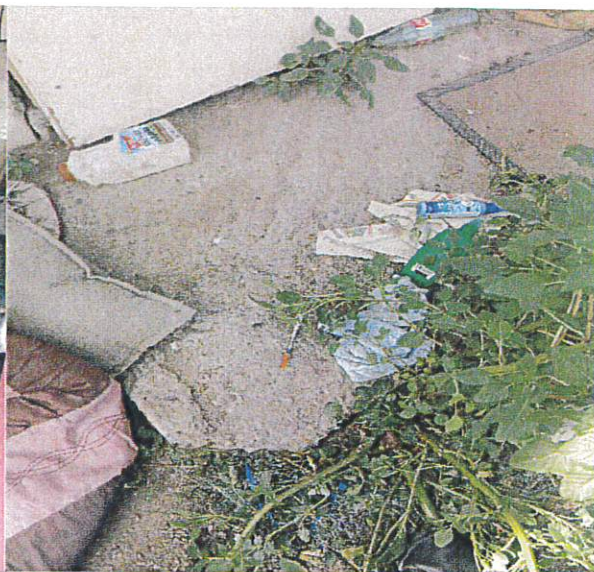
3. Property Report

1. All fire extinguishers were out of date. Last service was in 1999. The minimum size is a 2A10BC and must be mounted on the wall. If the extinguisher is less than 40lbs, it can be hung no higher than 5ft on the wall. If it is over 40lbs, then it cannot be hung any higher than 3.5ft on the wall.

2. There needs to be enough extinguishers on the property so that no one would have to travel any further than 75 linear feet to get to one.
3. All missing or damaged ceiling tiles throughout the property need to be replaced.

4. There needs to be a minimum of a 3ft clearance around the electrical panel. We must always have free and clear access to the electrical panel.
5. Extension cords cannot be used as permanent wiring. NMAC 14.10.5 Devices must be either plugged directly into the wall or into an approved surge protector.

6. Flammable materials in the front office area, subject to fire ignition.
7. Remove Weeds, trash, debris, and outside storage that are fire Hazards.

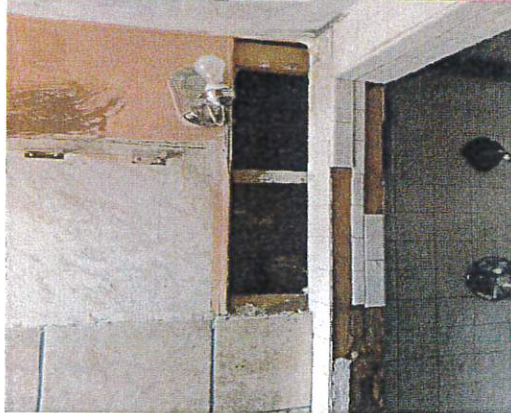
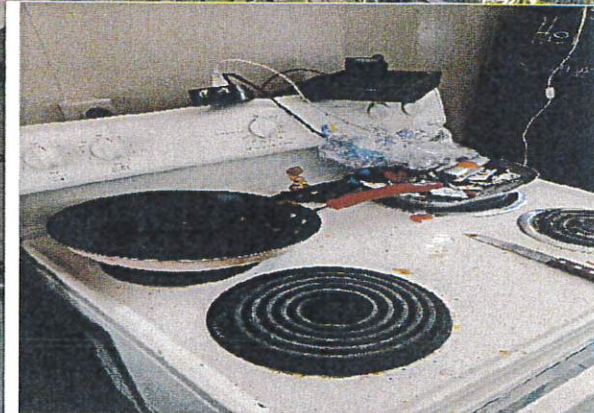
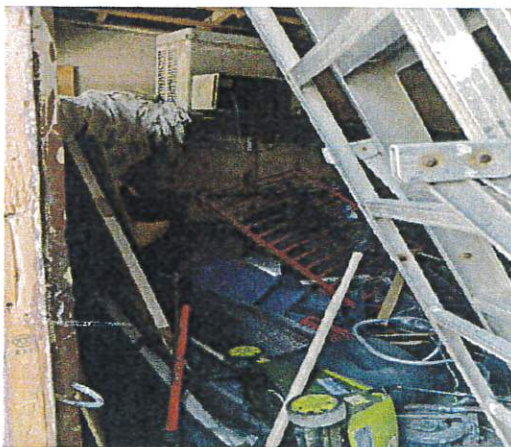
Hazardous Electrical wiring Findings -Certified Electrical Inspector- Ben Edwards

1. Newer panel at breezeway
 - A. Mixed breaker brands in panel not listed for service panel.
 - B. Missing dead-front allowing exposed live bus and wiring.

- C. Missing bridge on breaker for 240V circuit. Unable to turn circuit off safely.
 - D. Has a ground wire used as a ungrounded conductor.
2. Outside perimeter

- A. Missing covers on boxes and conduit bodies allowing exposed live wiring.
 - B. Exposed live wiring prohibited use in wet locations, nor sunlight resistant.

- C. Broken ground rod clamp to electrical service panel not bonded to earth.
 - D. Unsupported / unanchored conduit.
 - E. Low voltage wiring attached to tree trunk for anchoring.

- F. Low voltage camera system not rated for exterior use, wiring inadequate.
3. Breezeway and carport have new MC cable installed without permitting.
4. Electrical service

*Permits and installations by NM licensed contractors required
All utilities shall be restored prior to occupancy*

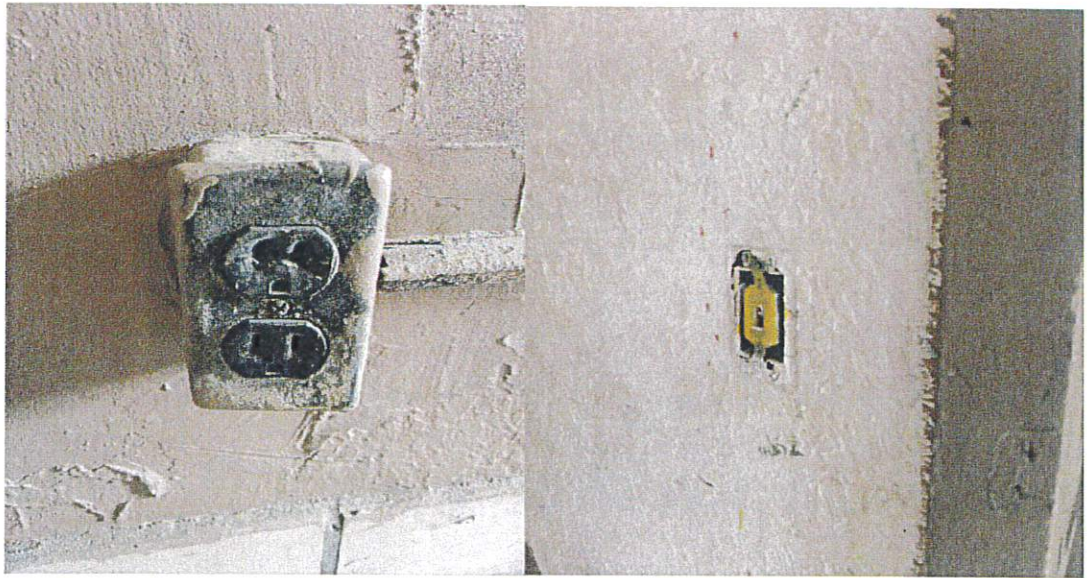
5. Property Report

- A. Does not have required 36 inch working clearance in front that is required when new sub-panel was installed.
 - B. Service is not bonded to earth.

- C. Water bond grounding electrode connected at wrong location.
 - D. Service does not have a bond of grounded conductor to missing grounding electrode conductor.

- E. Service equipment was modified for a new sub-panel, , modification voids UL listing.
 - F. Rigid nipples between service equipment and new sub panel missing bushings to protect wiring and preventing electrical faults.

- G. Has mismatched breaker not UL listed for panel.
 - H. Under sized equipment ground for circuits.
 - I. Sub-panel has the grounded and equipment ground bonded, prohibited after service disconnect.

- C. Several broken receptacles allowing an imminent shock and fire hazard when plugging in devices and while items are installed.
 - D. Most receptacles were missing protective over plates allowing an imminent shock hazard when plugging in items into receptacles.

- G. Several sleeping units with new electrical wiring installed without permit (e.g., receptacles).
 - H. Some spaces had outlets replaced within 6 feet of sinks without installing GFCI protection.

- I. Several switches that had broken handles making them non-operational. One such location was at the bottom of a stairwell.

- J. Exterior egress lighting from sleeping rooms was not operational.
 - K. portable air conditioning unit(s) overloaded the circuit for an individual sleeping unit.
 - L. Portable air conditioning units require a dedicated circuit. (per manufacture specification)
 - M. No means of electric heat was evident on any room.
 - N. Several extension cord and power strips were observed in most rooms and being used as a permanent means of wiring.
 - O. Sleeping rooms had overloaded circuits, with refrigerators, lighting, tv's, microwaves, portable AC units on a single circuit.
7. Office
- A. Has same issues as Sleeping units' rooms
 - B. Inadequate wiring, lamp cord(18ga) used for electrical circuit wire (12 ga)
 - C. Office exit sign is only the cover screwed to the wall. Exit not identified or illuminated.

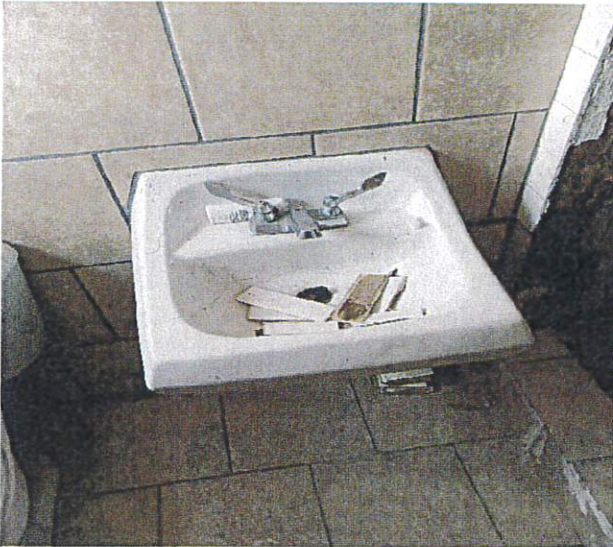
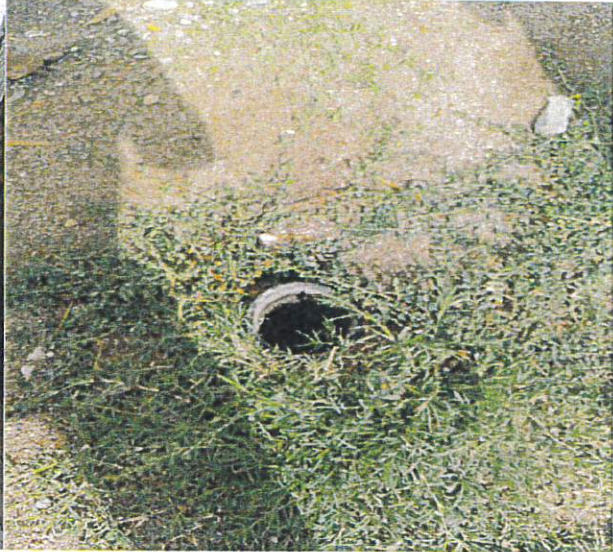
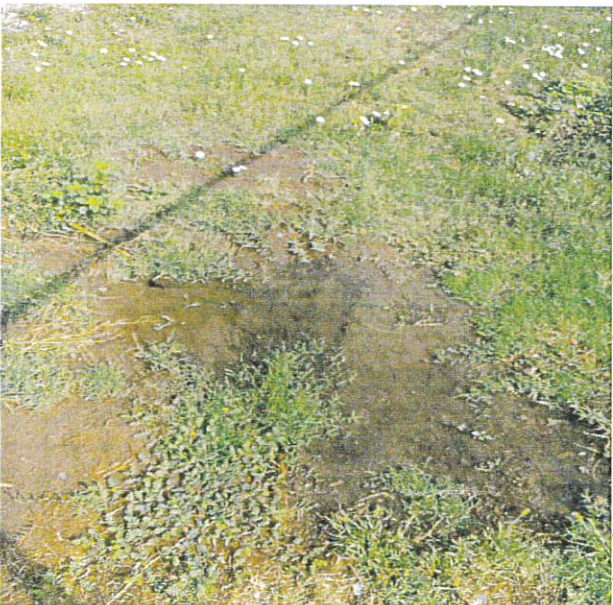
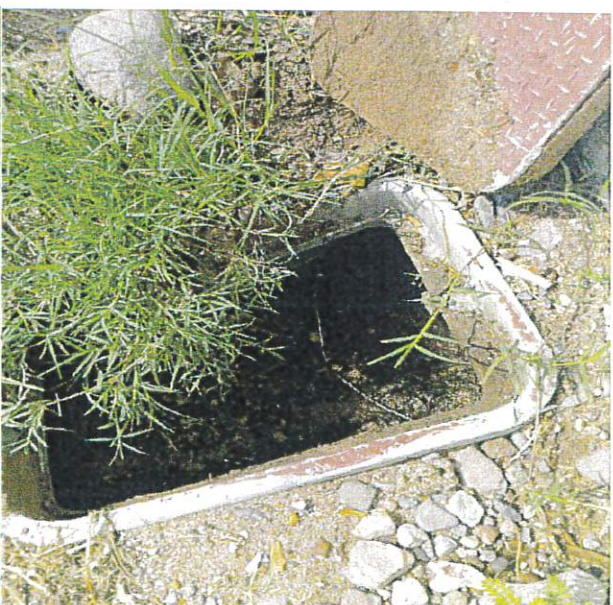
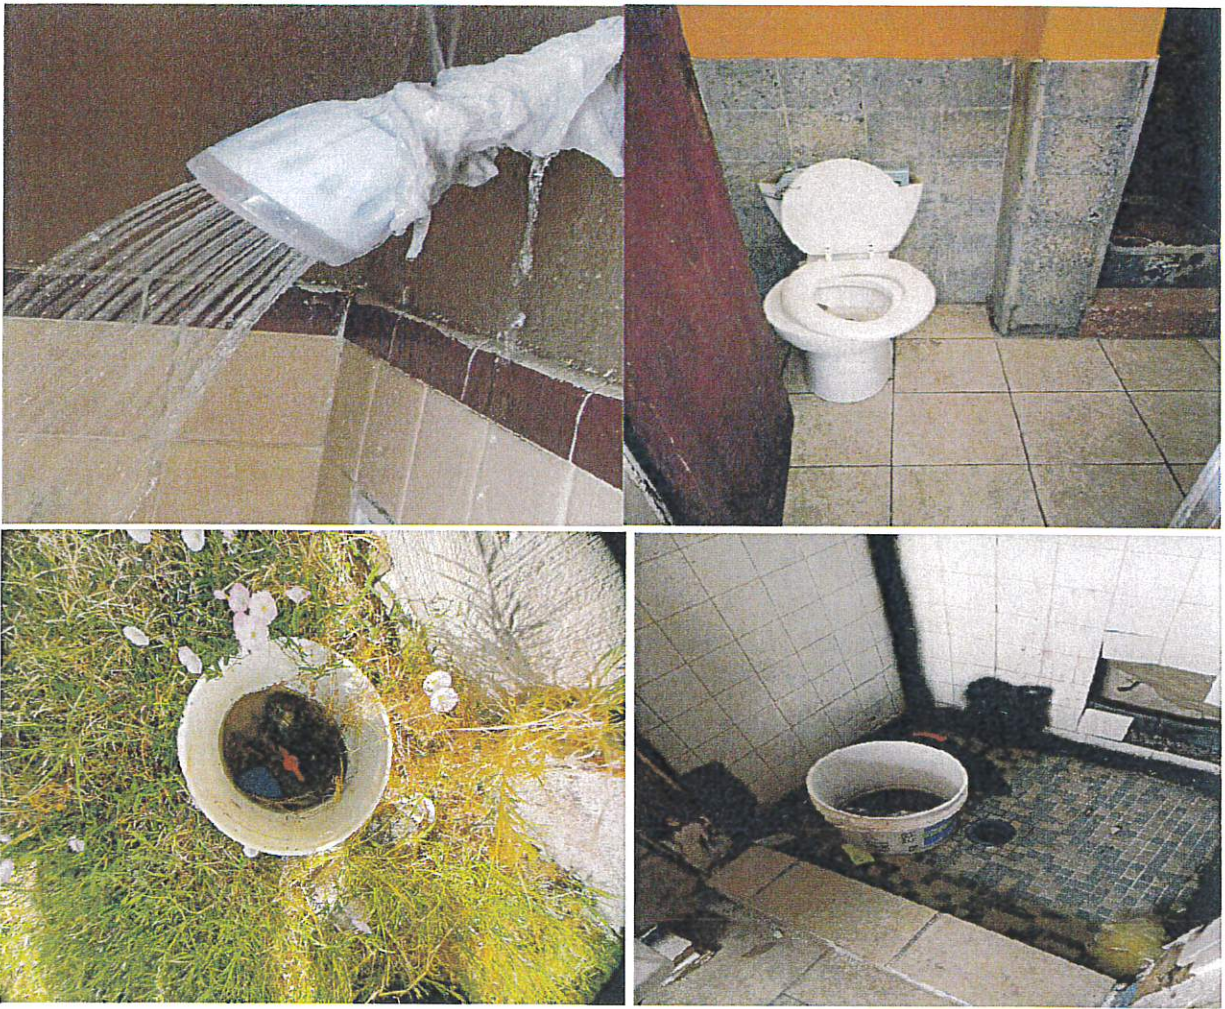
1. Multiple open sewer clean outs discharging sewage
2. Several PVC drains broken and allowing sewage ponding and sewer gas to escape
3. Domestic water piping exposed in multiple locations with no freeze protection and leaking causing ponding
4. Underground domestic water piping leaking up through the ground causing ponding
5. Gas piping on exterior of building unsecured in places
6. Rusting on gas piping noted near ground level
7. No backflow control device at the water meter to isolate the building water system from the City's water supply system

1. Several fixtures with broken valves, or missing handles, shower heads, etc.
2. The drains to all sinks have been re-piped with non-compliant, non-drainage fittings and the sewer vents had been removed making the drain vent system non-compliant.
3. All fixture traps require a vent to the atmosphere to maintain a water seal in the traps that keeps sewer gas from escaping into the occupied spaces

1. No ventilation for washer or dryer, detected sewer gas odor
2. There were two unused gas outlets that were not plugged/capped
3. A water leak from appliance connection dripping onto the floor

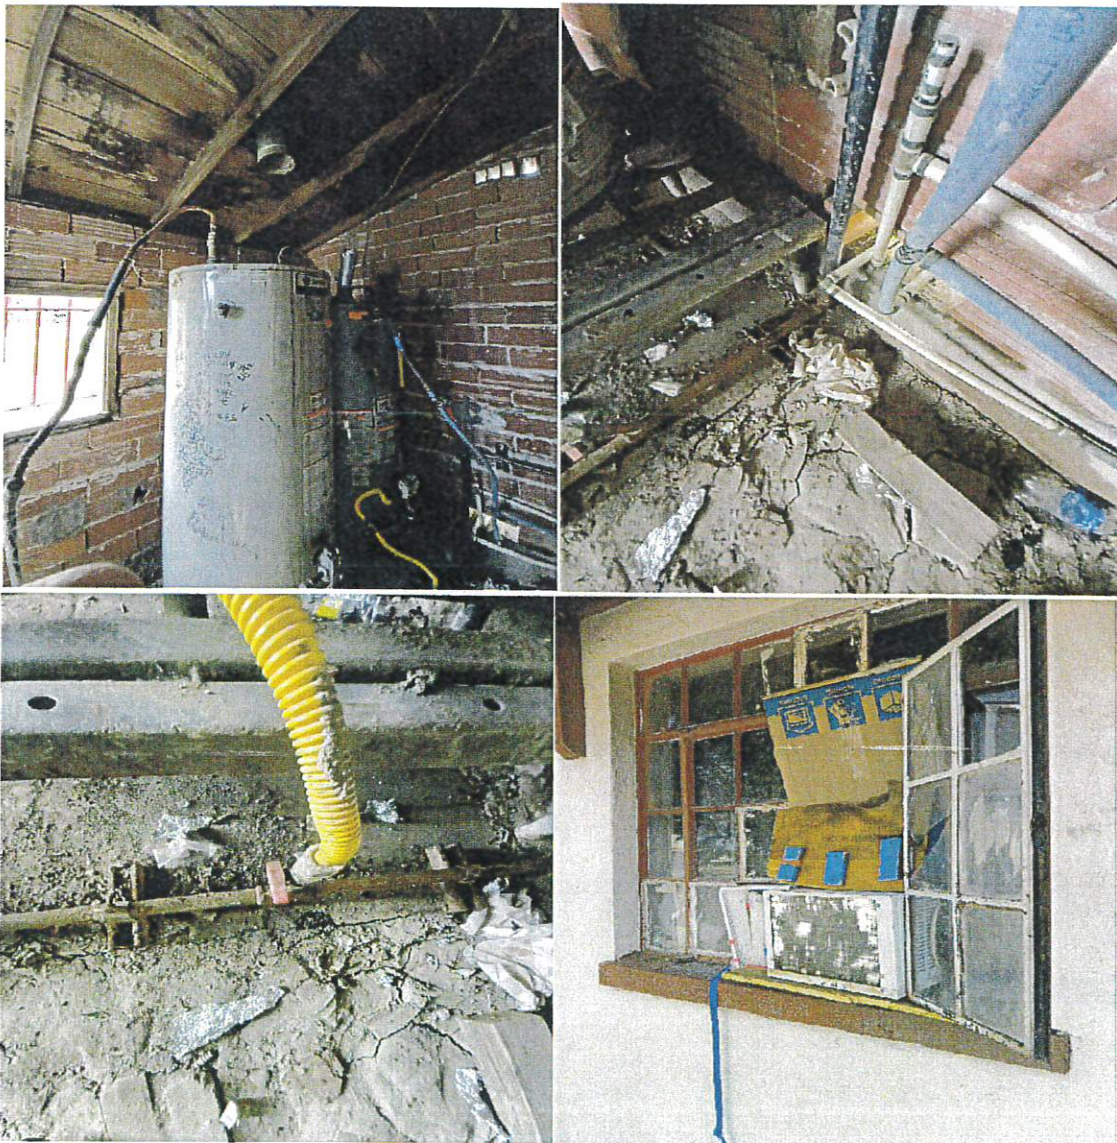
1. No permanent heating is being provided; all original heating systems (gas wall heaters) have been removed
2. No permanent cooling is provided
3. The windows in the bathrooms have been painted or otherwise sealed shut, no ventilation
4. no exhaust fans for moisture removal from showers

1. No ventilation for washer or dryer, detected sewer gas odor
2. Multiple unused gas outlets that were not plugged/capped
3. A water leak from appliance connection dripping onto the floor

1. There are two, approximate 100-gallon, gas water heaters with faulty service connection
2. No permanent combustion air provided to the mechanical room.
3. The control wiring on both water heaters is tampered with and unattached to units
4. Gas piping to units is undersized to provide for BTU input requirement
5. Gas piping at floor level is rusted from exposure to moisture
6. Unconnected gas valves without a plug or cap.
7. The units are no longer vented to the exterior a dangerous condition during operation
8. The temperature and pressure relief valves (T&P) on both units are not installed to code
9. The T&P valve on one unit had been tampered with and inoperative.

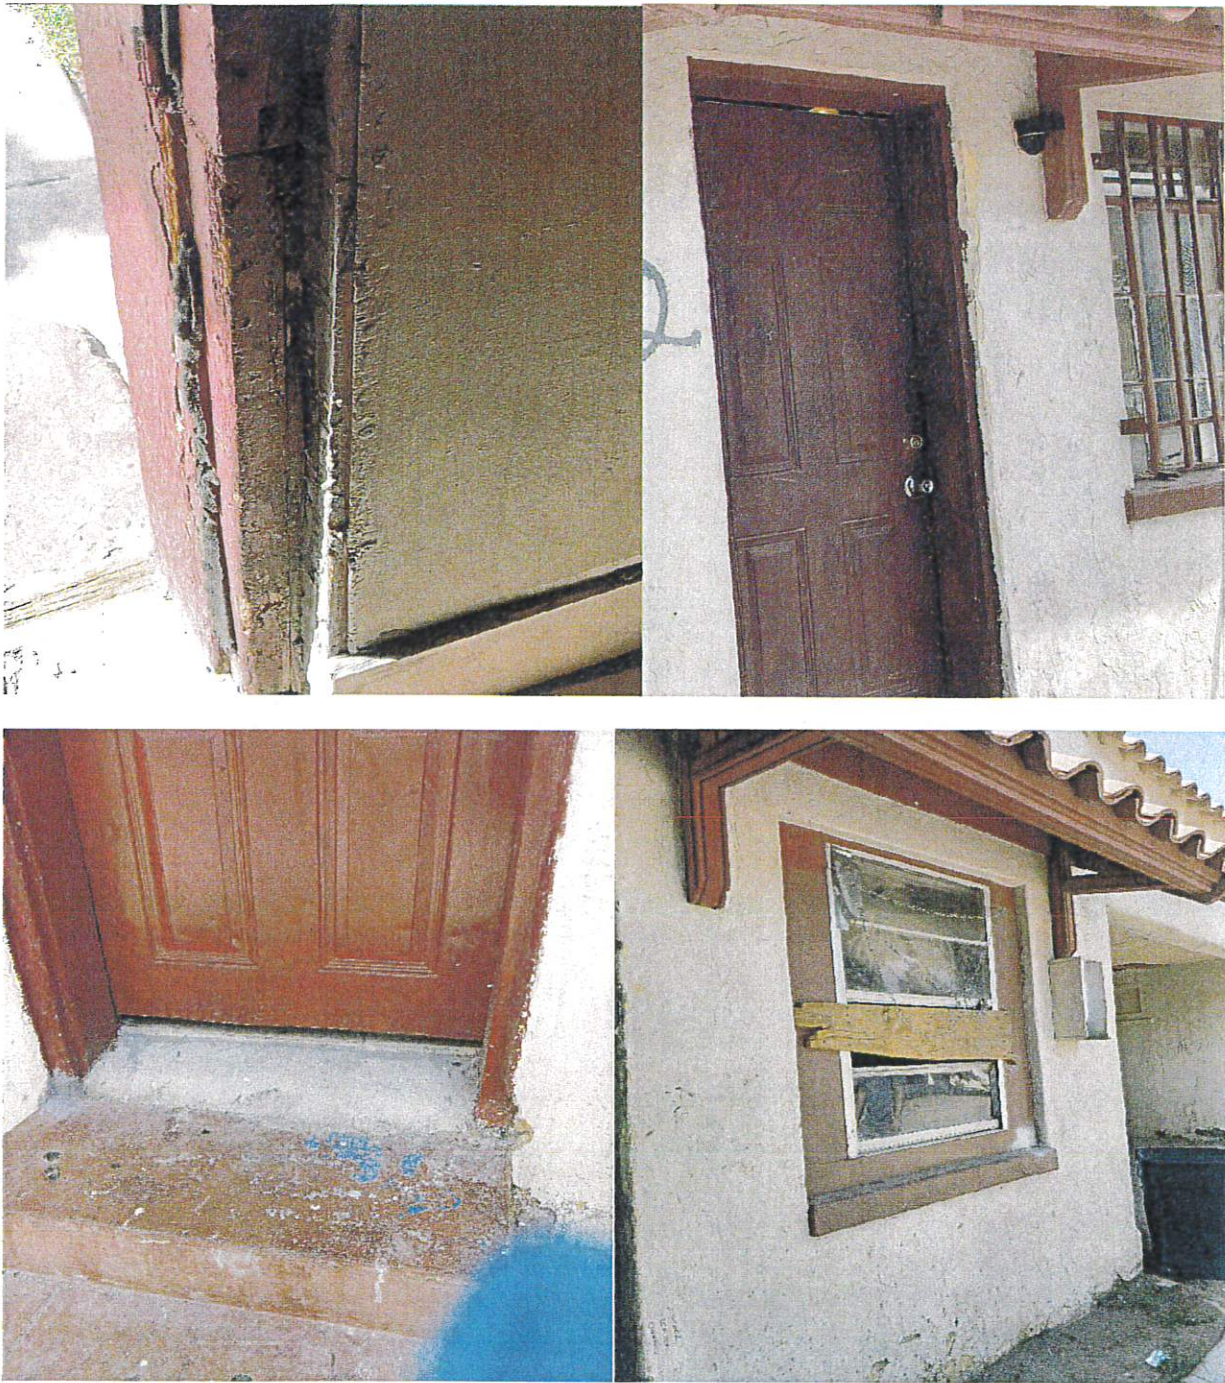
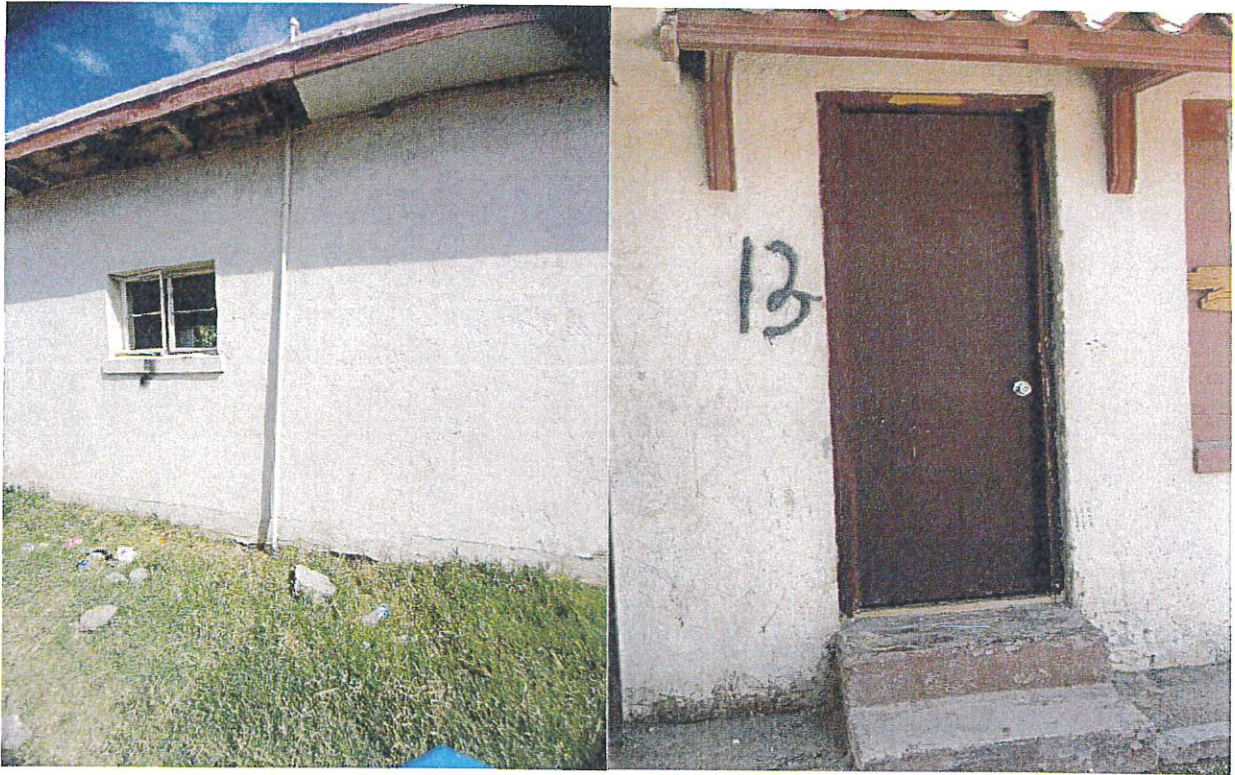
1. Faulty weather protection due to several broken windows, door weatherstrip and missing exterior door thresholds.
2. Sleeping units and Office non-compliant with Energy Efficiency Code, insulation, air leakage.
