# BRANFORD ROAD SAFETY AUDIT

ROUTE 146: BRANFORD RIVER TO LIMWOOD AVENUE

MAY 2022

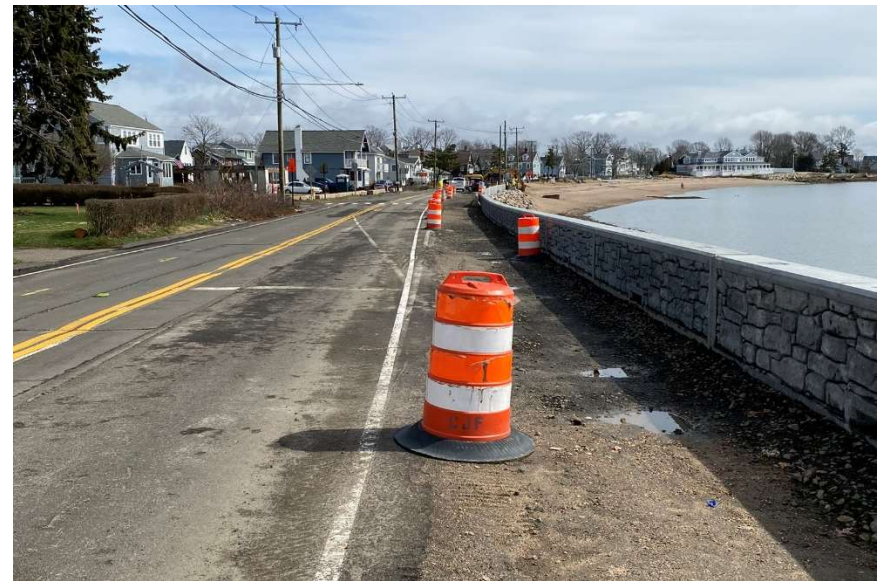
*Exhibit 18: Sidewalk construction underway on Limewood Avenue*

- The sidewalk construction on Limewood Avenue is expected to cause an increase in pedestrian traffic. A town parcel at the end of Route 146 is being improved and expected to be a draw. See Exhibit 18.

- The curve at Route 146 and Limewood is not perceived to be an issue. DOT staff expressed concern for the burying of utility lines which may eliminate some of the visual cues of this curve.
- Crosswalks near this area should be avoided due to poor visibility around the curve at this location.

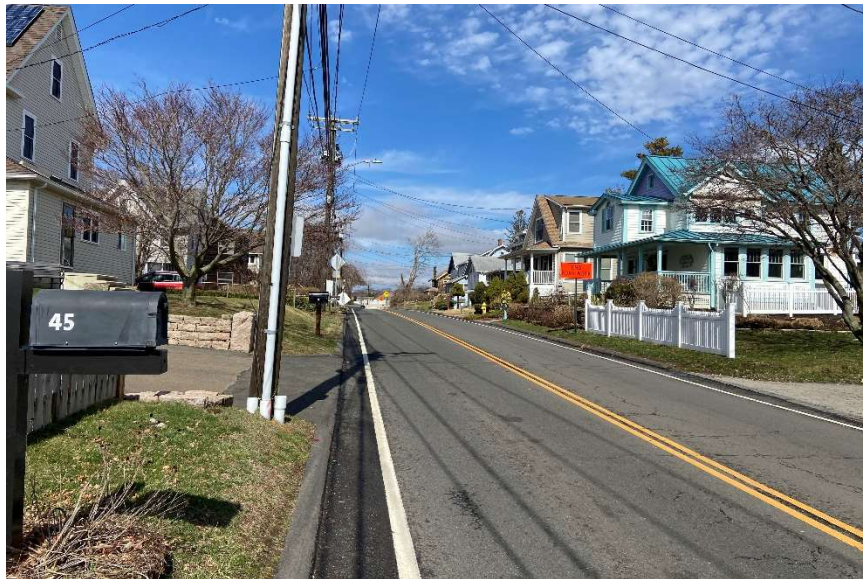
*Exhibit 19: Utility poles on Sybil Avenue*

- Shoulders are narrow on Sybil Avenue. Pedestrians often use Wilford Road to get to Limewood Avenue to avoid traffic on Sybil Avenue.
- While GIS shows that the right-of-way (ROW) is approximately 40-ft, there is apparent encroachment on ROW from adjacent properties, especially from properties on northeast side.

- Utility poles are located on the west side of the roadway and would likely have to be removed if sidewalk were to be installed on that side. However, participants felt that a sidewalk on the west side would be preferable as it would connect with a sidewalk currently being constructed at Limewood Avenue, without the need for a crossing near the curve. See Exhibit 19.

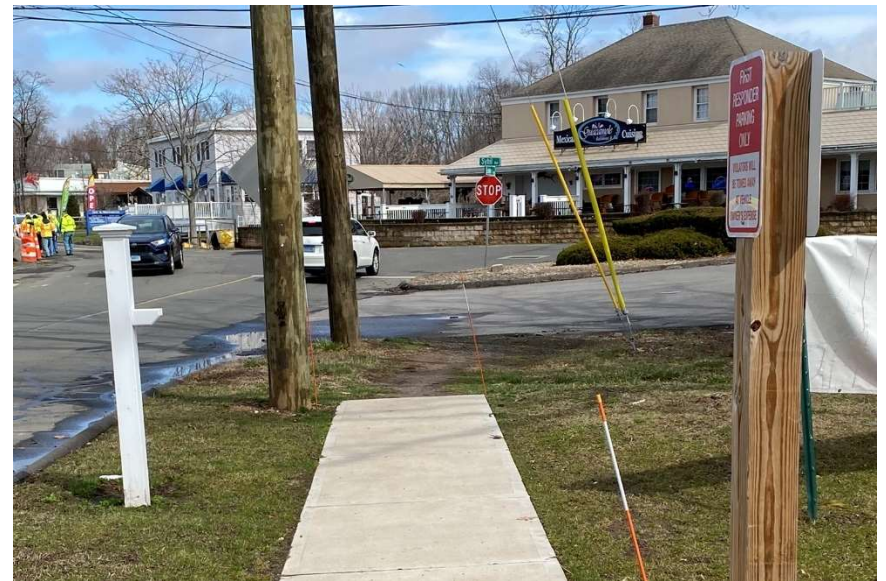
- A mini-roundabout was discussed at Linden Avenue intersection. It could include gateway signage and plantings as appropriate.
- The property to the south of the intersection of Route 146 at Linden has many undefined curb cuts.
- An all-way stop at Linden was reviewed using 2019 summer volumes, but found at that time to not be warranted.
- Participants noted the potential for bicycle lane, which may help narrow roadway.

*Exhibit 20: No connection to sidewalk at firehouse*

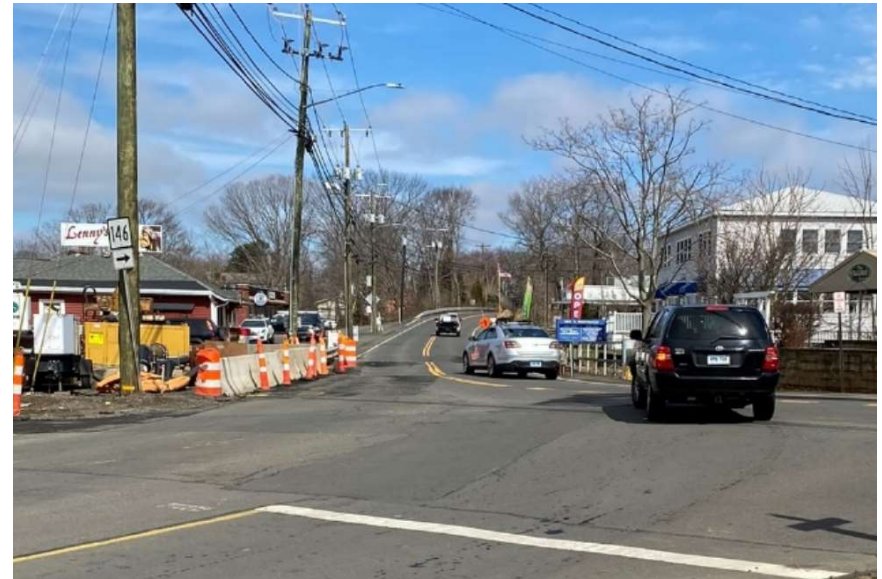
*Exhibit 21: Route 146 north of Linden Avenue. View looking north.*

- Shoulder width consistency is not present in this area.
- Additional countermeasures for single-vehicle crashes in this area should be explored and open to consideration by DOT.

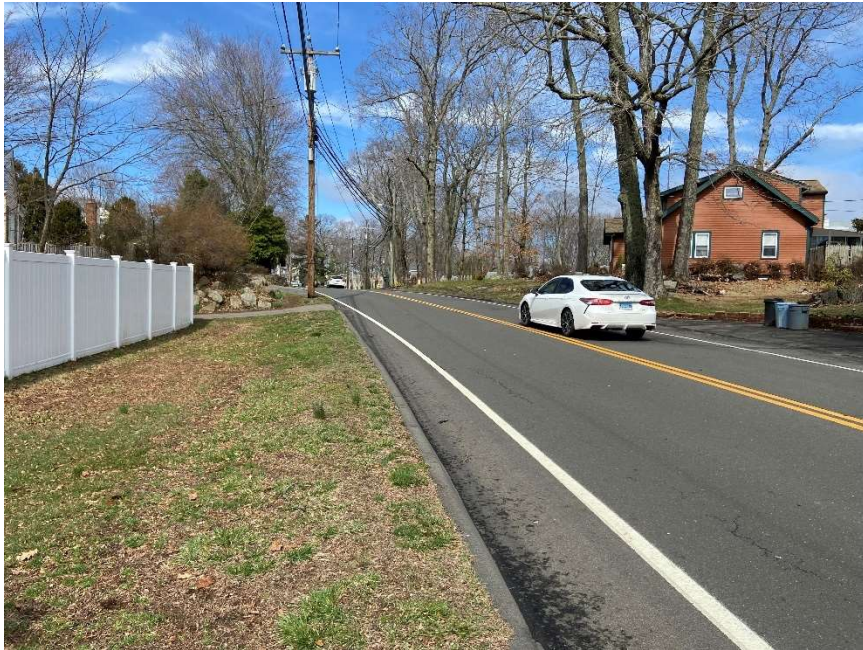
*Exhibit 22: View of Route 146 looking north from Block Island Road. Note the vertical grade and reverse curve obstructing sight lines to the north.*

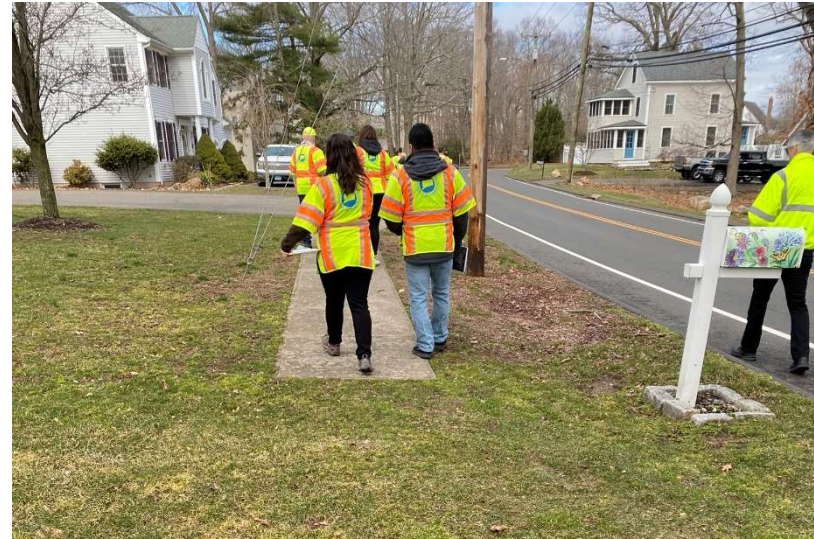
*Exhibit 23: Small section of existing sidewalk at 123 South Montowese Street.*

- There is a narrow shoulder and limited sidewalks in this area. Exhibit 23 displays gaps in the sidewalk network at this location. Any existing sidewalk is on the west side of Route 146.

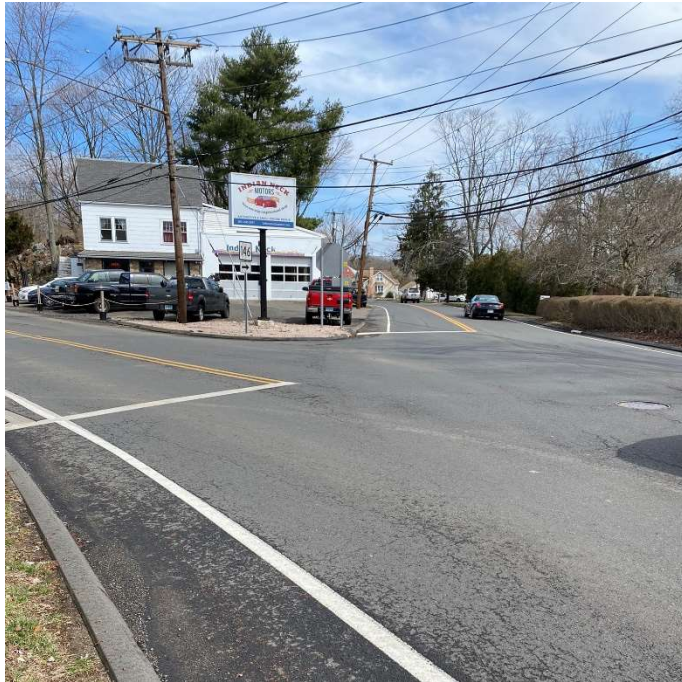
*Exhibit 24: Intersection of South Montowese Street and Indian Neck Avenue*

- The Housing Authority is renovating its buildings. Construction will include new driveways and realigned sidewalks.
- The three-way stop at Indian Neck Avenue and South Montowese Street functions well. Sidewalks go up Indian Neck Avenue and connect north to the train station.
- The entrance drive to Sliney Field will be widened.
- The sidewalk on Indian Neck Avenue is continuous all the way to the Branford Train Station.

- Discussing crossings, due to the geometry of the road, a crosswalk on the northbound approach seemed the most feasible. See Exhibit 24 for a photo of the intersection. The northbound approach is just to the right, outside the frame of the photo.

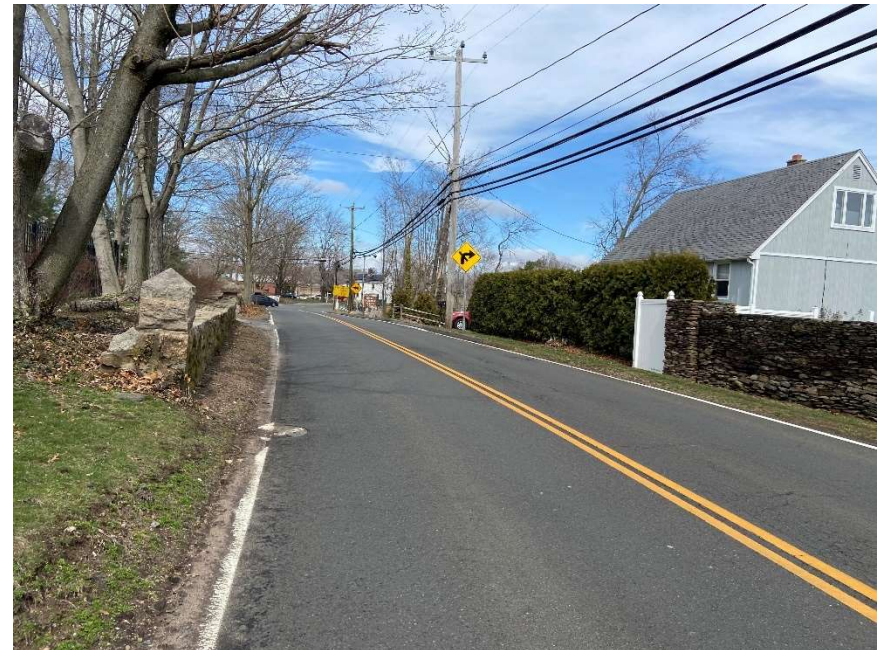
*Exhibit 25: Narrow section of Route 146 north of Ark Road*

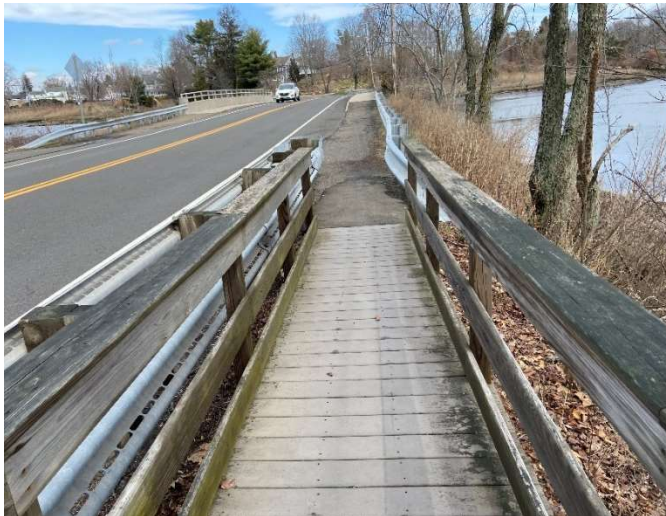
*Exhibit 26: Gap between the boardwalk and the sidewalk along the bridge*

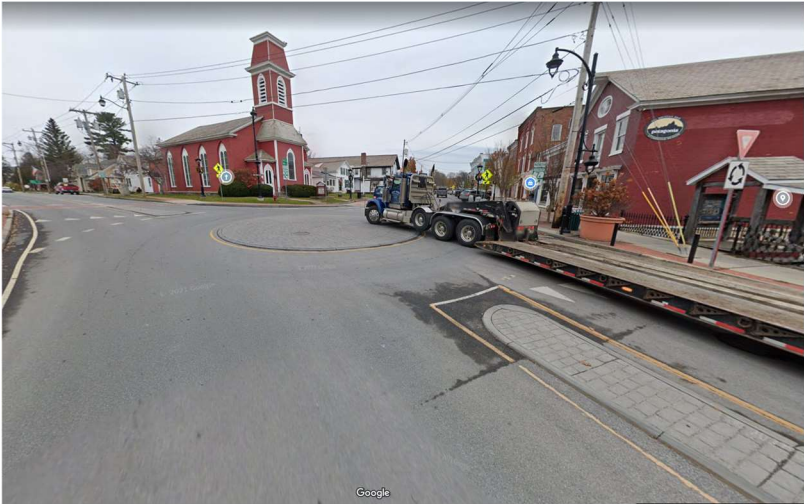
Exhibit 30: Example of a mini-roundabout in Manchester, VT with a diameter of 65-feet. Note the decorative, mountable center island to allow large vehicle movements. (Source: Google Maps Streetview)

- 2) Consider mini-roundabout with decorative, mountable island with a diameter of approximately 65-feet at the intersection of Route 146 and Linden Avenue. Include crosswalks on all approaches to the roundabout and consider decorative crosswalk to keep crosswalk in line with scenic character of roadway. To maintain night-time visibility to decorative crosswalk, consider marking standard continental crosswalk markings on top of decorative surface. Consider maintaining RRFB at crosswalk north of Linden Avenue as recommended in the short-term plan.

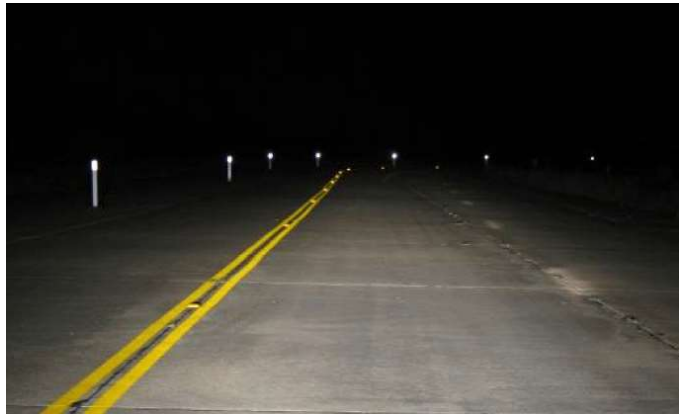
*Exhibit 33: Example of post mounted delineators at night. Source: FHWA / Texas Transportation Institute*

recommendation is a Proven Safety Countermeasure by the Federal Highway Administration (FHWA) for enhanced delineator for horizontal curves.<sup>1</sup> This recommendation is also less visually intrusive than other signage such as chevrons. Refer to Exhibit 33 for an example of delineators at night.

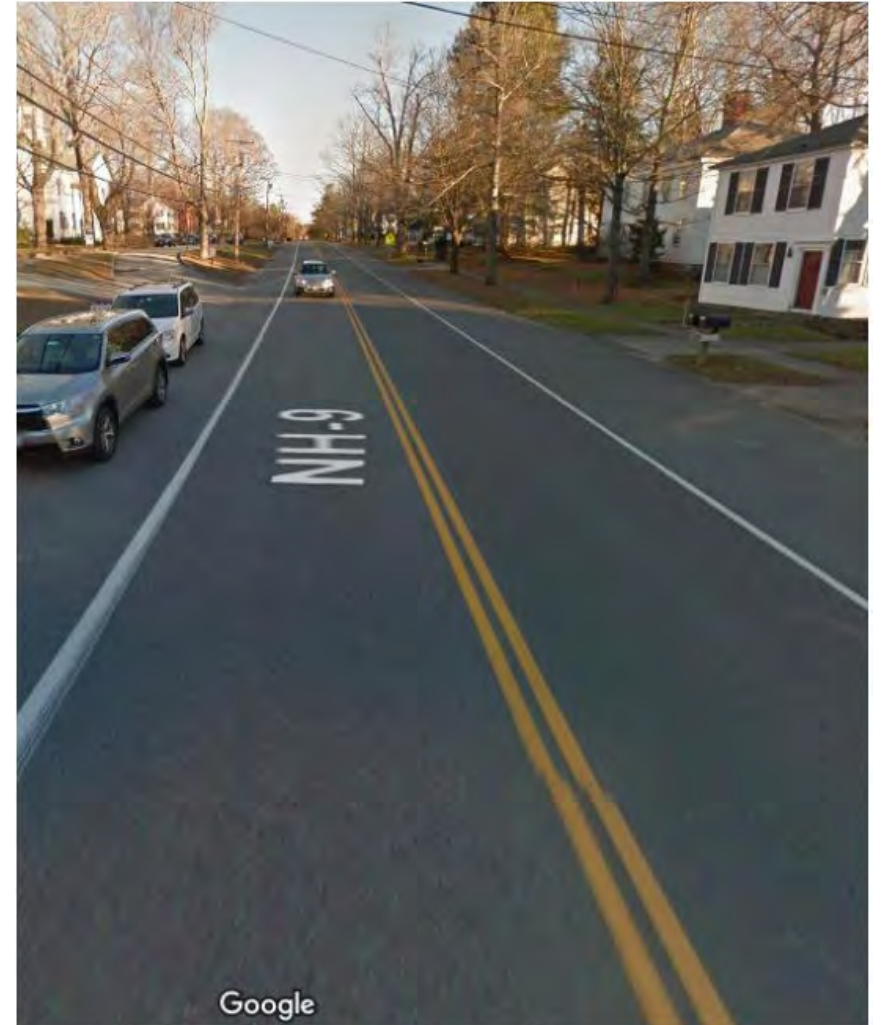
A 10-ft lane installed in Hopkinton, NH

- Standard CTDOT lane width is 11 feet
- Narrow lane width (as low as 9 feet) can promote slower speeds and provide space for other purposes
- Narrower width may be appropriate in areas with limited daily traffic and truck traffic

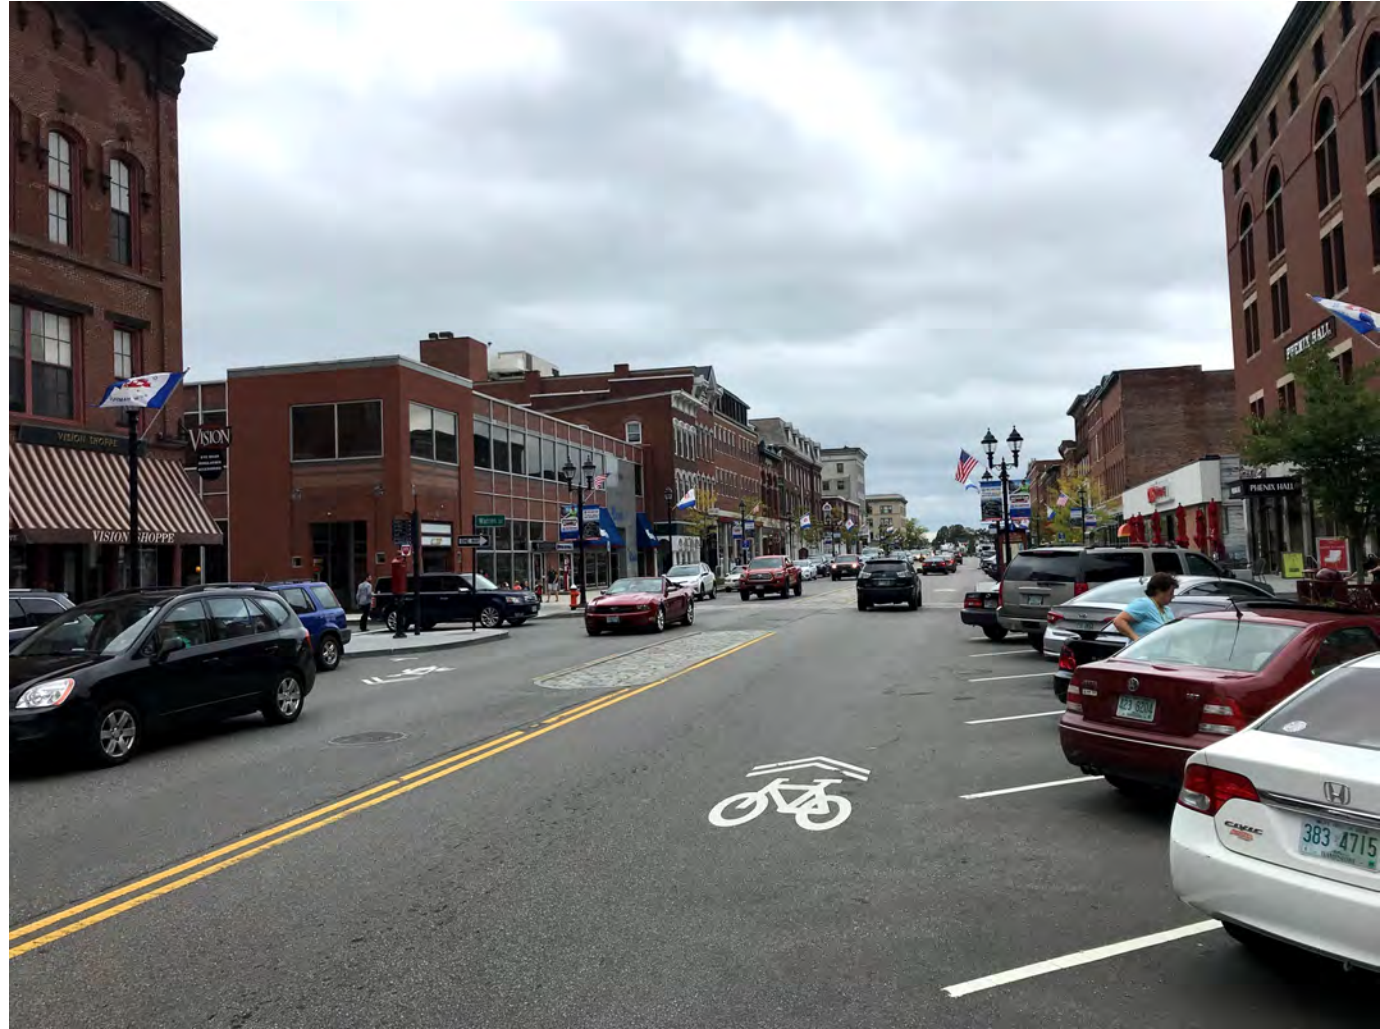
Bike Sharrow in Concord, NH

- Bike sharrow markings in lane can alert motorists to presence of bicyclists in roadway
- Sharrows likely appropriate based on vehicular volumes near beach and target speeds in this area

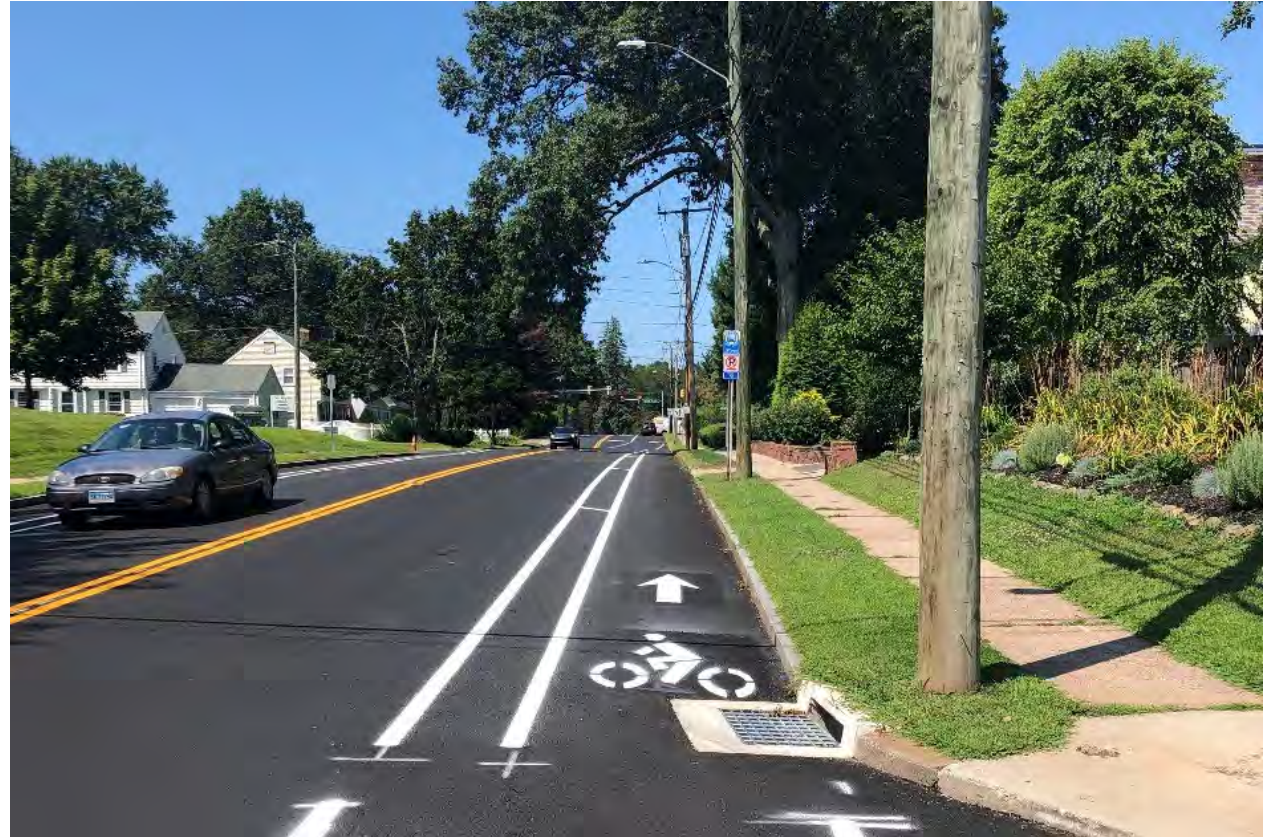
Buffered Bike Lane in West Hartford, CT

- Bike lanes and other bike facilities can provide comfortable bike travel in ROW
- A buffer can also be striped to reinforce separation from motorists

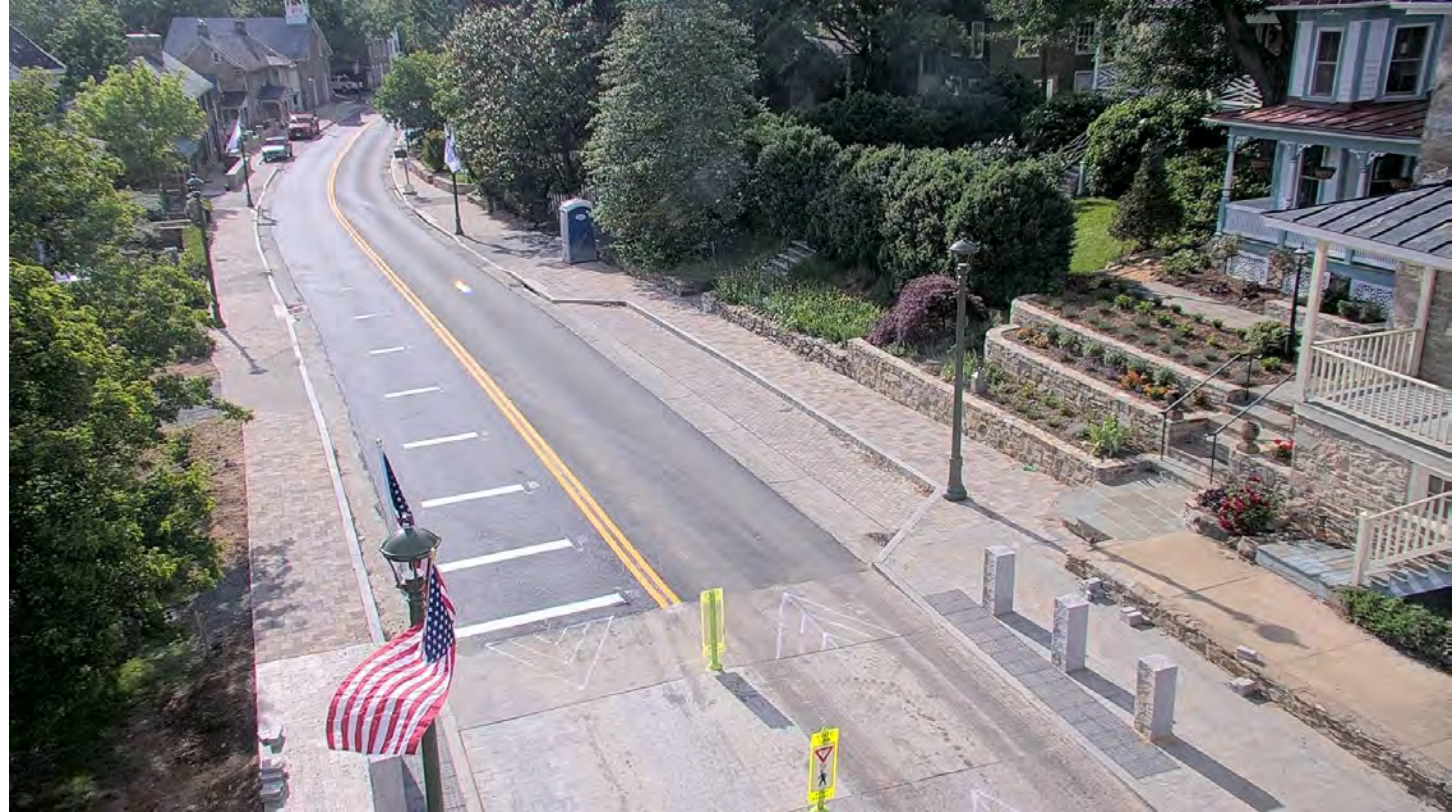
- Improves pedestrian safety by causing motorist speeds to decrease at the crossing.
- Typically between 3 and 6 inches above street level. It is common for a raised crosswalk to be level with the street curb.
  - Height increases the visibility of a pedestrian in a crosswalk to a motorist.

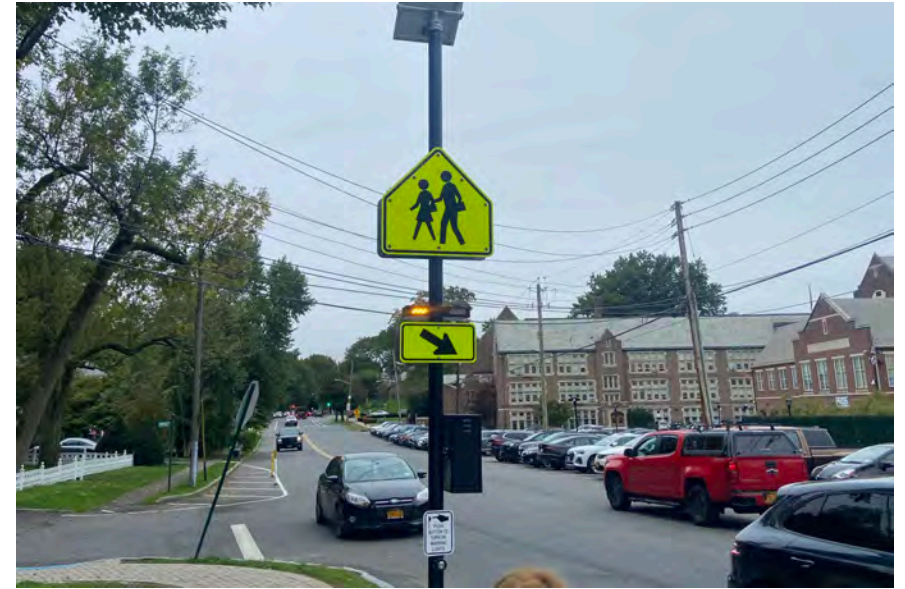
- RRFB
  - Rectangular Rapid Flashing Beacon
  - Provides enhanced visibility of crosswalks, but is **not** a regulatory signal

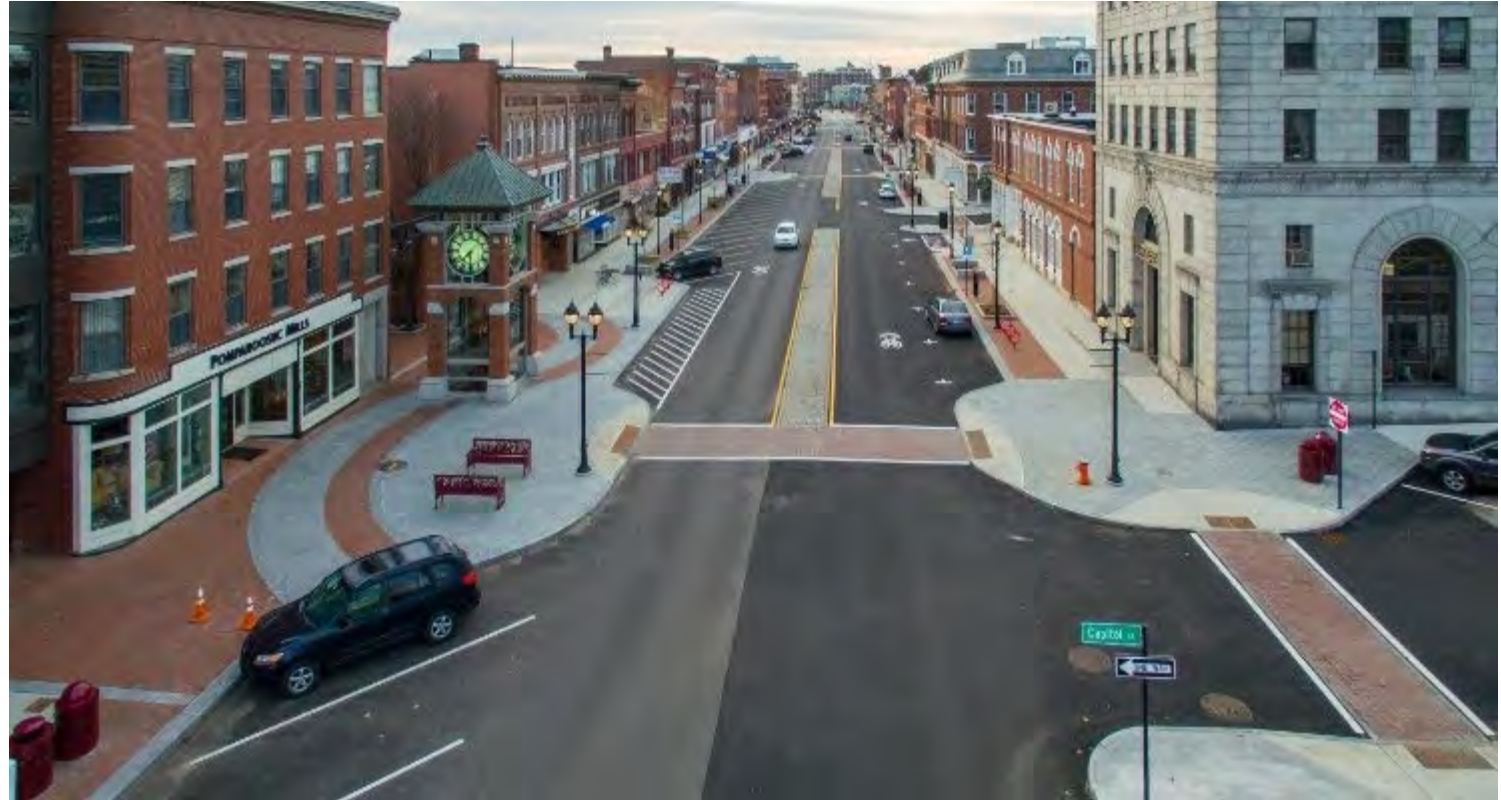
- A curb extension is a horizontal extension of the sidewalk into the street resulting in a narrower roadway and a shorter crosswalks.
- Slows automobile turning speeds, shortens pedestrian crossing distance, and increases pedestrian visibility

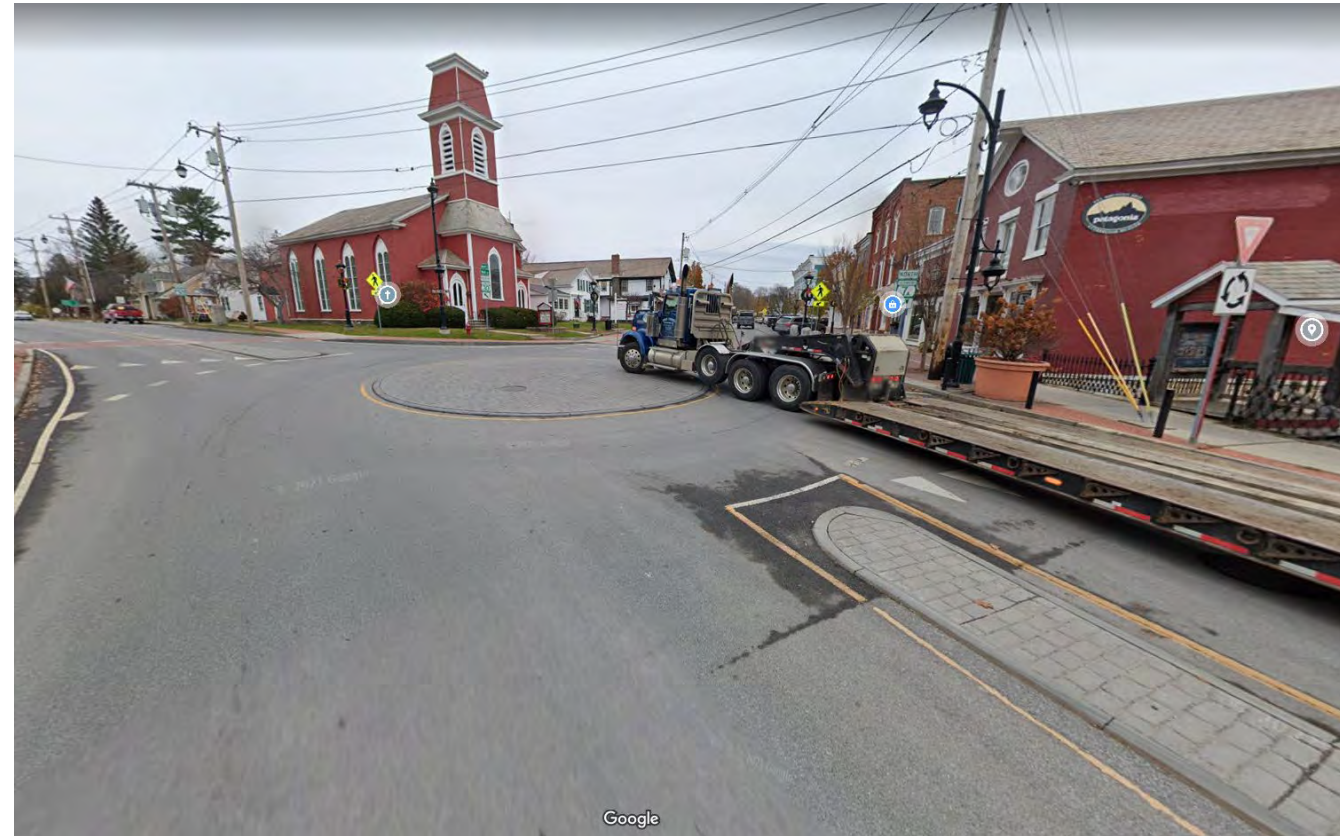
[Manchester Center, VT](#)  
VT Route 30 & 7A  
Diameter = 65'

- Similar to larger roundabout, but with a mountable median traversable by large trucks
