# **USS *Yorktown* Remediation Plan Final**

Research Planning, Inc.  
1121 Park Street, Columbia, South Carolina 29201

**19 July 2023**

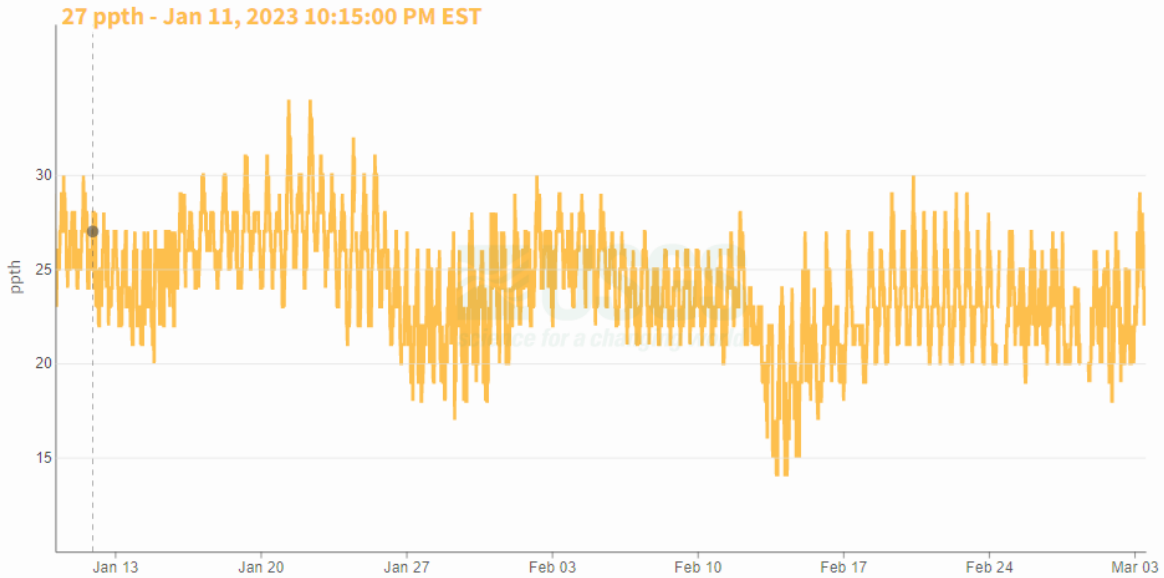
Several compartments and tanks in the forward region of the vessel are subject to flooding or have had water ingress in the past. Tidal influences in flooded compartments were minimal during observations. Several tanks were observed to be brackish, measuring between 5 and 20 ppt. Tanks above 20 ppt are considered sea or saltwater with regards to grouping. Charts of the salinity in the adjacent water for the period of the survey and previous year are shown in Figures 2-6 and 2-7.

Figure 2-6. Salinity of Cooper River, January - February 2023.

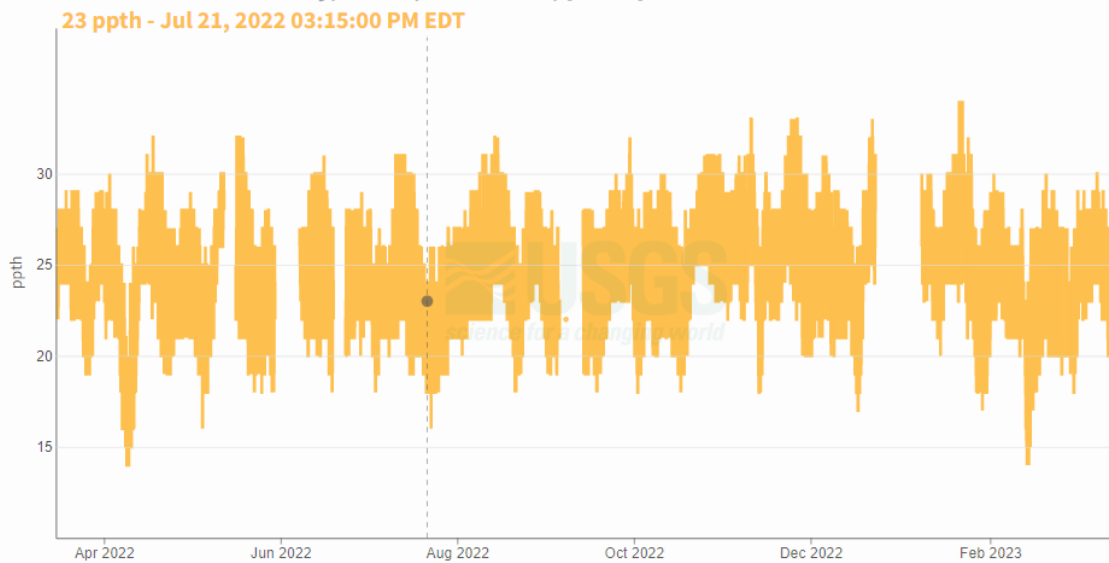
Figure 2-7. Salinity of Cooper River, April 2022 - February 2023.

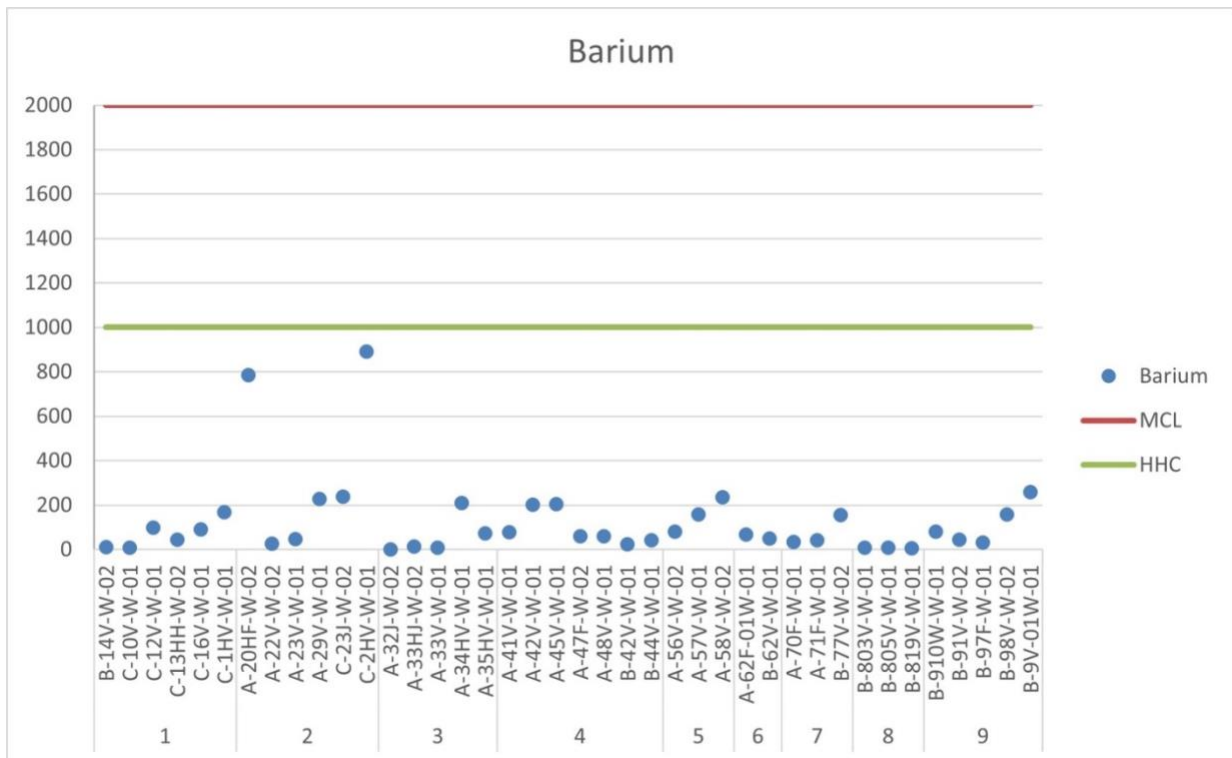
The water concentrations for the tested metals are shown by tank and deck in Figures 3-1 to 3-8, with colored lines representing the CMC (red) and CCC (green) standards. The CMC is the most appropriate water quality standard to consider because any discharge of water from the tanks onboard the USS *Yorktown* would be a one-time release, rather than a continuous discharge. Most of the water in the tanks exceeds the SCDHEC CMC saltwater standards for the tested metals except for barium, selenium, and silver. Lead levels in multiple tanks exceed the saltwater standards by three orders of magnitude; chromium by a factor of 30; and mercury by a factor of 40. Therefore, any water removed from the USS *Yorktown* as part of the efforts to remove the bulk of the oil would require treatment prior to discharge into Charleston Harbor. Small releases of water from leaks through the hull would likely be rapidly mixed into the water column and diluted below the salt water quality standards. Therefore, it is not recommended to pump off any water as a mitigation option, other than to access tanks for oil removal or to establish and maintain watertight integrity. Any replaced water would leach metals from the tank walls and eventually reach similar concentrations.

**Figure 3-2.** Concentration of barium in µg/L in water on the USS *Yorktown*, compared with SCDHEC salt water quality standard.

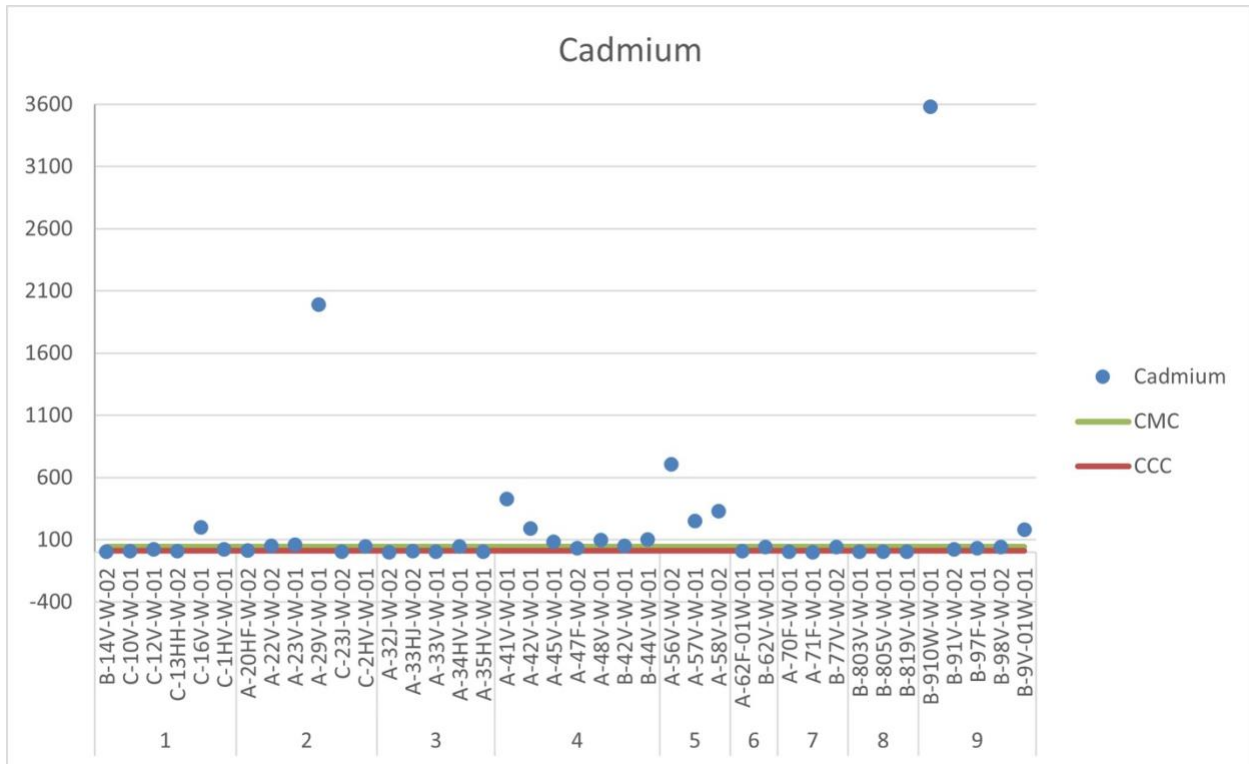
**Figure 3-3.** Concentration of cadmium in µg/L in water on the USS Yorktown, compared with SCDHEC salt water quality standard.

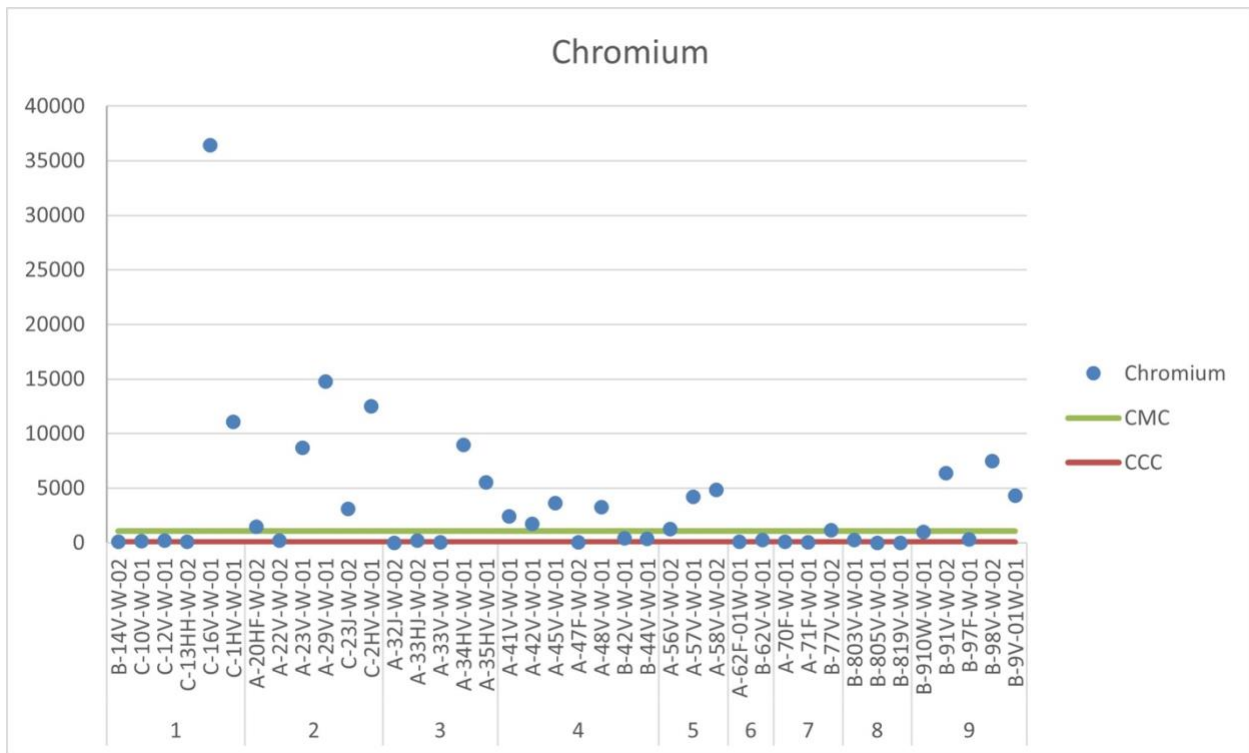
**Figure 3-4.** Concentration of chromium in µg/L in water on the USS Yorktown, compared with SCDHEC salt water quality standard.

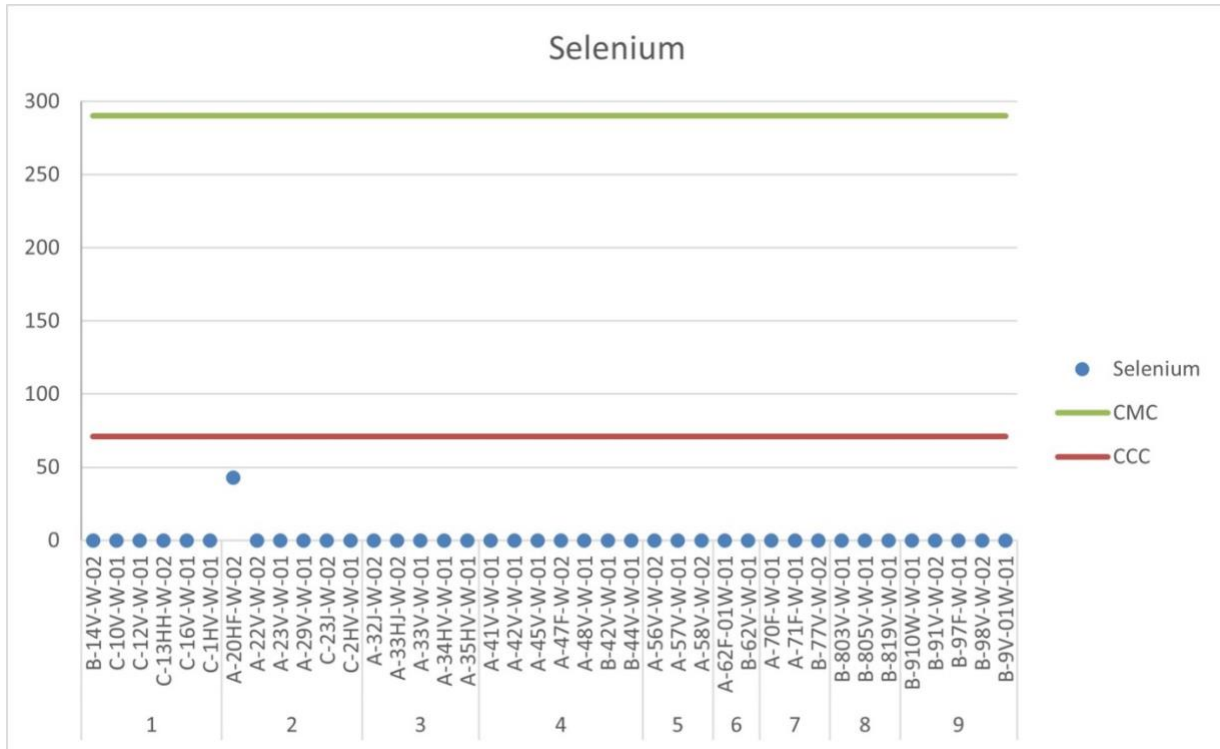
**Figure 3-7.** Concentration of selenium in  $\mu\text{g/L}$  in water on the USS *Yorktown*, compared with SCDHEC salt water quality standard.

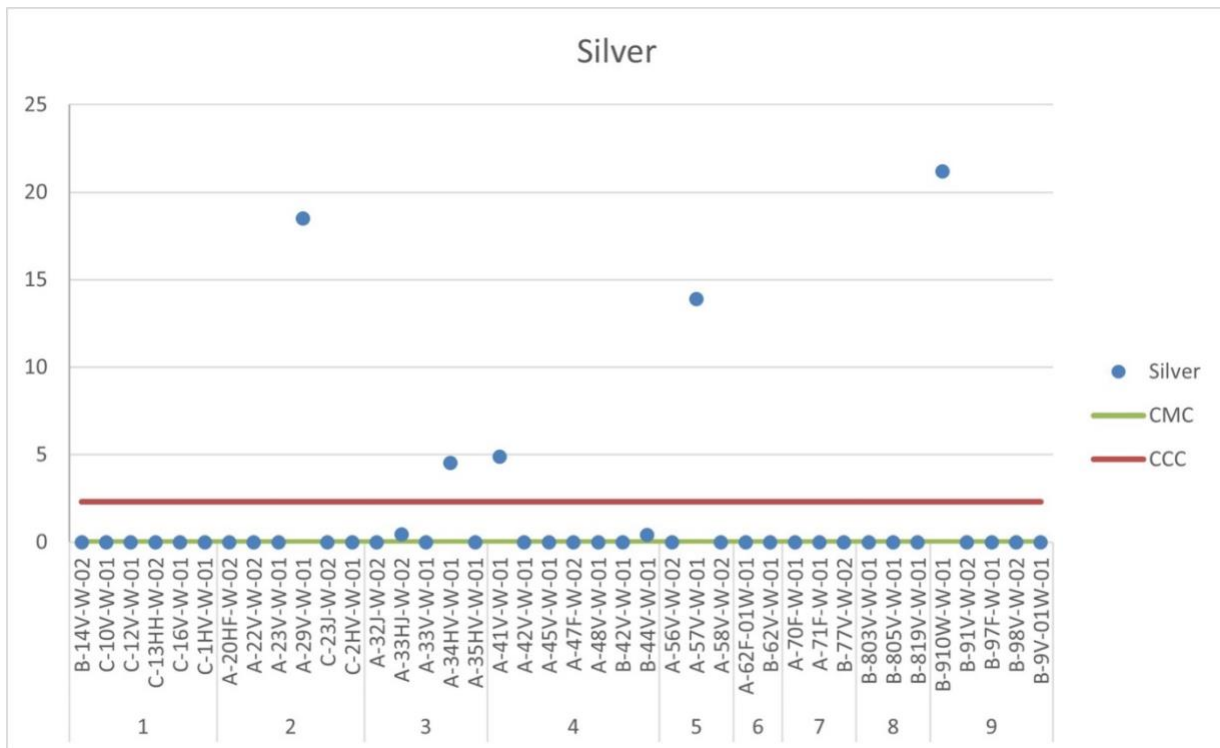
**Figure 3-8.** Concentration of silver in  $\mu\text{g/L}$  in water on the USS *Yorktown*, compared with SCDHEC salt water quality standard.

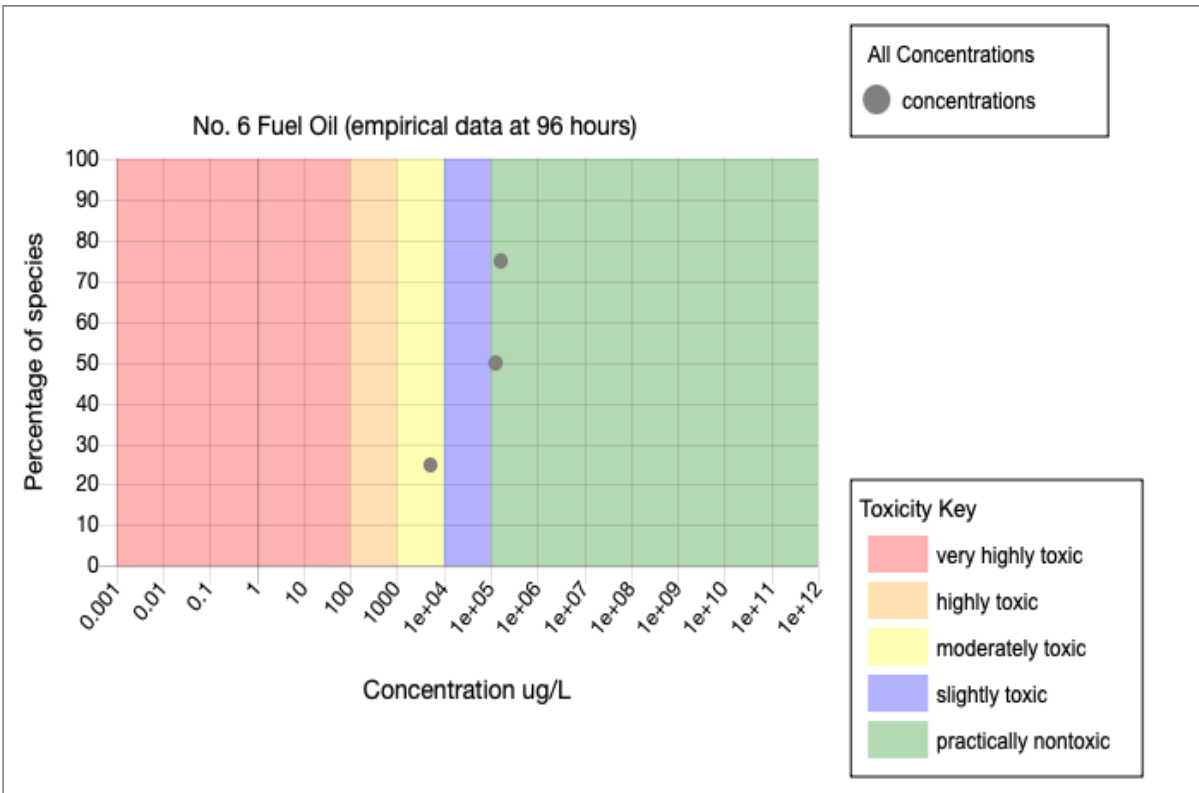
Figure 3-11 shows the species sensitivity distribution plot for all the available aquatic toxicity data in the National Oceanic and Atmospheric Administration (NOAA) Chemical Aquatic Fate and Effects (CAFE) database<sup>2</sup>. The lowest 96-hour LC<sub>50</sub> (concentration that resulted in 50% lethal effects) is 5,100 µg/L for a copepod test. The LC<sub>50</sub> for Atlantic silversides is 130,000 µg/L, and for a diatom is 160,000 µg/L. The release of water from one or more of the tanks with DRO concentrations above 5,000 µg/L on the USS Yorktown would likely cause temporary impacts in the immediate area of the release; with the strong tidal currents in Charleston Harbor, oil concentrations would be rapidly mixed into the water column and diluted below effects levels.

**Figure 3-11.** Species sensitivity distribution plot for aquatic toxicity tests for No. 6 fuel oil, from the NOAA Chemical Aquatic Fate and Effects (CAFE) database

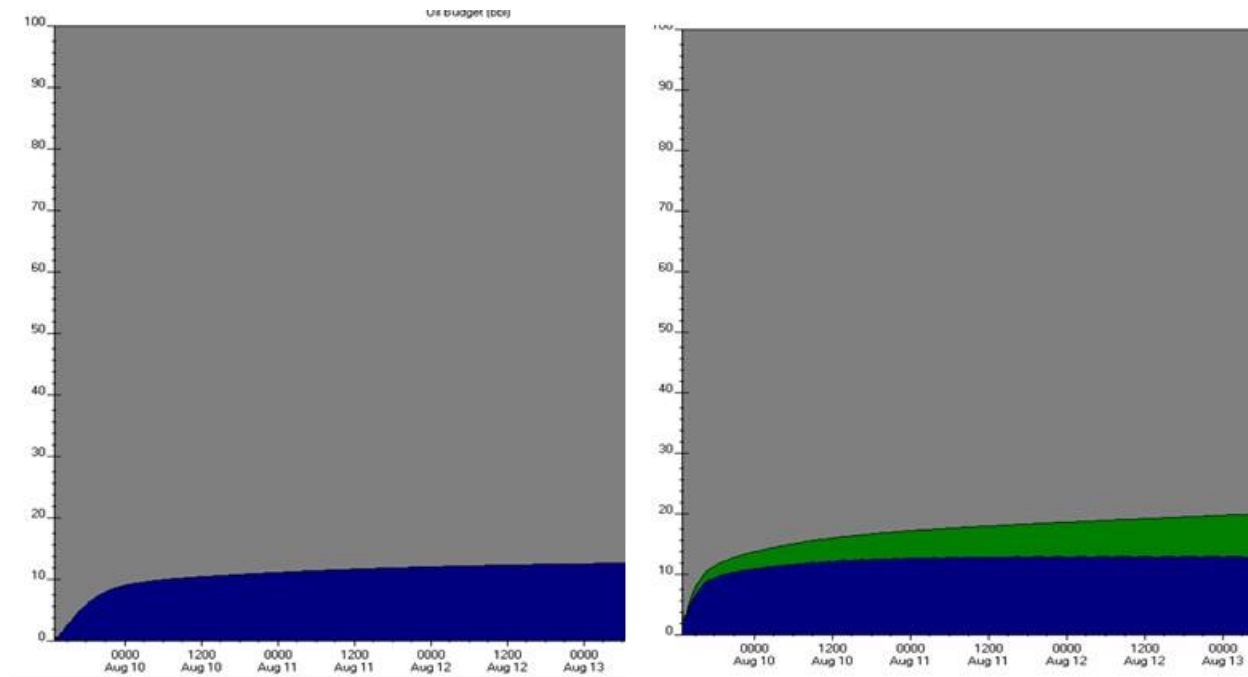
Heavy fuel oil is a persistent oil; only 5-10% is expected to evaporate within the first hours of a spill (see oil weathering plots in Figure 3-12). Consequently, the oil can be carried long distances

**Figure 3-12.** Plot of the oil weathering from the NOAA ADIOS2 model for a heavy fuel oil, with winds of 5 knots (left) and 20 knots (right). Blue = evaporated; green = dispersed; grey = remaining. Note that there is very little natural dispersion, even at wind speed of 20 knots.

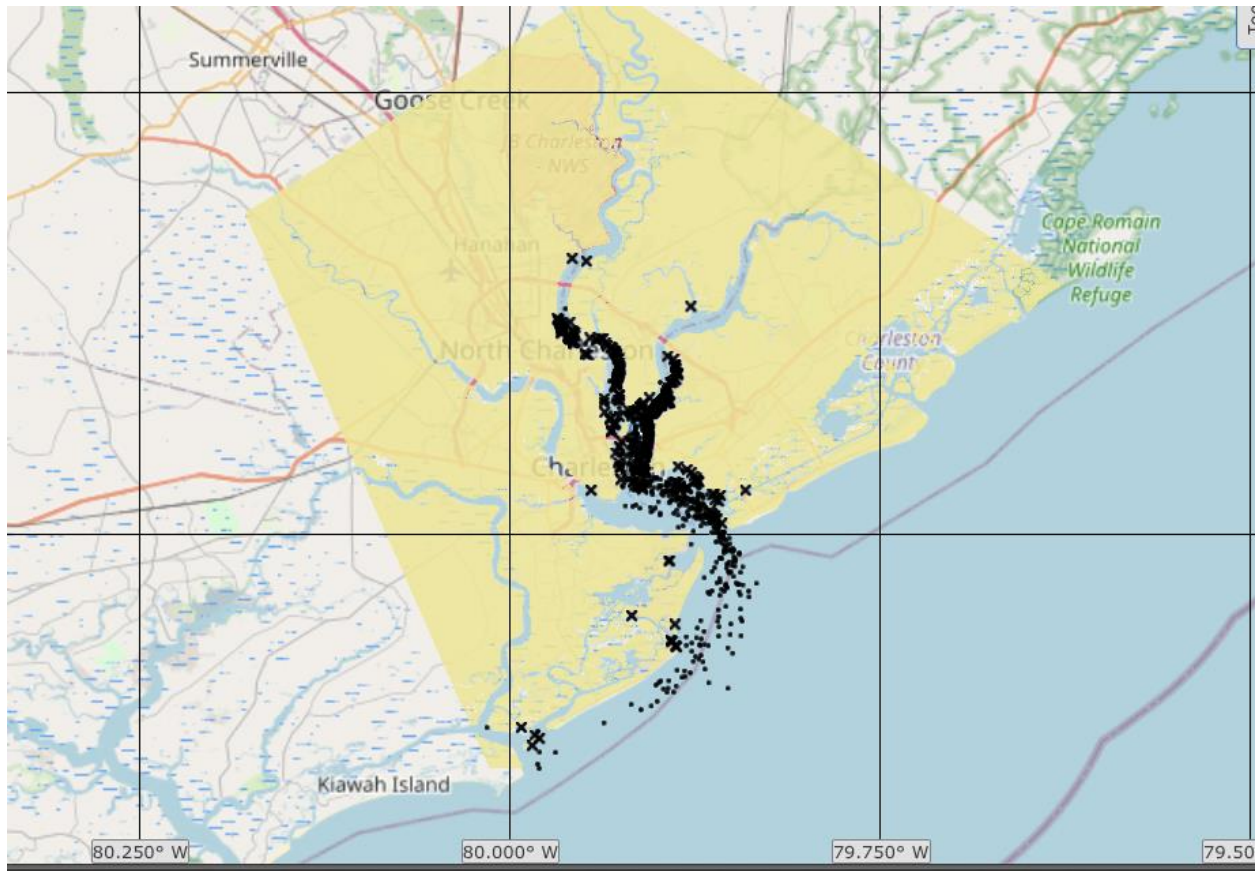
WebGNOME was used to generate an oil spill trajectory for a release of 50 barrels of No. 6 fuel oil from the USS *Yorktown*. The location file for Charleston Harbor, which contain pre-packaged information about tides, currents, and shorelines for the region, was used. Wind data were pulled from the National Weather Service forecast for 8 March 2023. Water temperature was set at 70°F, water salinity at 15 ppt, and sediment load was set at 50 mg/L. The model was run for 2 days. Figure 3-13 shows the spread of the spilled oil. Models were run with different volumes with similar results.

**Figure 3-13.** Trajectory for the release of 50 barrels of No. 6 fuel oil from the USS Yorktown on 8 March 2023, using forecast winds, by running the NOAA WebGNOME model for 2 days.
